Studies of Faults in Used Valves, a Case Studies

R. Dusil

STUDIES OF FAULTS IN USED VALVES. CASE STUDIES

Robert Dusil
Steel Research Center, Uddeholms Aktiebolag, Sweden

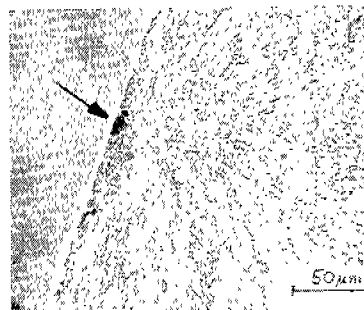
Fig. 3 Crack initiation at a brittle oxidic inclusion.

Fig. 3 shows an oxidic slag inclusion of the Al_2O_3 -type which served as a fatigue crack starter. An area of stable crack growth can be observed around the inclusion.

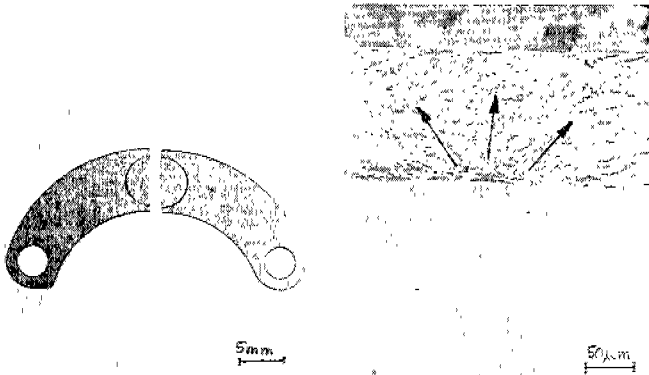
Surface defects such as scratches and rolling defects can affect the service life of the valve. Fig. 4 shows a valve reed which broke in the middle above the hole. Fatigue fracture was initiated at a longitudinal scratch (Fig. 5, 6) perpendicular to the maximum stress under the loading. The appearance of the edge is similar to the tumbled edge (Fig. 7) with blanking marks. However, the surface, which exhibits pronounced polishing scratches, seems to be unaffected by tumbling. Ineffective tumbling and high operating stresses can be regarded as a contributory cause of failure.

Fig. 4 Valve fracture.

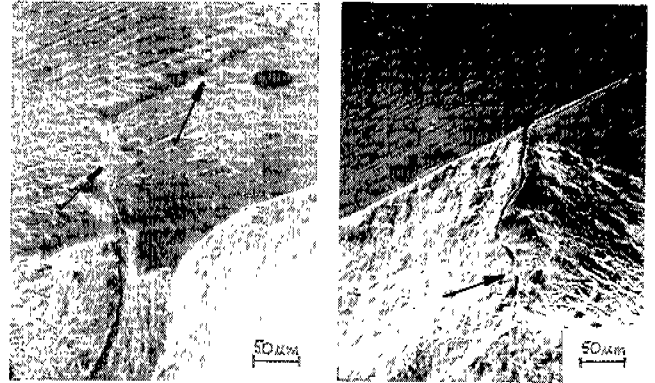
Another example in which the crack follows the

surface scratches is shown in Fig. 8. The part was a valve in the compressor of a pneumatic vehicle brake.

Fig. 8 The crack follows the surface scratch.

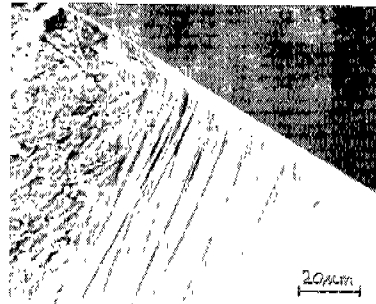
Heavy transverse scratches have a devastating effect on service life (see Fig. 9). The scratches are probably of mechanical origin. Such defects are difficult to eliminate by tumbling due to their depth.

Fig. 9 Fatigue failure started at transverse scratches.

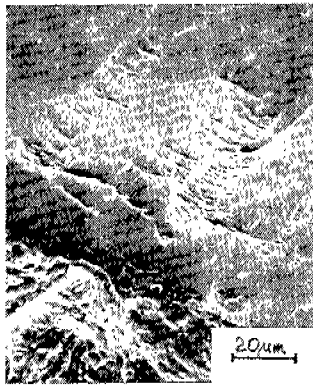
The surface of the valve may contain rolling defects (Fig. 10) rolled-in metal fragments (Fig. 11) and similar defects which may provide starting sites for fatigue cracks. Suction valves shown in Fig. 25 were put into service directly after blanking, i.e. with untumbled edge and surface. Failure was caused by fatigue fracture which started at defects originating from rolling (Fig. 12). The stable growth of the cracks is evident in the pictures.

Fig. 10
Rolling defect.

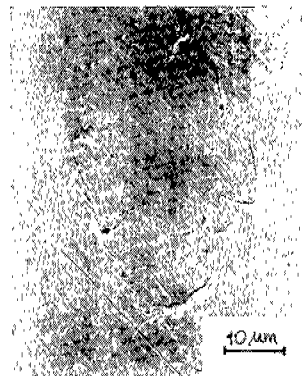
Fig. 11
Metal fragment pressed into the surface of the strip.

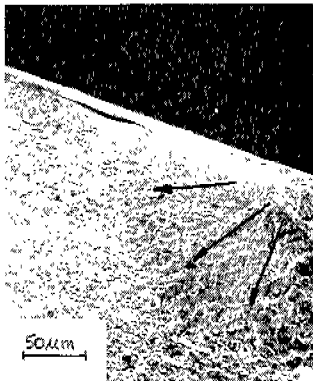
Fig. 12
Crack initiation and stable crack growth at rolling defect.

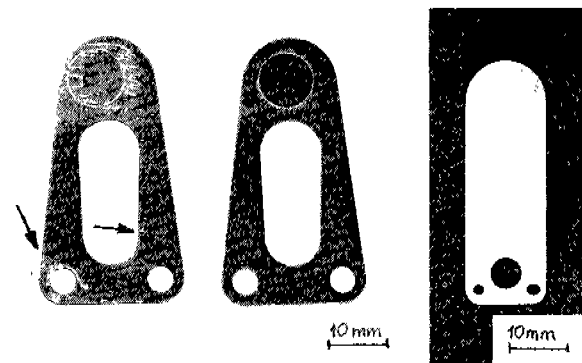
Fig. 15
Valve reeds with slot (left) and hole (right). Arrows indicate fatigue fracture.

Slots or holes which are made to reduce the flexural resistance of the component substantially reduce its service life as well with their defect-riddled edges. Note that this part of the component is subjected to the greatest bending moment.

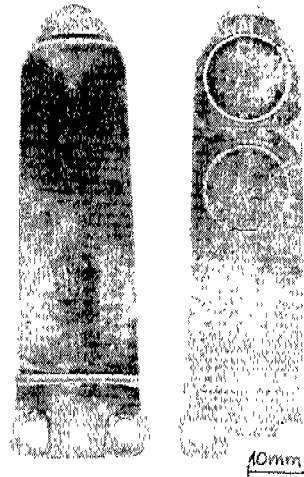
Investigation of valve reeds after extended periods of service (Fig. 18) disclosed shallow grooves in the reed surface which contacts the valve seat and the stop (Fig. 19). These grooves are probably due to wear. Study of these defects revealed a copper desposit and a rounded surface topography without any jaggedness or notches. Crack initiation or fracture has not been found in the worn surfaces.

Fig. 18
Valve reed after 6 years of service.

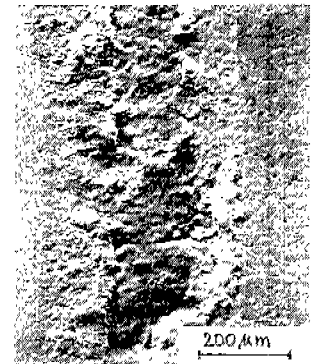
Fig. 19
A copper desposit was found in the groove.

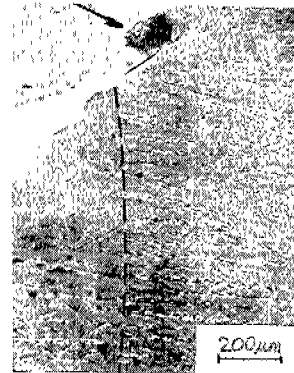
If any foreign particle should land between the contact surfaces, a notch could form. Figures 20 and 21 show the start point and the stable crack growth of the fatigue failure which was formed on the contact surface between the valve reed and valve seat.

Fig. 20
Notch formed on the contact surface (dashed line).

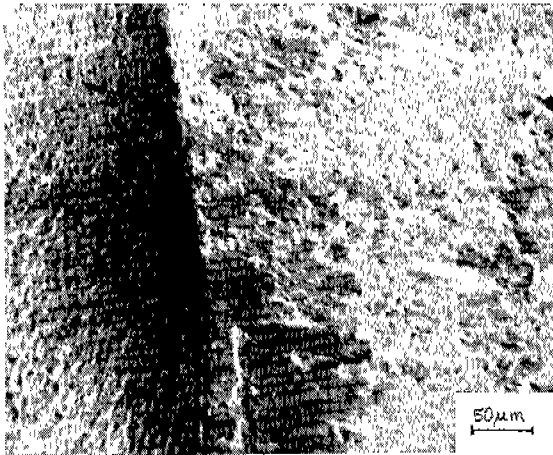
During long-term tumbling, which normally takes place in a moist atmosphere, corrosion attack can occur. If the valve operates in a damp environment, for example when condensate forms in air compressors, the reed may be damaged by rust or by corrosion (9). Fig. 22 and 23 show a part of a broken valve and a detailed close-up of the fracture surface. The reason for the failure was fatigue fracture which started at surface defects caused by corrosion. As is evident from Fig. 23, the notch was very shallow, but note that the crack was initiated and grew stably over a broad area. The valve material was a 1 % carbon steel.

Fig. 22
Corrosion damage on the surface of the reed. Arrows indicate the stable crack growth.

For applications in corrosive conditions, the material should be chosen especially carefully. Service life is substantially prolonged by the use of martensitic stainless steel, UHB Stainless 716 containing 0.35 % C, 13 % Cr and 1 % Mo.

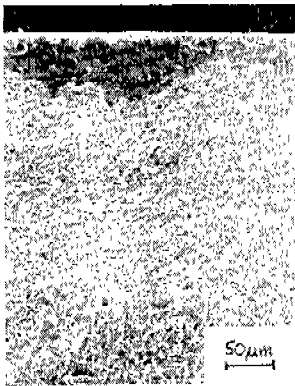
Fig. 23
Fatigue fracture initiated at shallow corrosion pits.

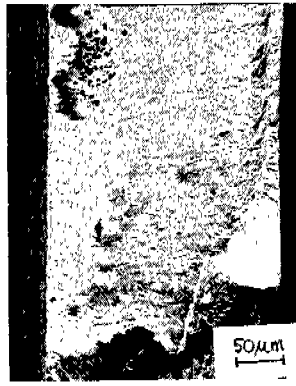
The fatigue fracture shown in Fig. 24 originated as indicated by the fatigue markings, at the

corrosion pit. The pit was approximately 30 μm deep.

Fig. 24
Fatigue crack in a reed valve originating at a surface pit and propagating through the thickness.

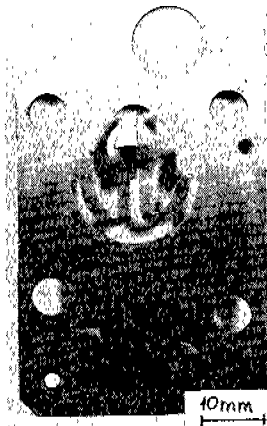
As is evident, thickness and the diameter of the opening are dominant factors which determine the stresses in the reed. If the strength of the material is exceeded, a failure is obtained in the centre of the reed (Fig. 25 and 26), where the highest stresses occur when the reed is bent down. This can be caused by overloading or be due to the failure of other parts of the compressor. In the literature, these stresses are called flexural "overshoot" stresses (8).

Fig. 25
Appearance of the fracture in the centre of the reed.

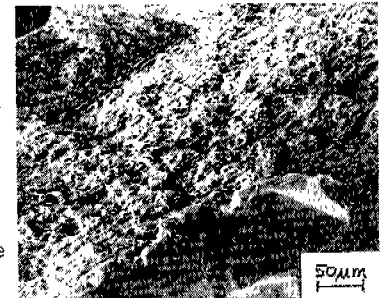
Fig. 27
Ductile fracture with dimples. The fracture surface is partially worn.

Fractographic study on overloaded valve only revealed ductile dimple fractures (Fig. 27). Such fractures are due to obviously undersized valves. No evidence of any fatigue crack starters was found.
