Damage Evaluation of Full-Scale RC Slab by Ultrasonic Tomography

H. Hayashida

T. Ueda

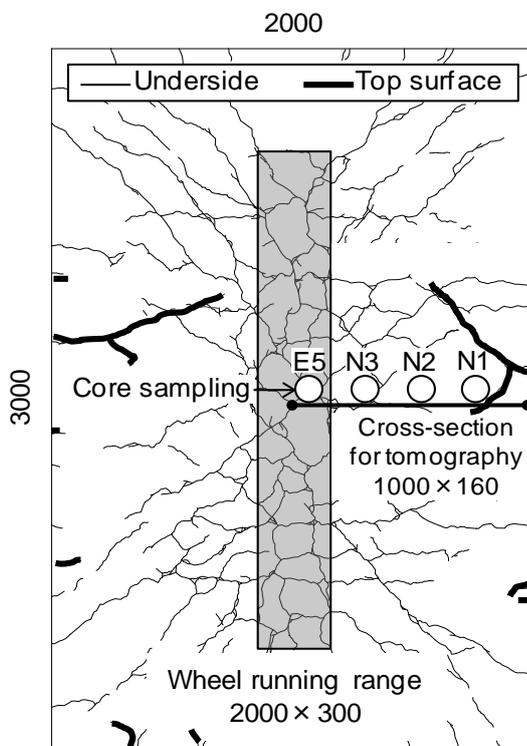
Fig. 3. Cracks in the slab after the wheel running test

In the wheel running test using this running load, the number of runs before the design bending value was attained was 110,000. Cracks in the slab at the end of the wheel running test are shown in Fig. 2. The cracks on the underside are indicated by thin lines, and the cracks on the top surface are indicated by thick lines.

As shown in Fig. 8(d), vertical cracks are seen in the area from the top edge down to about the height of 8 cm. These cracks are observable on the upper surface of the specimen slab, as shown by the thick lines in Fig. 3. These cracks are thought to be generated by negative bending, because Core N1 was close to the supporting point in the wheel loading test. Next, as shown in the top figure of Fig. 7, Region G, which is a region with low velocities in the tomographic analysis, exists on the right side of Core N1. The cracks in Region G may have been generated by negative bending, because they are in the direction of progress of the vertical cracks. Next, regarding the ultrasonic velocity of the core shown in Fig. 8(d), the velocity greatly decreased from the point 7 cm in height to the point 15 cm in height, which seems to correspond to the distribution of the vertical cracks. However, no decrease in velocity that corresponds to the distribution of the vertical cracks is seen in the tomographic analysis shown in the top of Fig. 7. The reason for the above is thought to be as follows. During the wheel running test, the micro cracks opened and closed repeatedly. After the end of the test, the micro cracks closed because the load that opened the cracks was no longer acting on the specimen. Because of the closed micro cracks, the velocity did not decrease around the cracks at the measurement of the ultrasonic propagation velocity of the specimen slab. In the cores, which were used in the measurement of ultrasonic velocity and for fluorescent epoxy resin injection, the micro cracks were open because the confining pressure that had been acting on the specimen was released when the core was taken from the specimen slab. Because of these open cracks in the cores, the velocities in the areas surrounding the cracks decreased and the

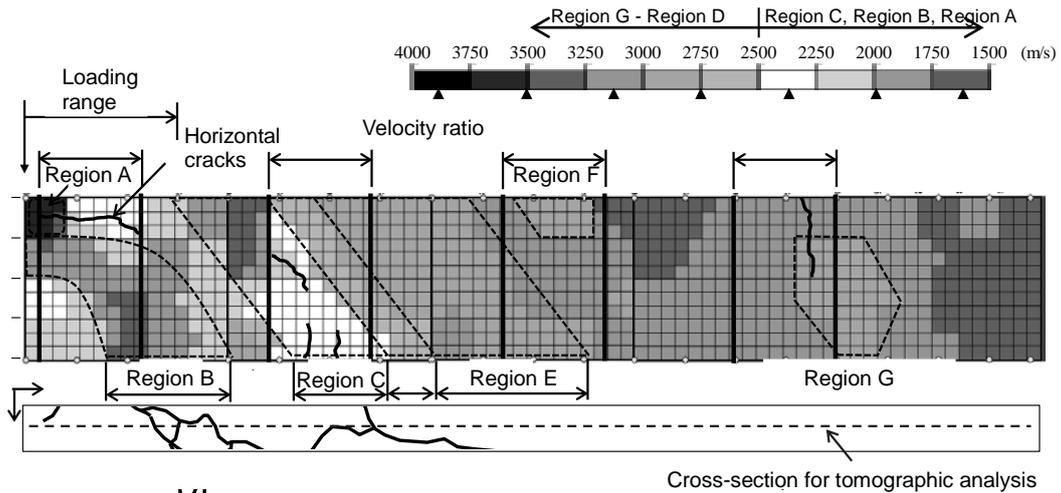
Fig. 7. The results of tomographic analysis of the slab specimen (top) and the conditions of the cracks on the underside (bottom)

In the top of Fig. 7, the ultrasonic velocity calculated for near the horizontal cracks (hereinafter, the velocity) is not constant. The velocity is lower in the left area than in the right area. The reason for the differences in velocity will be discussed in (b).

The velocity for Region A shown in the top figure of Fig. 6 is low relative to the velocities for the regions around it. This region is thought to have received compressive stress and damage because it is near the center of the wheel track and at the upper edge of the specimen. The difference in velocity in the areas near the horizontal cracks is thought to be because damage from compressive stress and damage near the horizontal cracks are mixed in this area. The damage (cracks) from compressive stress are not identified in the Fig. that shows the cracks in the core. It is possible that micro cracks, which are not identifiable by fluorescent epoxy resin injection, occurred. In the other cores, which will be discussed later, the ultrasonic velocity was low; however, micro cracks were not found in the fluorescent epoxy resin injection. Possible reasons for the above are given here; however, the details will be examined in the future studies.

The velocity for Region B shown in the top figure in Fig. 6 is low relative to the velocities for the regions around it. The low velocity found in Region B is thought to be related to the flexural cracks generated by the wheel loading. The reason for the above is as follows. As shown in the bottom figure in Fig. 6, flexural cracks are found in the part of Region B on the bottom surface of the specimen. A previous study (Mihashi *et al.*, 2010) pointed out that micro cracks that were too small to be seen by the naked eye accumulated around the cracks that were generated by tensile stress. In the current study, it is thought that the velocity in Region B was low because of the flexural cracks generated by wheel loading and micro cracks at and around the flexural cracks.

The results of tomographic analysis for the location of Core N3 shown in the top of Fig. 7 shows that the velocity of Region C is low compared to those in the surrounding regions. Region C extends from the edge of the wheel loading range on the top surface of the specimen slab diagonally downward. The cracks discussed in (1) are in Region C. In light of their location and direction, these cracks are thought to appear after micro cracks had developed, accumulated and reached their limit of being micro cracks by punching shear. Based on the above,

Regions D and E, which abut Region C, were found to distribute diagonally and parallel to Region C, which is the region damaged by the punching shear. The velocities in Regions D and E gradually become smaller as one move away from the center of the wheel running track.

As shown in Fig. 8 (c), marked cracks are not found in Core N2. The results of tomographic analysis for the location of Core N2 in the top figure of Fig. 7, in addition to Region E described earlier, show that the velocity of Region F is lower than those in the surrounding regions. Next, the ultrasonic velocities of cores shown in Fig. 8 (c) are examined. The degree of decrease in the ultrasonic velocity is small as a whole; however, the ultrasonic velocity at the locations from the height of 1 cm to 5 cm is low, which corresponds to the velocity in Region E, and the ultrasonic velocity at the location at the height of 15 cm is low, which corresponds to the velocity in Region F. The low velocity in Region F is thought to be from either punching shear damage or compressive stress damage.

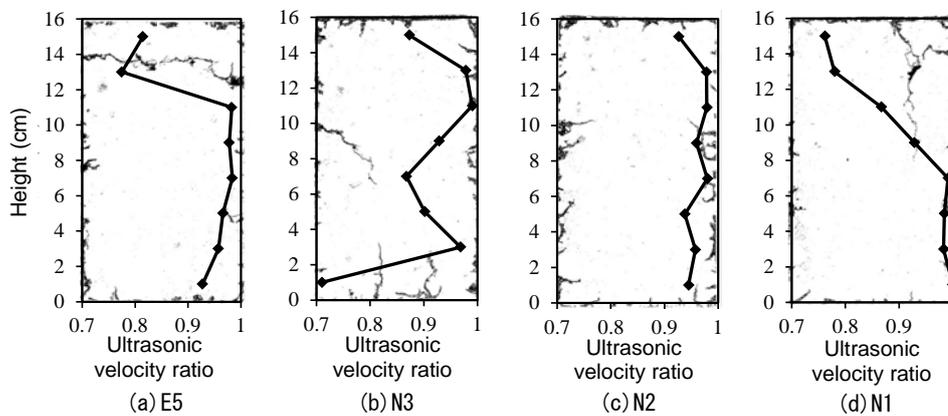
Fig. 8. The conditions of cracks on the cross sections of the cores and the results of ultrasonic velocity measurement

Core E5 is from immediately below the loading range, and as shown in Fig. 8 (a), horizontal cracks were found at heights of about 14 – 12 cm.

As shown in Fig. 8 (a), the ultrasonic velocities at the heights of 15 cm and 13 cm are considerably low. In light of the condition of cracks and the analysis results of tomography, these low velocities are thought to result from damage caused by compressive stress and damage near the horizontal cracks. The degree of lowering in the ultrasonic velocities at the locations from the heights between 11 cm and 1 cm is small; however, the ultrasonic velocities mildly decrease as the waves approach to the lower end of the core. This lowering of ultrasonic velocities is thought to be from the micro cracks discussed in (2) (c).

Core N3 is from near the edge of the loading range where cracks from punching shear are generally thought to occur. As shown in Fig. 8 (b), the existence of diagonal cracks around the heights of 10 – 7 cm and the occurrence of vertical cracks around the heights of 3 – 0 cm are observed.

As shown in Fig. 8 (b), the ultrasonic velocities are very low in areas from the heights of 11 cm to 7 cm and in areas from the heights of 3 cm to 1 cm, both of which are areas with cracks that were discussed in (1). Similar to Core E5, the ultrasonic velocity at the point with a height of 15 cm, which is close to the top edge of the specimen, is much lower than those of other areas.
