Monitoring Historic Concrete and Associated Cementitious Repair- A Case Study of Boathouse 4, Portsmouth Historic Dockyard, UK

A.H. Alwaal and S. Barnett

School of Civil Engineering and Surveying, University of Portsmouth, Portsmouth, UK

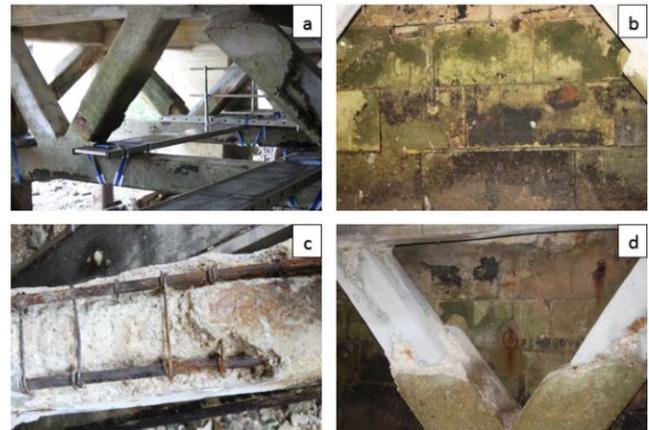
Fig. 2. Deteriorated concrete in the undercroft (Coats *et al.*, 2015)

According to a condition assessment survey report conducted by Concrete Repairs Limited (CRL), deterioration and distress were found on the concrete elements forming the building mainly as a result of either chloride-induced corrosion or carbonation induced corrosion aggravated by chlorides. There was a variation in the condition of the reinforcement exposed within the undercroft wherein some locations, the steel was found to be clean and uncorroded while in other locations, complete loss of section was observed. Conventional concrete patch repairs and cathodic protection were undertaken on the elements forming the undercroft as well in other parts of the building, totalling more than 1000 patch repairs (Pierce., 2013).

Figure 2 presents several pictures of damaged concrete in the undercroft of BH4. Based on the visual observations shown in Fig. 2, the concrete damage process could be described as follows:

- General view looking across the undercroft. Note the faint green staining to the elements indicating the typical level of the tides (shown in Fig. 2(a))
- Green vegetation growth possibly indicating historic water penetration into the structure (shown in Fig. 2(b)).

- Exploratory breaking out into an area of spalling. Note the condition of the reinforcement with some loss (shown in Fig. 2(c))
- Sub-efflorescence, rusts staining and repair (shown in Fig. 2(d))

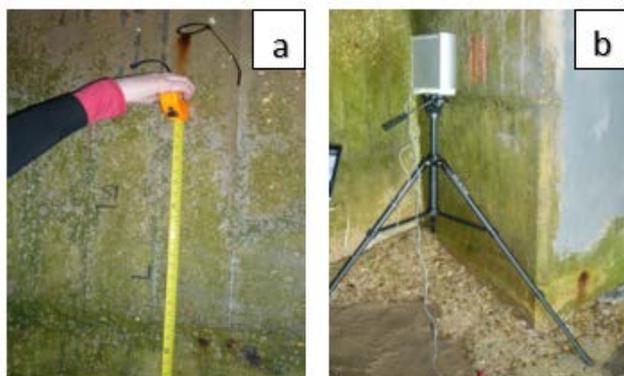
Fig. 4. Patch 1: (a) Shows the dimensions, (b) Shows the scanner set up

Patch 1 identifies the presence of algae growth on concrete. The patch is located on a wall, slightly above the high tide level. The scanned area is 160 mm h x 100 mm w (shown in Fig. 4 (a) (b)).

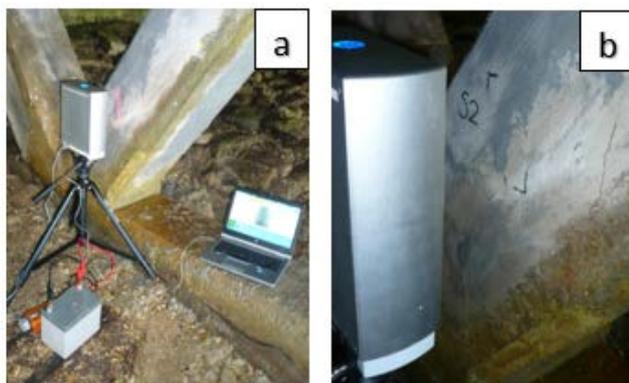
Fig. 5. Patch 2 truss element: (a) shows the scanner, external battery and laptop for data acquisition, (b) Shows an up-close view of the scanned area

Patch 2 is located on a diagonal truss element, slightly below the high tide level. The scanned area is 130 mm h x 90 mm w (shown in Fig. 5 (a) (b)). The white area on the top left-hand side of the scan identifies brushstrokes where a patch repair has been applied to the truss, so the patch includes both original concrete and repair materials.

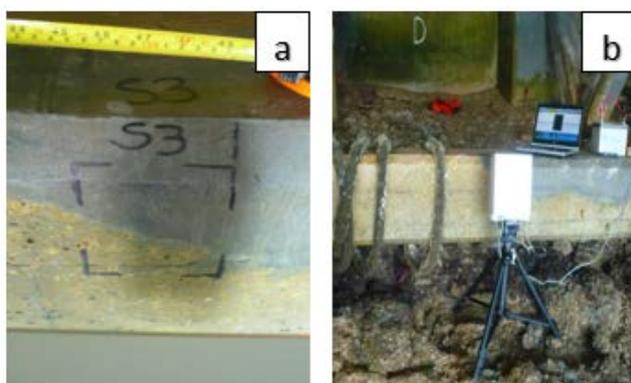
Fig. 6. Patch 3: (a) shows the dimensions, (b) Shows the scanner set up

Patch 3 is located on a horizontal beam, closer to the low tide level than the other sites. The scanned area is 135 mm h x 95 mm w (shown in Fig. 6 (a) (b)). Each patch was scanned three times over the space of three years. Data from two sets of scans taken 9 months apart are presented here.

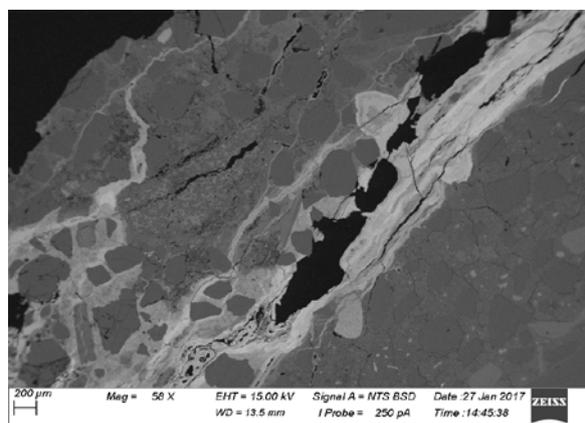
Fig. 7. Backscattered electron image (BSE)

Figure 7 shows Backscattered electron image (BSE) of concrete with some rust from corroded steel which has gradually been washed out of the concrete (white areas on the image). Mapping of elements of this region given in Fig. 8 shows the presence of S (sulphur), Na (sodium) and Cl (chlorine) which is an indication of the presence of sodium sulphate (Na_2SO_4) and sodium chloride (Na Cl).

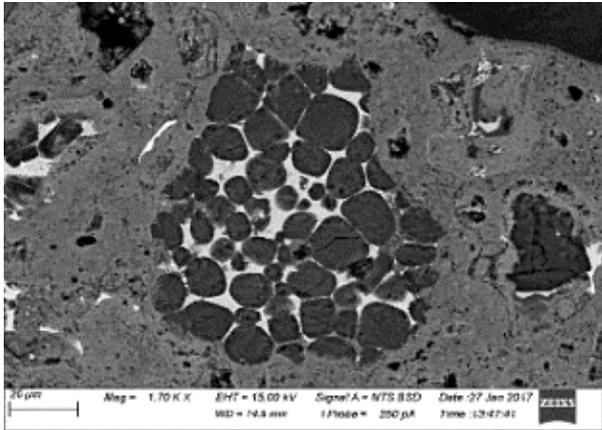
Fig. 9. Backscattered electron image (BSE)

Figure 9 shows Backscattered electron image (BSE) of concrete with a cluster of particles similar in appearance to belite nest (Pintér & Gosselin, 2015) However, element maps show no Ca in the darker particles which are rich in Si only. Fig. 10 illustrates the mapping of elements in this region.

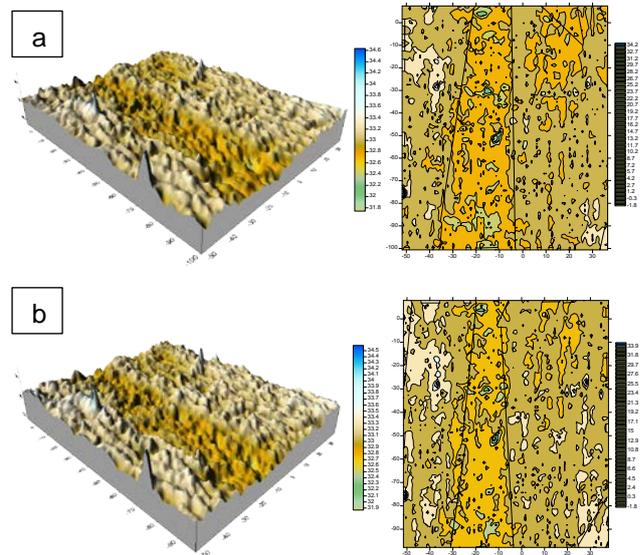
Fig. 11. Generated 3D and contour maps of patch 1 using Surfer software: (a) Reference scan (first scan), (b) Compared (second scan) 9 months later

Figure 11 illustrates the surface topography of patch 1: (a) reference (first) scan, (b) compared (second) scan 9 months later. The global values are very similar. However, there are some localized feature changes.

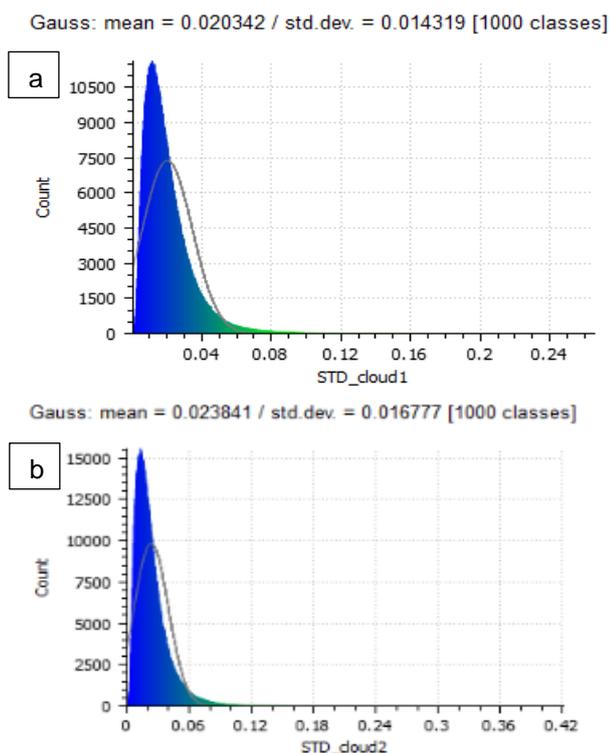
Fig. 12. Histogram plot of STD cloud 1&2

Figure 12 illustrates a histogram plot of (a) cloud 1 (reference), (b) cloud 2 (compared). The statics illustrate no significant changes as the roughness has not considerably changed with standard deviations being 0.014 mm and 0.017 mm for the first and second scans.

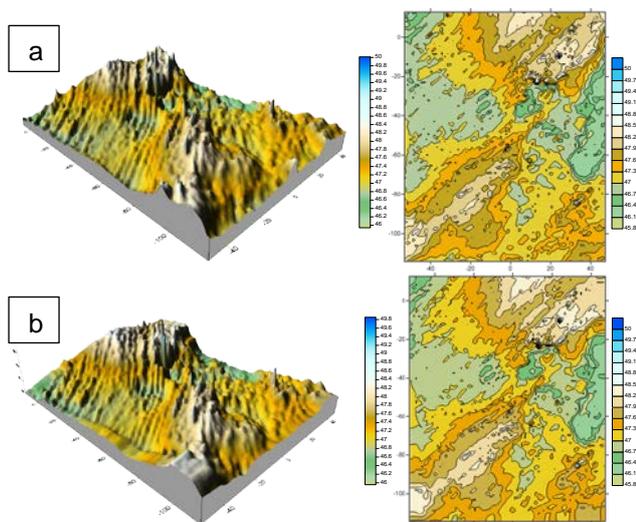
Fig. 13. Generated 3D and contour maps using Surfer software: (a) Reference scan (first scan), (b) Compared (second scan) 9 months later

Figure 13. illustrates the surface topography of patch 2, (a) reference (first) scan, (b) compared (second) scan 9 months later. The maps clearly show almost every points are the same in relation to every other point. No changes could be detected.

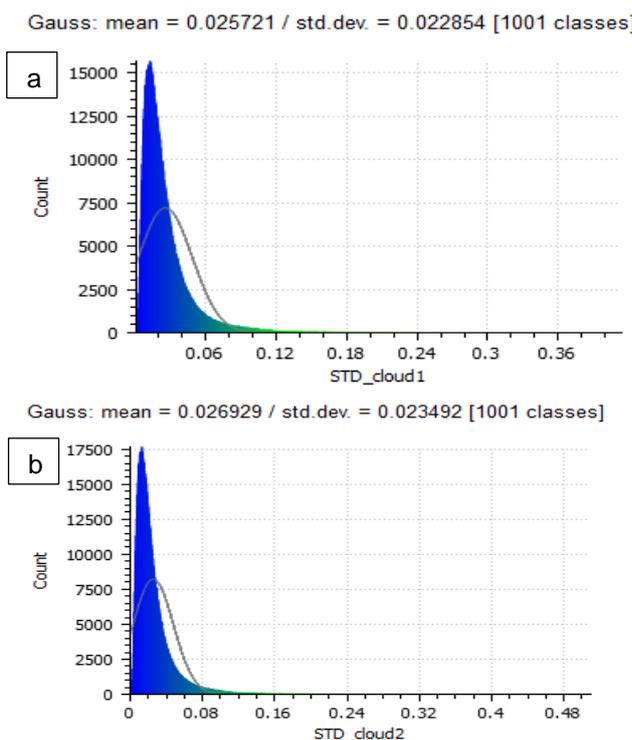
Fig. 14. Histogram plot of STD cloud 1&2

The results below indicate the surface roughness is consistent over time where the standard deviation is 0.023 mm in both scans as shown in Fig. 14 (a) (b).

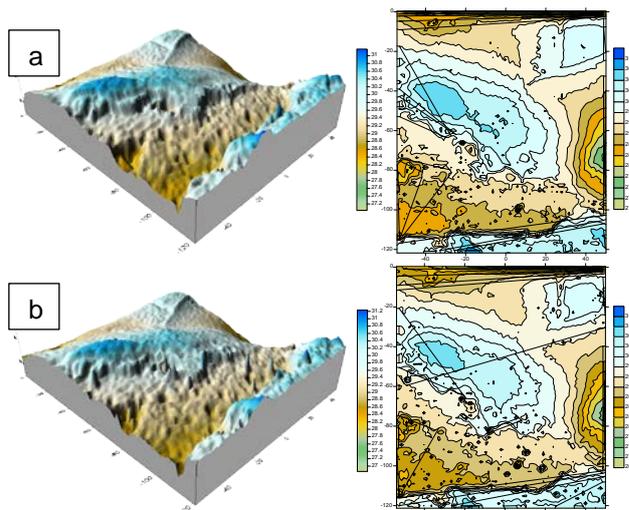
Fig. 15. Generated 3D and contour maps using Surfer software. (a) Reference scan (first scan), (b) Compared (second scan) 9 months later.

Figure 15 illustrates the surface topography of patch 3, (a) reference (first) scan, (b) compared (second) scan 9 months later. Changes in surface form have occurred at some particular locations. This patch is

closer to the seawater, so changes in the surface are expected to occur more rapidly than other patches. It reflects the exposure of the surface concerned. Moreover, visual evidence identifies a change in colouring to the repair material over time (as shown in Fig. 16).

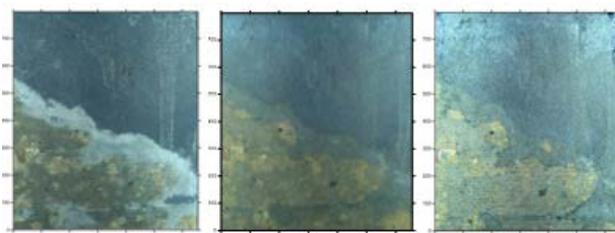
Fig. 16. Repair colour changes over time

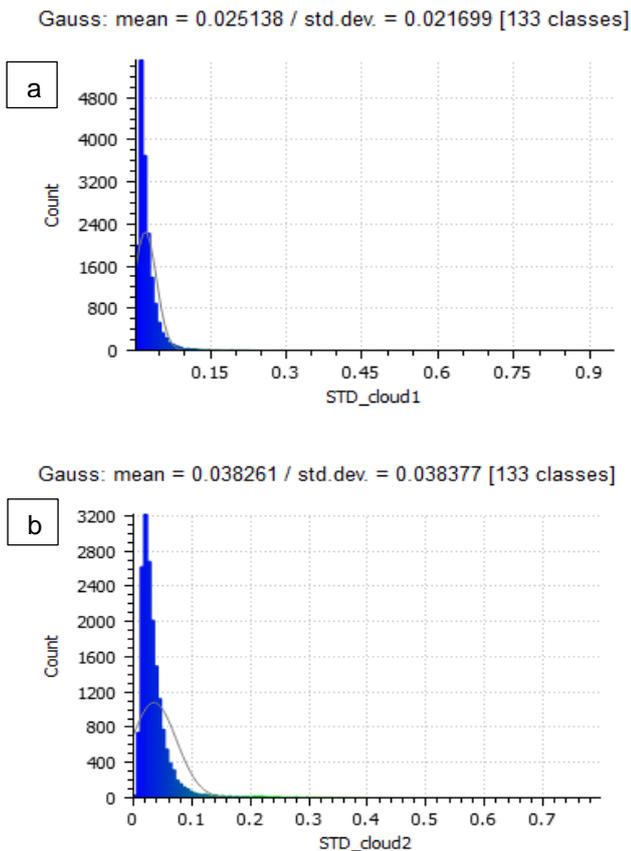
Fig. 17. Histogram plot of STD cloud 1&2

The roughness has increased over time between the two clouds where the standard deviation in cloud 1 is 0.022 mm compared to cloud 2 which is measured at 0.038 mm (as shown in Fig. 17 (a) (b)).
