Rehabilitation of Low rise RCC Structure along 9m High Retaining wall

A. Nakhawa

V.B. Deshmukh

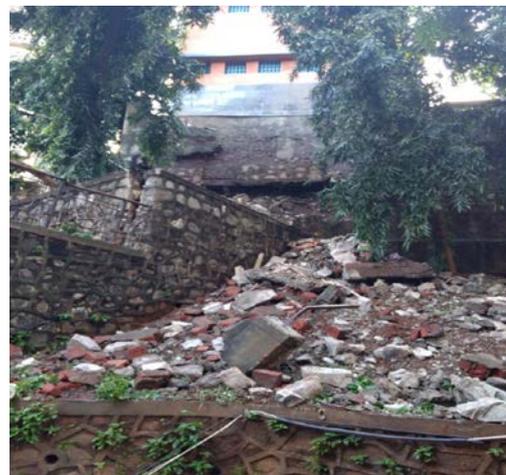
Fig.2. Partial Collapse of Old Retaining wall

In the last year monsoon (rainy season), due to high rainfall intensity duration of 100 mm/hr, the East Side of the retaining wall was partially collapsed. The high intensity of rainfall caused the rise of pore pressure, which subsequently increased the earth pressure. The high earth pressure swayed away the soil deposit beneath the foundation of retaining wall over the length of 10 m at two different locations as shown in Figs. 5 and 6. The retaining wall was in equilibrium condition as no crack was seen in the outer surface of the wall as well in the above structure.

The immediate rehabilitation of failure was to seal the cavity beneath the foundation. The failure zone beneath the foundation was rectified by injecting low pressure cement grout followed by the false brick work of 450mm thick. The brick wall was raised gradually in stages of 0.6 m vertically from the level where it was disrupted. The gap of 0.6 x 0.6 m along the length between stabilized soil and brick wall was filled up by M25 grade concrete. Weep holes using perforated pipes of 0.65 m diameter were made aligned staggered at spacing of 0.9 m c/c. The brick wall of 450 -600 mm thick was plastered externally with 25 mm thick in 1:3 mix rich cement mortar. The rehabilitation work was observed at regular time interval for 45 days and no further distress was observed.

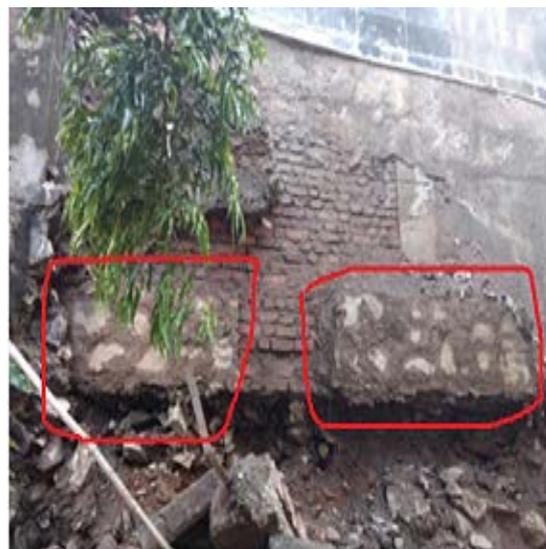
Fig.5. Soil below the eccentric Footing is seen to be partially slipped off

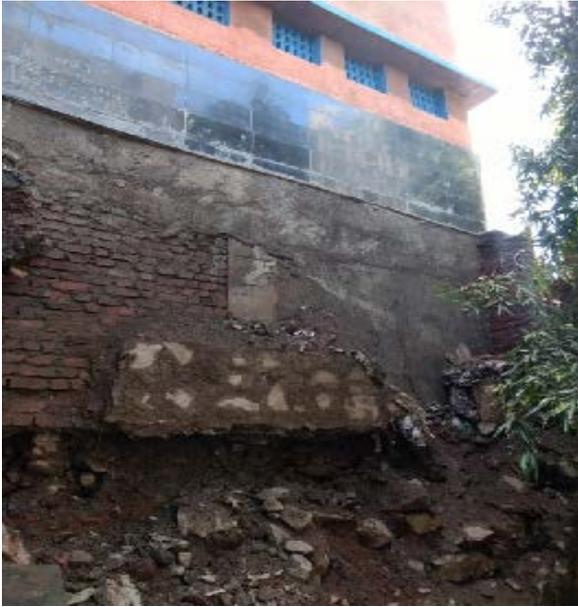
Fig. 6. Soil below the eccentric Footing is seen to be partially slipped off

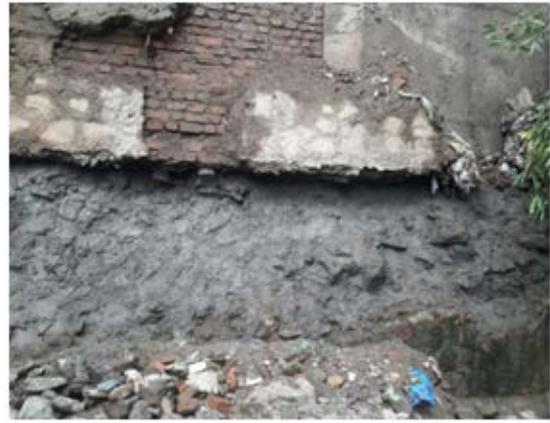
Fig. 7. Immediate soil stabilization by Cement grouting and plaster

The slipped soil was stabilized by cement grouting and plastering the same (Fig. 7) – this was done immediately after a lapse of 4-6 hours from the partial collapse and was followed by a false brick work 450 mm thick, as immediate support mechanism, which was raised gradually from the level where the wall was disrupted, in stages of 600mm vertically. Grouting was carried out using rich cement slurry at low pressure. The gap between the stabilized Soil and the brick work was filled and casted with M25 concrete in stages of 600mm in height and with an average width of 600mm (Fig. 8).

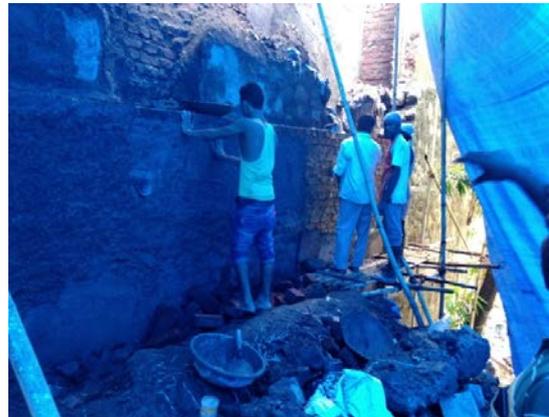
Fig.8. Immediate support mechanism by 450-600mm brick work

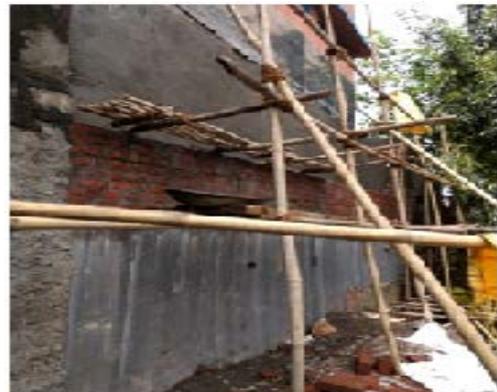
Fig.9. Plastered wall WIP

Weep holes aligned staggered at 900 mm c/c using perforated 65-75mm diameter pipes are provided. The 450 -600mm thick brick work is plastered externally with 25mm thick rich cement mix 1:3 mix (Fig. 9). The above works were carried out to improve the better stability for the structure behind.

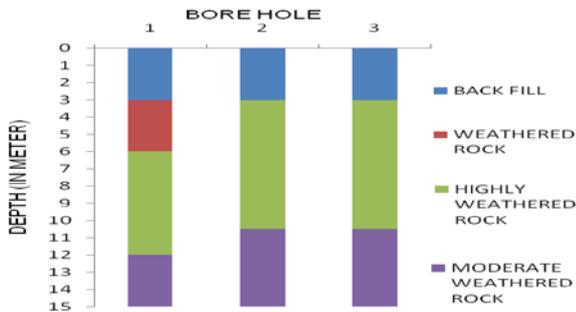
to 3 3m from the ground level. It is followed by medium to highly weathered rock up to average depth 12 m below the ground level. The bottom most layer interacted is moderately weathered condition. The bore holes were terminated at 15 m below ground level. This showed that the foundation was laid on the highly weathered rock and was safe to resist the load of toilet block. The second and third layers are weathered to highly weathered condition which is underlain by moderately weathered rock deposits. It is clear that foundations of the structure were laid on the second and the third layer of the soil, and that it was in line with design proposed.

Fig.10. Bore Logs taken on the Site

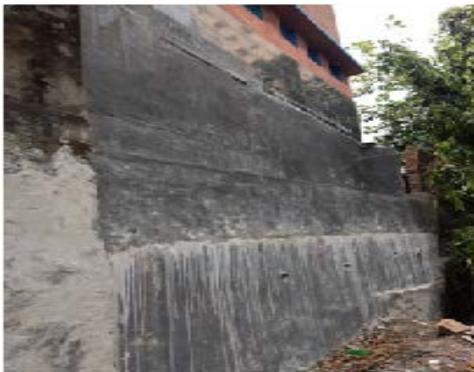
Fig. 29. Retaining wall after completion

The methodology was designed for successful rehabilitation of partly distress retaining wall supporting the toilet block structure. The partial slipped off of supporting soil beneath the retaining wall was stabilized using cement grouting subsequently supported by stepped brick retaining wall. The wall was safeguard against the excess pore pressure due to rain water using weeping holes. The distress or displacement in the toilet block was verified by NDT tests and progressive load test. The results of the tests are within the permissible limits as per Indian Standards. Moreover rehabilitated retaining wall is performing satisfactory without any distress or settlement after it has
