Improvement of abnormal wear between the vane-slot and vane in Rotary Compressor

Bo HUANG*, Guo qiang GAO

SHANGHAI HITACHI ELECTRICAL APPLIANCES CO., LTD.
SHANGHAI 201206 CHINA

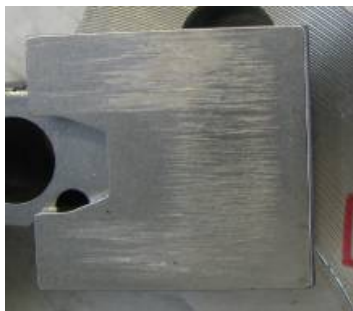
On March 8, 2011, Hefei Gree stopped using one of our compressor models because of the high rate of the lower limit of this model. Until December 2010, At Hefei Gree two compressors stopped running (locked) and 5 compressors having the problem of suction and discharge. After disassembly it was found that it was the abnormal wear that leads to the vane being stalled (Fig.1&2)

Fig.1 Heavy wear

Compressor 1 #: locked, the weight is 20.21kg, Both the sides of the vane and vane-slot have abnormal wear; Apparently lack of oil, oil poured out during disassembly about 100 ml.

Add a oil channel at the cylinder vane slot. As the compressor starts, the back and forth motion of the vane can bring the oil from the oil channel to the gap of the vane and vane slot

To sum up: Adding an oil channel at the vane-slot is the most suitable method. It will be the first to be implemented to the production models

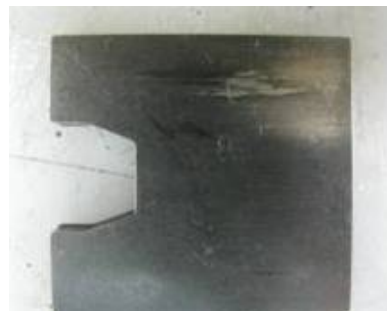
Fig.2 Localized wear

Compressor 2#: No suction and discharge of the gas, the weight is 20.37kg, low pressure side of the vane has abnormal wear and corresponding place of the vane-slot has evident wear, oil poured out during disassembly of about 200 ml.

(2) From the location of the wear, there is something common, if it is the local abrasion then the location of the wear is close to the upper-bearing side.

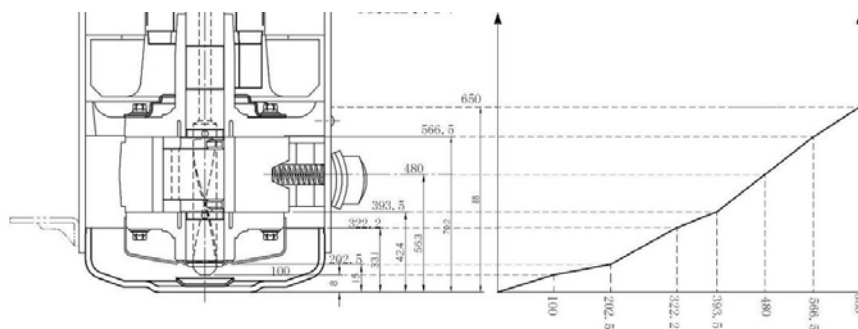
From the calculations the oil surface reaches to the edge of the upper bearing, By the observation, the oil level surface is up to six point welding done at the upper bearing and the shell 。 To this compressor model, the actual oil amount has reached the upper limit of the volume, The amount of refrigerant allowed is 2300 g, So the oil dilution rate: 0.213 (Generally oil dilution rate should be greater than 0.2)。 From the design perspective there is no problem with oil dilution rate. As discussed with the customers, it cannot be confirmed that the amount of refrigerant into the compressor has exceeded 2300g or abnormally high. But the amount of refrigerant input into the air-conditioning system is designed to be 2100g and is less than the value we allow.

Fig.3 The location of Oil surface

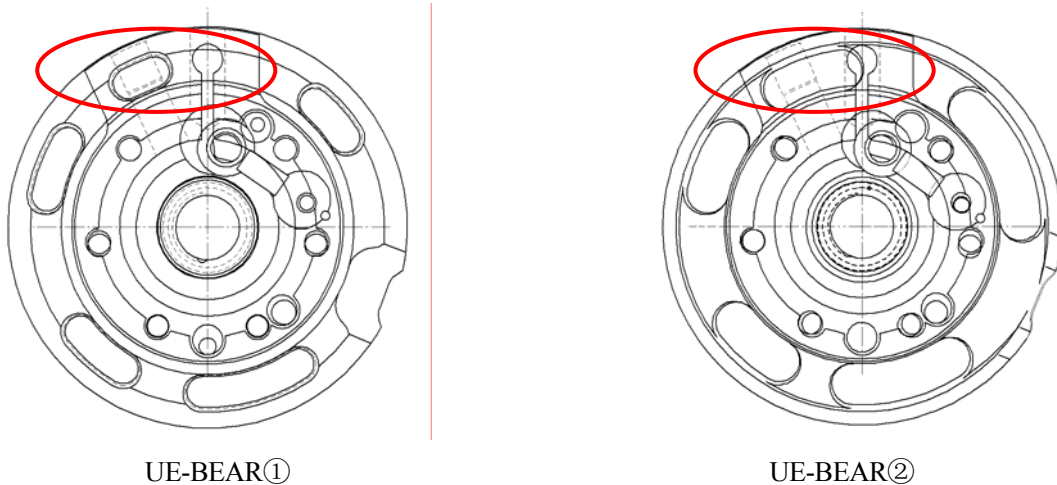
The kidney shaped hole at the upper-bearing which we are using now is not in contact with the vane-slot (UE-BEAR①) and this would affect the lubrication of the vane-slot. Otherwise if the hole is in contact with the vane-slot(UE-BEAR②), It will increase the lubrication at the vane-slot. Later we will make efforts to improve the lubrication structure.

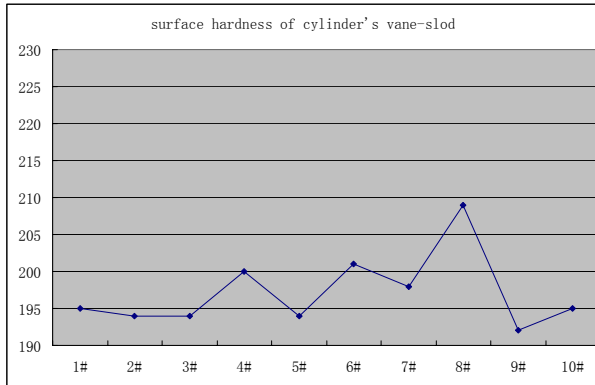
Fig.6 Surface hardness of the cylinder's vane-slot

From the hardness distribution Graph, The surface hardness of the vane-slot is closed to the lower limit (Requirement value 190 ~ 230).

Currently used, Cylinder hardness of HB 190 ~ 230, actually the hardness of the vane slot is about HB 185 .We can improve the cylinder hardness from HB200 to HB240. This can reduce the probability of occurrence of adhesive wear; the drawback is that, with the increase in the cylinder hardness machining process becomes difficult

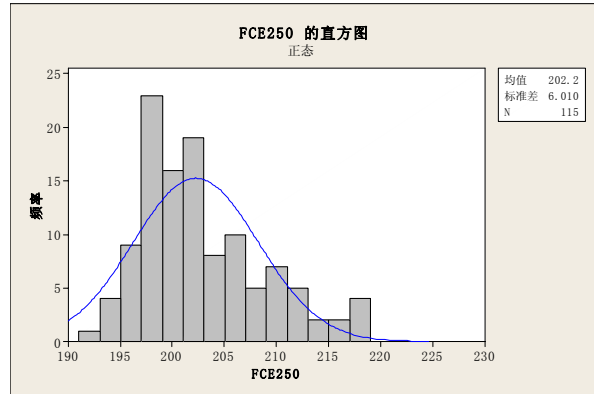
Fig.7 Bulk cylinder hardness distribution

The hardness survey data, Cylinder hardness distribution of FCE250 material, the middle value is close to the lower limit. According to the data, during mass production process, there must be some cylinders having hardness value less than the lower limit.

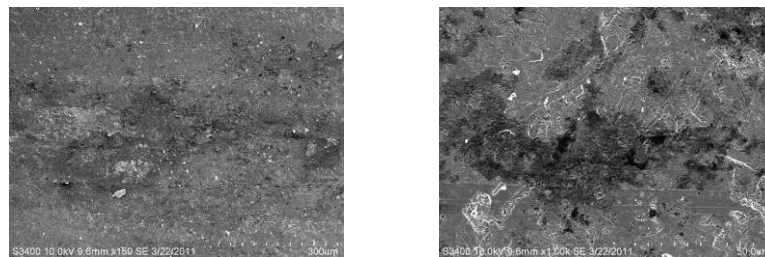
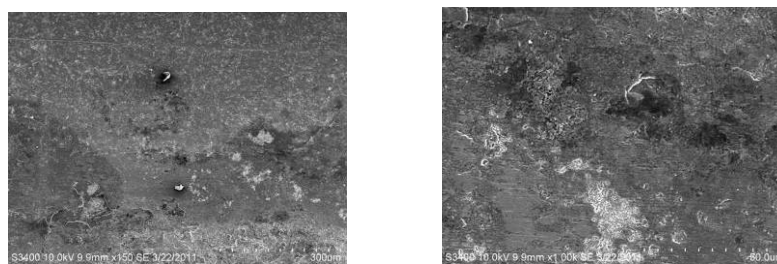
Fig.8 electron microscopy analysis 1

- 1) The friction at the high pressure side is more evident than at the low pressure side. And the friction on the both sides is relatively even, no apparent scratch caused by the foreign particles.

- 2) The black material content shown in the figure has a relatively high ratio of carbide and some other alloy elements but has no nitrogen elements
- 3) The grey and the white area contains nitrogen element and should be nitriding vane surface immersed in the sulphur

- 4) From the linear component analysis, black area has the high ratio of carbon, high ratio of alloy elements, less content of iron and nitrogen
- 5) From the conclusion above temporarily whether the friction caused by the expansion or the material transfer of cast iron cylinder happened at the vane surface. Because no matter the martensite or the remaining austenite leads to the expansion .Vane surface overheated and decarbonizes or the material transfer both will cause the high ratio of carbon and less ratio of iron at the surface

High pressure side friction marks morphology

Low pressure surface friction marks morphology

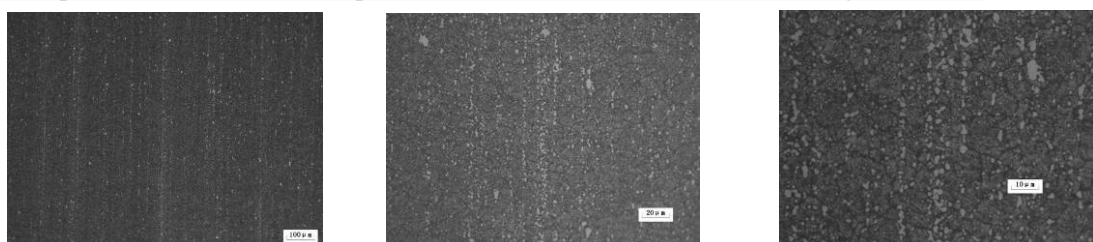
Vane heat treatment process consists of mainly quenching and tempering many times. Metallographic analysis found that carbide grain boundary along the separation, At high magnification, we can observe the needle shaped and hidden needle shaped martensite, but cannot see the remaining austenite,

Fig.9 electron microscopy analysis 2

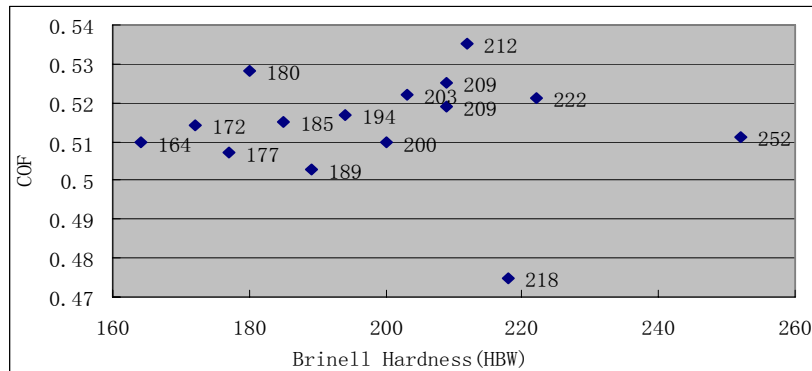
A) With the increase of Hardness, friction coefficient also increases

Fig.10 Relation between coefficient of friction and Hardness

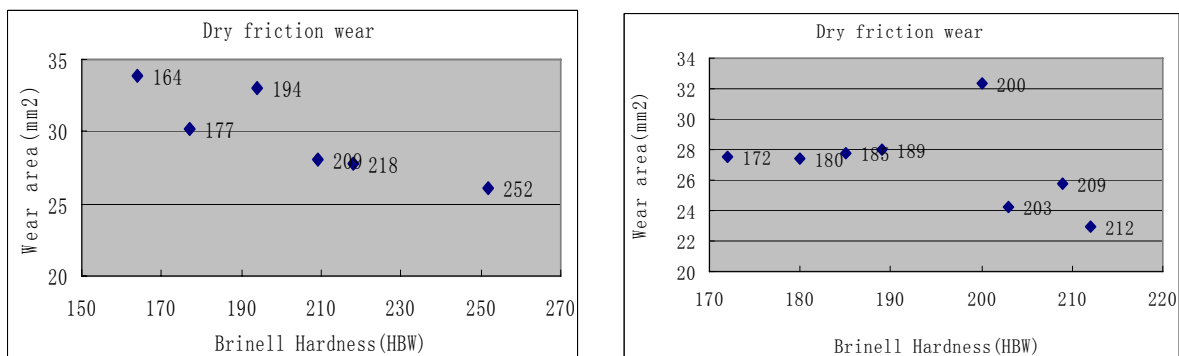
B) With the increase in hardness, cylinder wear tends to be slightly lower.

Fig.13 Relation between Wear size and hardness

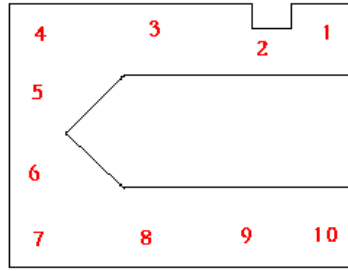
Fig.14 Points selected to measure the deformation

From the statistical data , After assembly of the pump and welding, the part of the vane-slot near upper bearing has larger deformation .Due to which the clearance between the vane and the vane slot decreases

6 Can improve deformation caused during the welding process

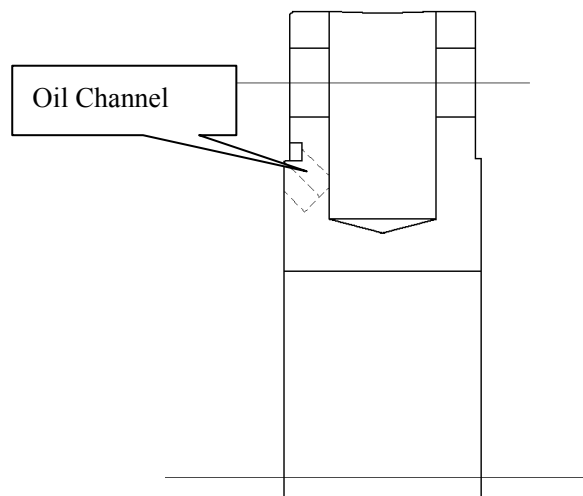
Fig.19 Oil channel

After adding oil channel to the vane-slot. Even though the clearance is decreased to 10 μ m.It can run normally. But if the clearance is decreased to 8 μ m, the compressor can work but the operating condition

cannot be established. The friction between the vane and vane-slot increases, the vane cannot move properly and vane is not able to make the contact with the outer diameter of the piston during the process. So the operating condition cannot be established. So adding the oil channel at the vane slot can improve the oil lubrication and reduce the probability of the compressor from being locked or having abnormal wear
