FHWA/IN/JTRP-2000/1

EVALUATION AND POLICY FOR BRIDGE DECK EXPANSION JOINTS

Luh-Maan Chang Yao-Jong Lee

School of Civil Engineering Purdue University

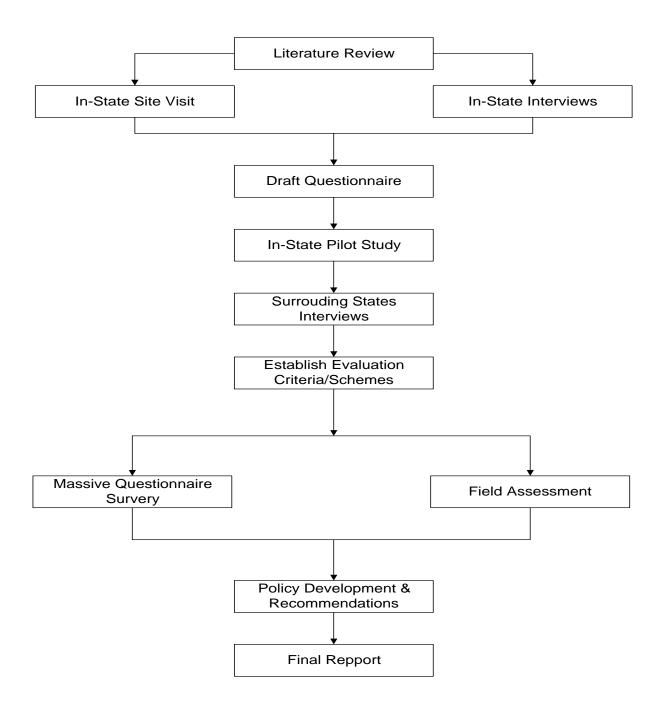
Figure 3.1 Research Methodology

A flow chart depicting the methodology of this research is shown in Figure 3.1 below.

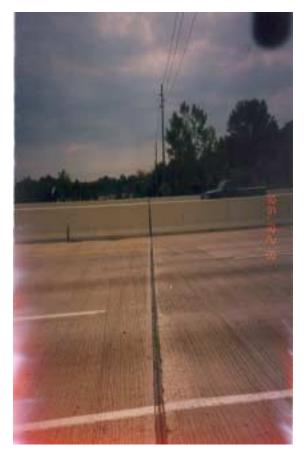
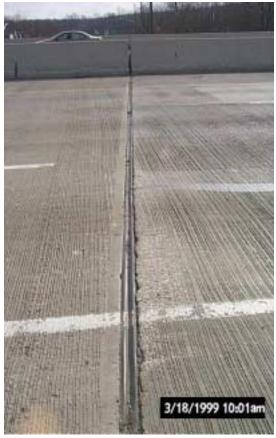
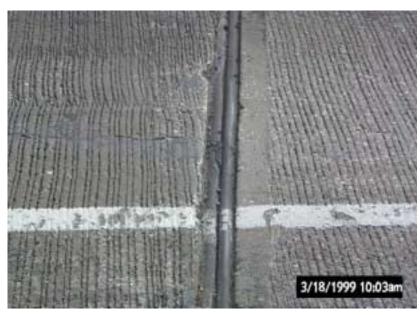
B.S. JOINT

JOINT TYPE	LOCATION	BRIDGE CODE	PAGE
B.S.	I-465 over Fall Creek Road	I-465-123-4267B	G2
FLEXCON 2000 (1)	I-65 and Greenwood Road	I-65-100-55-59-B	G3
FLEXCON 2000 (2)	I-70 adjacent to Harding Street and Conrail	I-70-76-2385A	G4
I.A.	South Port Road over Little Buck Creek	I-65-104-55-64- DRA	G5
LDI		I-70-76-5394B	G6
MODULAR	I-65 over White River	I-65-118-4915C	G7
PAVETECH (1)	I-65 over Dr. Martin Luther King Drive	I-65-116-4913B	G8
PAVETECH (2)	I-65 at Clinton Street	I-65-117-4914C	G9
SLIDING PLATE AND TOOTH FINGER	I-70 Eastbound over Rural Street	I-70-19-2432B	G10
S.S. (1)	38 Street Eastbound Lane over I-65	I-65-118-4636B	G11
S.S. (2)	I-74		G12
XJS (1)	I-74 at east side of Indianapolis	I-74-94-4211C	G13
XJS (2)	I-59 near Carbon		G14

Spalled concrete and loose seal were selected and designated as the most severe problems for this type of joint. Loss of concrete for B.S. joint leads to loose joints and leaks with subsequent salt deterioration and spalling of back wall, substructure bridge seats, and bearing areas. This in turn can cause raised decks and have an impact on traffic. Debris problems also occur in some cases and the seal can become hardened, whereby no expansion back to the original thickness occurs after a period of time.
