# JOINT TRANSPORTATION RESEARCH PROGRAM

SPR-3472

## Evaluation of Effects of Super-Heavy Loading on the US 41 Bridge Over the White River

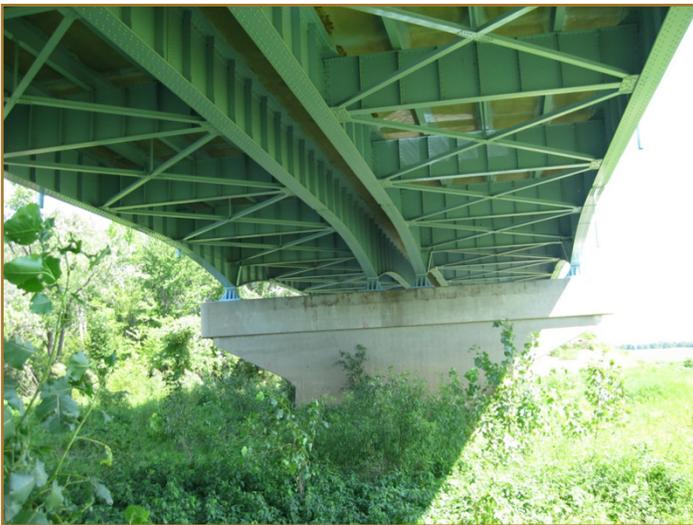
Built in 1958, the US-41 White River Bridge is a two-girder, riveted steel structure located near Hazelton, IN. The bridge is comprised of two, sixteen span superstructures sharing a common substructure. Each superstructure also contains four pin and hanger expansion joint assemblies.

**US-41 White River Bridge twin structures**

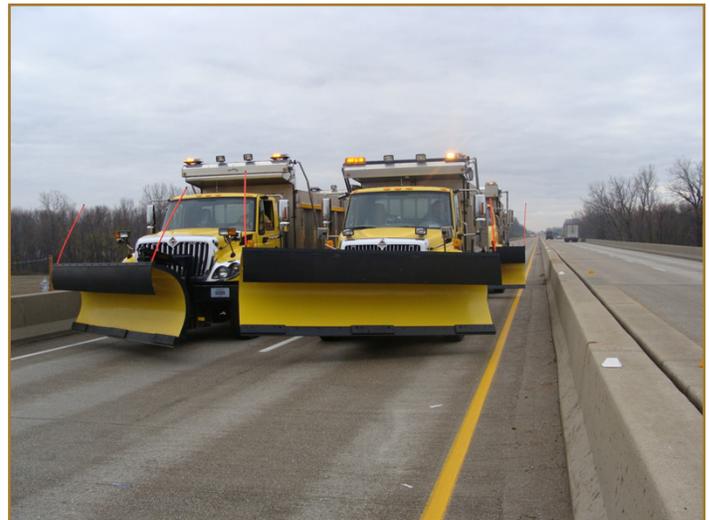
**Static test configuration**

1. Perform controlled load testing to gain insight on the typical behavior of the bridge.

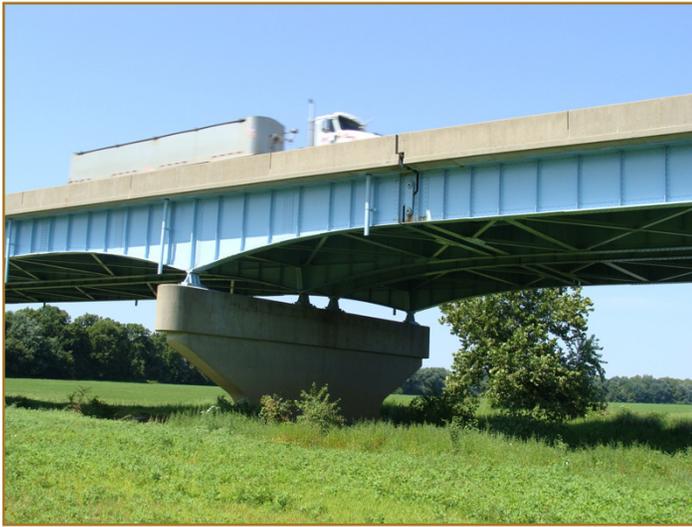
Pin and hanger

Based on the results of the study, only two actions items were suggested: 1.) Perform an in-depth inspection of the pin and hanger assemblies; and 2.) Lubricate all pin and hanger expansion joints. This study was not able to evaluate the pins of these joints directly; therefore, an in-depth inspection of the pins by a qualified inspector is advisable in response to this series of super-heavy loadings. Also, during the long-term monitoring, bending was measured in the four hangers instrumented; thus, lubricating the joints should allow for better movement and in turn less bending.

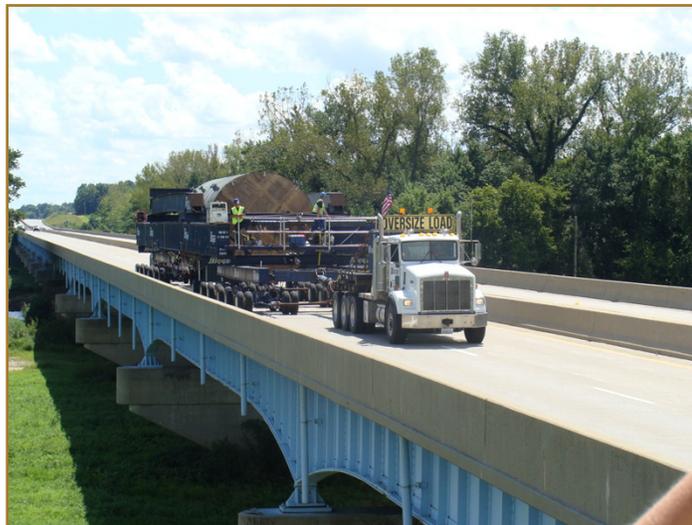
Beam and dolly transporter for superload test

Over a period from August 2009 to August 2010 a series of nearly one hundred super-heavy loads ranging in weight from 200,000 lbs to up over 1,000,000 lbs crossed the northbound superstructure of the bridge. The loads were moved to support the construction of a new power plant facility located in Edwardsport, IN. It was unknown what effect this number of super-heavy loading events, over a relatively short period, would have on the long-term performance of the US-41 White River Bridge. Therefore, long-term remote monitoring was used to quantify any negative effects due to the series of superloads. Five primary tasks were undertaken as part of this study:
