# Study on Deterioration Mechanism and Prevention and Curing Techniques of an RC Bunker

**Keywords:** RC bunker, deterioration, mechanism, prevention and curing techniques.

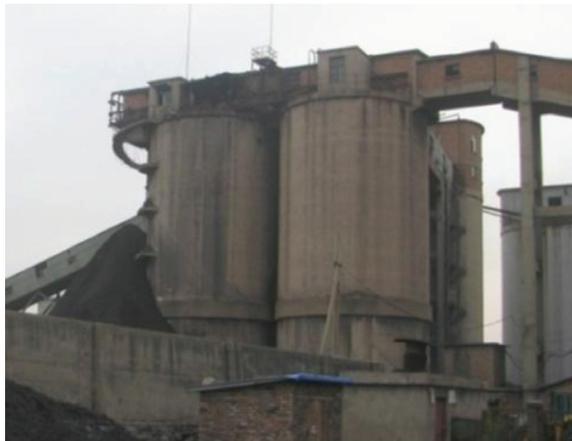
Figure 1. Panoramic view of the bunker.

Because of the special production and storage needs of a coal bunker, the RC bunker has a special shape (Figures 1 and 2). The stress distribution is complicated, the displacement is difficult to control, and local stress concentration is present. The silo wall undergoes outward extension due to the horizontal pressure of the stored coal. Meanwhile, large transmission equipment is arranged at the top of the coal bunker. In addition to withstanding the weight and quality of the upper transmission equipment, the dynamic response under a dynamic load is more intense. Long-term vibration of concrete causes internal damage due to fatigue and affects the structural safety.

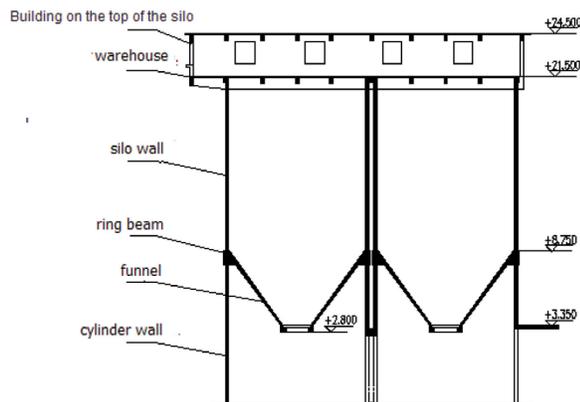
Figure 2. Profile of the bunker.

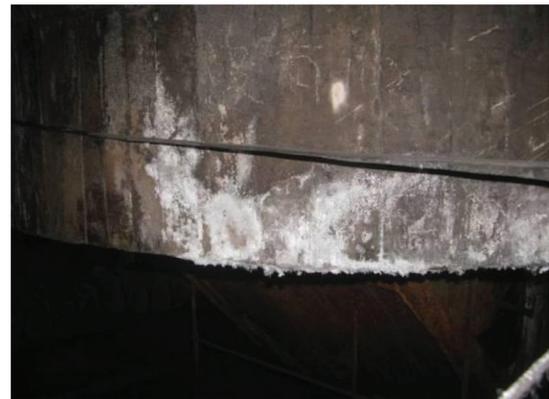
A concrete surface gets corroded in the coal mining ground industrial environment. In part of the surface of the warehouse, the silo wall, the cylinder wall, and the funnel, cracks appear along the reinforcement, and some concrete is also seriously damaged. Reinforcement corrosion is serious, and a small amount of rust can start it. Sometimes, the cylinder wall is subjected to vehicle collision during transportation, causing component damage. Because of the presence of a ring beam that protects the surface, there is no crack on the concrete surface. At the same time, at certain times, coal is often stacked in a high pile, which causes a certain lateral extension to the silo wall. The ladder gets completely damaged. Part of the appearance is shown in Figures 3 and 4.

Figure 3. Funnel concrete surface with corrosive medium.

- (1) After applying anti-rust treatment for the internal reinforcement of all kinds of components which need to be repaired, we need to adopt a polymer, a modified cement mortar, or concrete to repair the original concrete components.

- (2) For the warehouse and funnel, we adopt the method of pasting carbon-fiber-reinforced polymer (CFRP) for the reinforcement, applying prestressed steel strand-polymer mortar to reinforce the silo wall, pasting CFRP or section enlargement for reinforcement of the ring beam, and increasing the section or changing the loading for reinforcement of the cylinder wall.

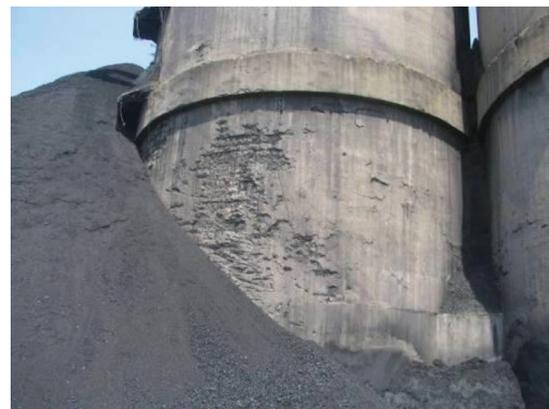
Figure 4. Damaged concrete wall of the bowl.
