# A Mechanism of Motor Failure

D. E. Crawford, Engineer-Product Reliability  
Hermetic Motor Products Department  
General Electric Company, Holland, Michigan

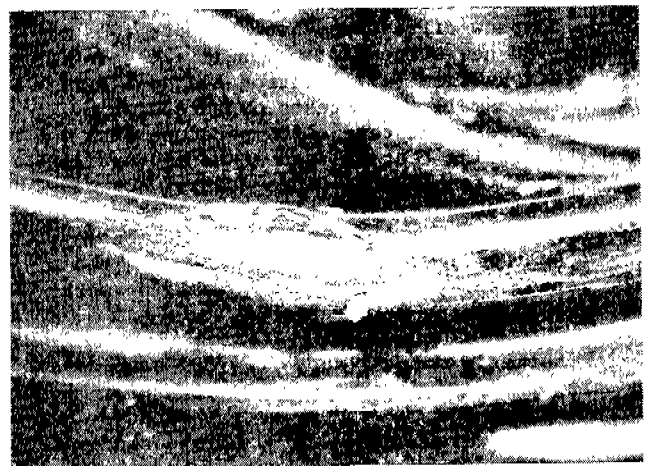
Figure 2: Wire to wire wear. The bare conductor is just visible in the middle of the wear spot. No arcing had occurred yet as mating wire was not exposed.

#### WIRE TO WIRE WEAR - FIGURES 1, 2, AND 3

This situation occurs between wires within a coil or a slot. The looseness and wear usually occur in the largest two coils because they have the most turns and the greatest mean turn length. This outer position also results in the least support for these wires as they leave the slot and join the end turn bundle. The magnetic forces between the wires in these two slots is also greatest and this stresses any bond weaknesses in this area. Failures are further concentrated between a point about one inch inside the slot (in the lamination iron) to a point about one inch beyond the surface of the iron in the end turns. This includes the knee of the end turn coils where the wire makes a relatively sharp bend toward the slot.

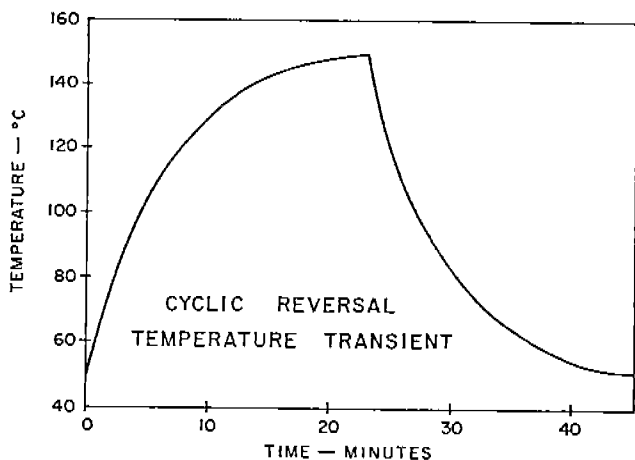
Figure 4: Cyclic reversal test scheme. Temperature rised while reversing on a three second cycle. Liquid R-22 is applied with power off to cool stator.

The most important parts of this work are the recognition of differential thermal stress as an important accelerating variable and the analysis of failures to develop and support the failure theory. The "Cyclic Reversal Test" was developed to test this theory and to allow us to study materials and process changes. The important change in the reversal test was the incorporation of a temperature swing of 100°C every 45 minutes. In our test the temperature is raised from 50°C to 150°C in 22 1/2 minutes by reversing the motor each 3 seconds after a half second delay. When the stator reaches 150°C the power is removed and it is force cooled with liquid refrigerant (R-22) applied at a rate which will bring the average winding temperature to 50°C in the next 22 1/2 minutes. (See Figure 4). This test procedure has increased our chances of failing a stator within a million cycles by about 10 to 1.

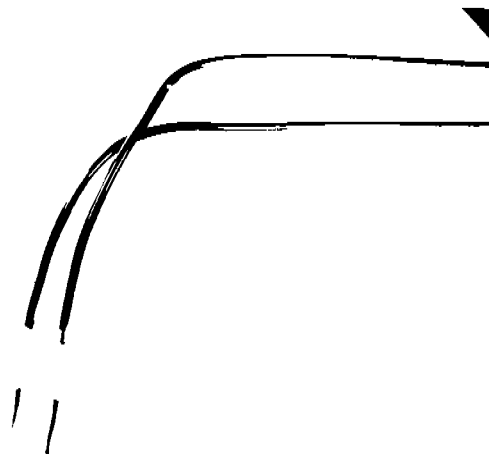
Figure 5: Coil to coil wear. The failing wires are removed from each coil. The crossover point is in the end turns and the straight wires to the right extend into the slots.

#### COIL TO COIL WEAR - FIGURES 5 AND 6

This occurs when two adjacent coils within the same pole become loose and vibrate against one another. The wire to wire wear results in severe failure because the higher voltages between coils cause more severe arcing. This leads to welding sooner along with higher currents in the shorted coils.

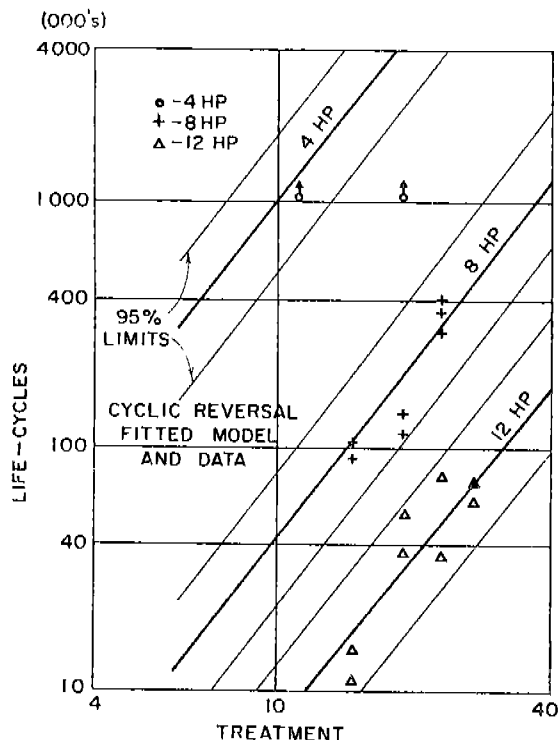
The graph below shows the above power law model fitted to the data in the "Cyclic Reversal Test Data" table. Study of this graph and model has helped us to understand the significant relationships between motor size, treatment processes and test life.

$$\text{Life} = K \frac{(\text{Treatment})^m}{(\text{Size})^n}$$
