# Effect of External Loading on Durability Properties of Pre-Stressed Concrete Girders with Microcracking

S.S. Srinivasan, M. Rung, and R.D. Ferron  
The University of Texas at Austin, TX, United States

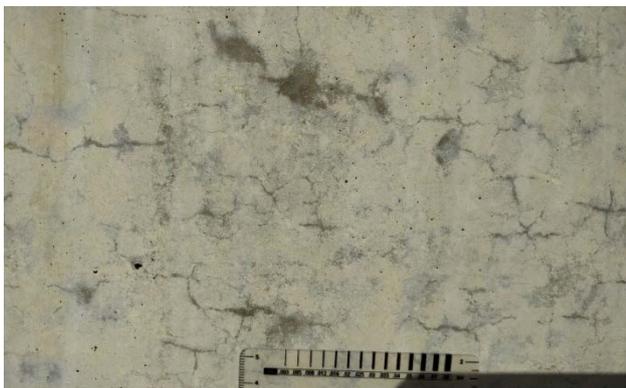
**Fig. 1.** Typical micro-cracks exhibited in girders with a crack ruler shown in the bottom of the photo

Over the last fourteen years, microcracks have appeared in numerous in-service, pre-stressed concrete girders across Texas at relatively early ages, e.g., within thirteen to eighteen months of casting. The crack pattern initially appeared in a “starburst” pattern and with continued exposure to the environment progressed into map cracking (Stacy, 2016; Tiburzi, Drimalas, & Folliard, 2017). Figure 1 shows a typical example of the microcracks.

responsible for volumetric changes (e.g., shrinkage, alkali-aggregate reaction, settlement, corrosion, etc.) is essential to prevent it. The mechanism behind the cracks found in Fig. 1 is not fully understood yet. The cracks appeared outside of the regular time-period of plastic shrinkage cracks, and they did not show the telltale signs of an alkali-silica reaction and corrosive products were negligible (Tiburzi *et al.*, 2017). Due to the low water-to-cementitious-material (w/cm) ratio of these concrete girders, the influence of autogenous shrinkage was studied and subsequently ruled out as a possible cause (Stacy, 2016). The cause of cracking is most likely material-related, as the microcracks developed before the girders were put in-service and had occurred while still in the pre-cast yards. Presence of microcracks has been shown to accelerate the ingress of deleterious material into the concrete and in turn accelerate the deterioration process of concrete structures (Benoit, Marc-André, Kevin, & Thomas, 2010; Wang & Bai, 2016). Regardless of the driving mechanism, the presence of the cracks led to concerns about the future integrity of the girders and questions about whether the maintenance program (in both schedule and cost) of pre-cast girders in-service needs to be changed have arisen.

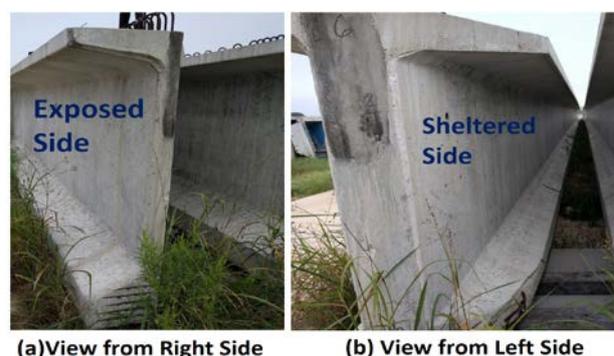
**Fig. 2.** Photos of a typical rejected girder showing (a) exposed side and (b) sheltered sides

oldest rejected girder was 13.8 years old. Upon arriving at the pre-cast yards, it was found that the girders were stored in such a way that one side was exposed to the environment (Fig. 2a), while the other side was relatively protected from the elements by neighboring elements (Fig. 2b). The pre-cast yards were requested to maintain this exposure condition for all girders selected for monitoring. As such, the side exposed to the environment was referred to as “Exposed” and the other side as “Sheltered.” However, it must be noted that the tops of the rejected girders were exposed to the environment. Each girder was further divided into “End” and “Middle” sections (Fig. 3c). The ends of the girders had pre-stressing release cracks, typically found in the end regions of precast beams due to the highly localized force applied to the girder during the release of the pre-tensioned forces (Okumus & Oliva, 2013). Fig. 3b shows a typical rejected girder with pre-stressing release cracks on the girders, traced in red (Fig. 3a). Fig. 3c shows a typical rejected girder with test locations marked as “End” and “Middle”.

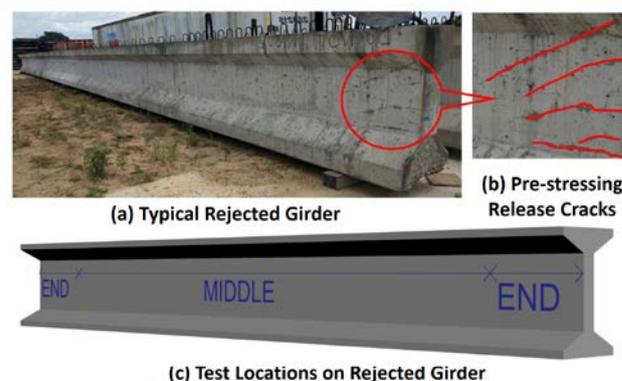
**Fig. 3.** (a) Typical Rejected Girder showing (b) prestressing release cracks and (c) pictorial representation of end and middle sections of girder

formation of pre-stress release cracks (shown in Fig. 3). The change in average crack width, cracking index, strain, pulse velocity, and resistivity are discussed. Figure 14 shows the change in (a) cracking index, (b) average crack widths, and (c) strain (collectively referred to as cracking in this paragraph) for all girders. The increase in cracking was higher in the end sections in all cracked and un-cracked rejected girders when compared to the middle sections. Likewise, the increase in cracking in the end sections of all cracked and un-cracked in-service girders was higher when compared to the middle sections. The increase in cracking in the end sections of all control (rejected and in-service) girders was comparable to that of the in-service cracked girders. This showed that the presence of pre-existing cracks proved to be a significant factor affecting the increase in cracking (average crack width, cracking index, and strain).

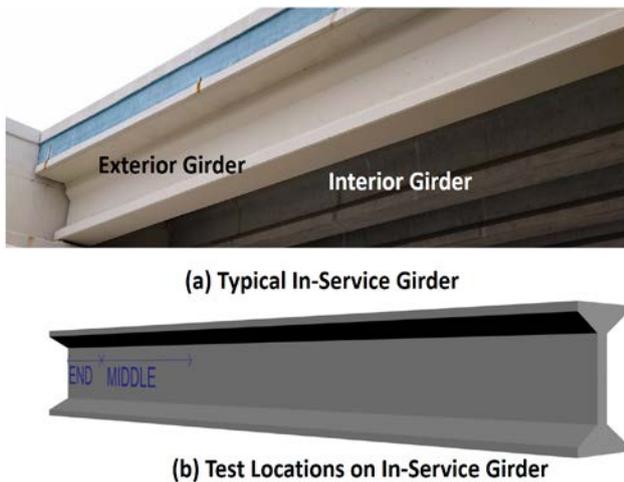
**Fig. 4.** Typical In-Service Girder showing exterior and interior girders

to the elements more readily than the interior girders (Fig. 4a). Each girder was further divided into “End” and “Middle” sections (Fig. 4b). Like the rejected girders, the ends of the girders have pre-stressing release cracks. It was found that the outside surfaces of the exterior girders were painted (Fig. 5a). In this paper, the measurements taken on the exposed side of the exterior girders are referred to as “Exposed” whereas the measurements taken on interior girders and the un-exposed side of the exterior girders are referred to as “Sheltered” (Fig. 5b).

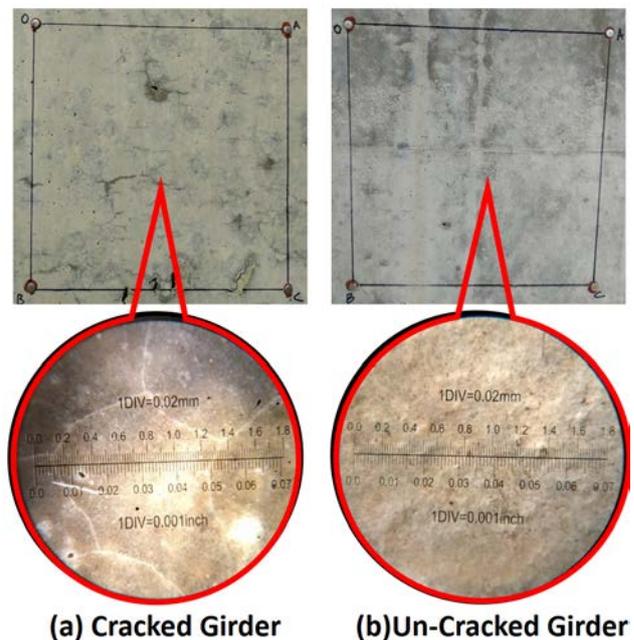
**Fig. 6.** Typical regions on an (a) extensively cracked and (b) un-cracked girder as visible to the naked eye (top row of photos) and at 50X magnification (shown in the circled call-out)

200 x 200 mm cracking index grids were set up at each test location on the girders, and the cracking index and average crack width were calculated, according to the method prescribed in the FHWA HIF-09004 (Benoit *et al.*, 2010) report. Change in strain was measured by installing DEMEC points at the corners of each cracking index grid, and strain measurements were made using a DEMEC strain gauge, according to the FHWA HIF-09004 report (Benoit *et al.*, 2010). Fig. 6 shows typical regions on an (a) extensively cracked girder and a (b) negligibly cracked girder at 50X magnification.

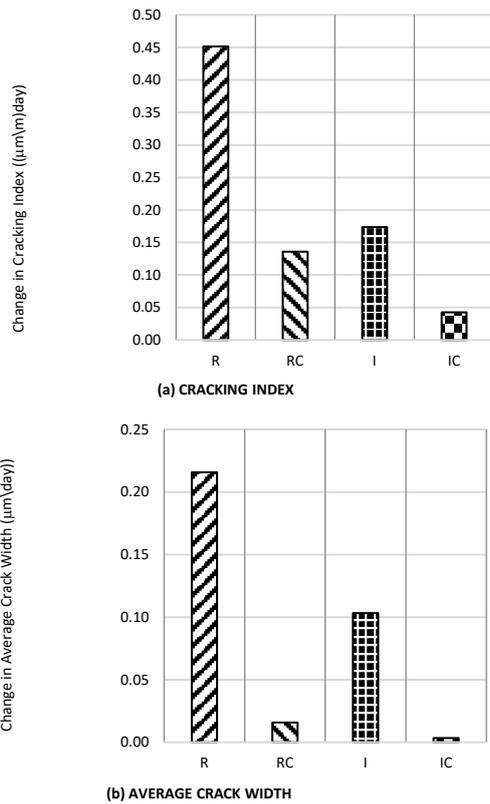
**Fig. 7.** Change in (a) Cracking Index and (b) Average Crack Width

All girders showed an increase in the cracking index and average crack width indicating that the microcracks were widening and increasing in number with time as seen in Fig. 7. The girders also showed a decrease in the pulse velocity and surface resistivity indicating a loss in durability as seen in Fig. 8. Change in strain showed that there was shrinkage in all girders, as seen in Fig. 9.

Some girders exhibited a higher increase in cracking index than in average crack width and vice versa. Figures 7a and 7b showed that the control girders (RC and IC) had a higher increase in cracking index than in average crack width. The higher change in cracking index in the control girders indicated that there was more of an increase in the formation of new cracks than an increase in crack width of existing cracks. Similarly, the in-service cracked girders exhibited a higher increase in average crack width than cracking index, indicating that there was more of an increase in the widths of the existing cracks than the formation of new cracks. The different rates of increase in cracking index and average crack width further support the importance of calculating both the cracking index and average crack width to measure the impact of cracking on durability accurately.

The rejected (RC) and in-service (IC) control girders also exhibited an increase in cracking index (Fig. 7a) and average crack width (Fig. 7b) values and a decrease in pulse velocity (Fig. 8a) and surface resistivity (Fig. 8b) during the period they were examined. The strain measurements also showed that the girders were exhibited shrinkage. However, the magnitude of change was lower than that of their cracked counterparts (compare R with RC and I with IC in Figs. 7, 8 and 9). Like the trend exhibited by the cracked girders, the rejected control girder had a higher loss in durability than the in-service control girders.

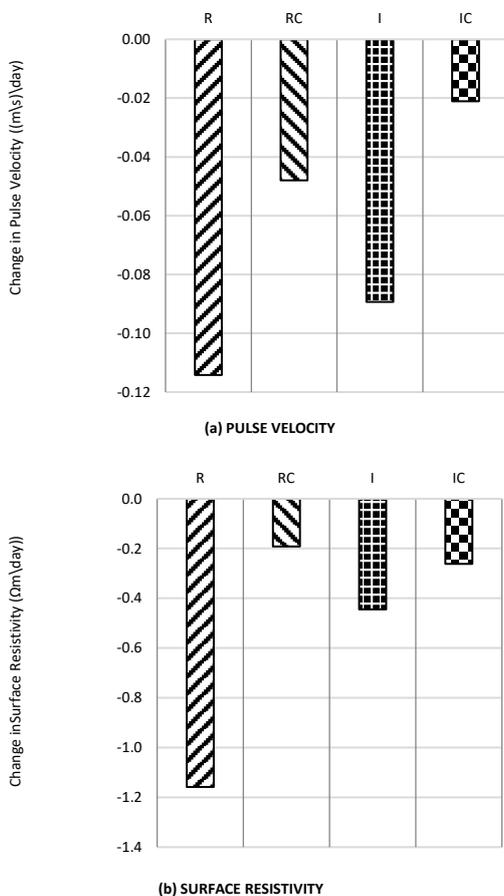
**Fig. 8.** Change in (a) Pulse Velocity and (b) Surface Resistivity

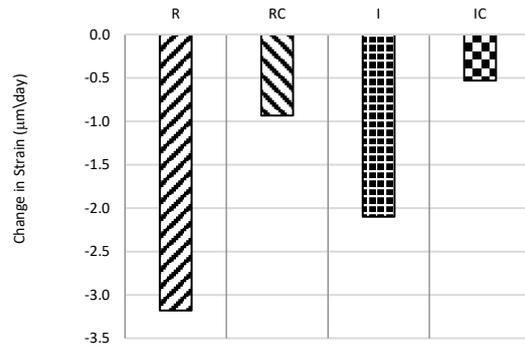
**Fig. 9.** Change in Strain

From Figs. 7, 8 and 9, it was seen that the effect of external loading on the girders was minimal. To better understand these factors, further analysis was conducted based on considering the impact of exposure conditions, i.e., sheltered, or exposed (as shown in Figs. 2 and 4), on the girders and presence of pre-existing cracks (as shown in Figs. 3 and 5).

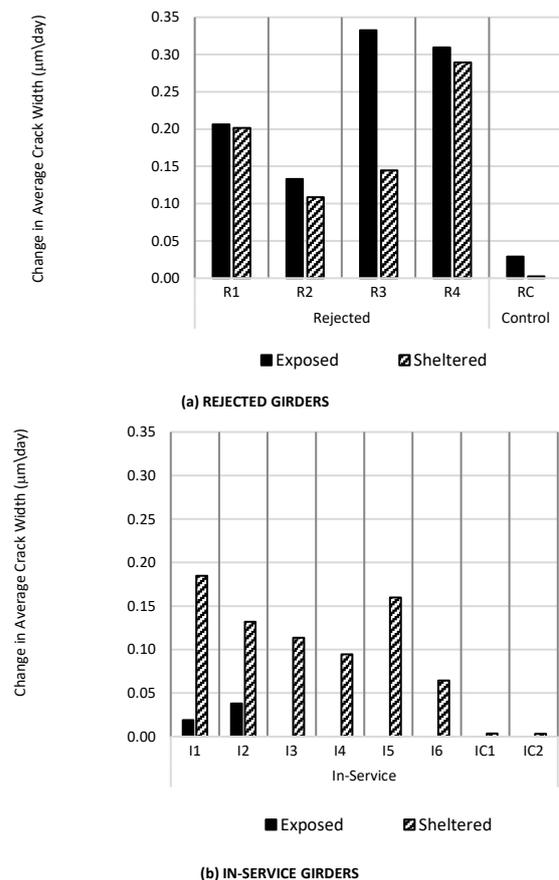
Fig. 10. Effect of Exposure Conditions on Change in Average Crack Width

included as it is an indicator of bulk concrete properties rather than surface properties and hence, a comparison based on exposure conditions, that would affect just one face, would not accurately indicate the variation in pulse velocity. Figure 10 shows the change in average crack widths for all girders. Overall, the increase in average crack width was greater for the exposed sides than the sheltered sides in the cracked rejected girders (Fig. 10a). However, the exposed in-service girders did not exhibit this behavior (Fig. 10b). In-service girders I1 and I2 were exterior girders, each with one side exposed and one side sheltered. As the girders were painted, the change in average crack width was minimal. The sheltered sides of I1 and I2 and the interior in-service girders (I3, I4, I5, I6, IC1, and IC2) showed a lower increase in crack width when compared to the sheltered sides of the rejected girders.

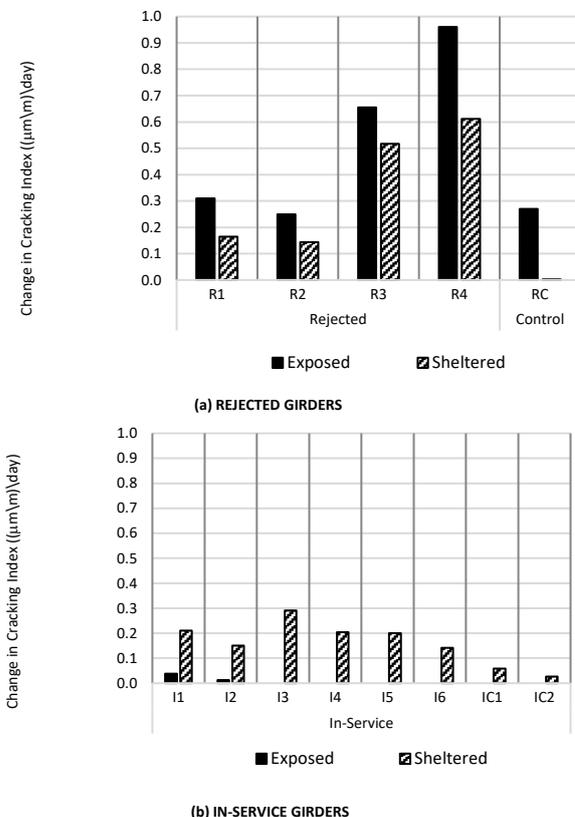
Fig. 11. Effect of Exposure Conditions on Change in Cracking Index

Figure 11 shows the change in cracking index for all girders. Like the change in average crack width, there was an increase in cracking index in all girders. This indicated the formation of new cracks as well as an increase in crack widths.

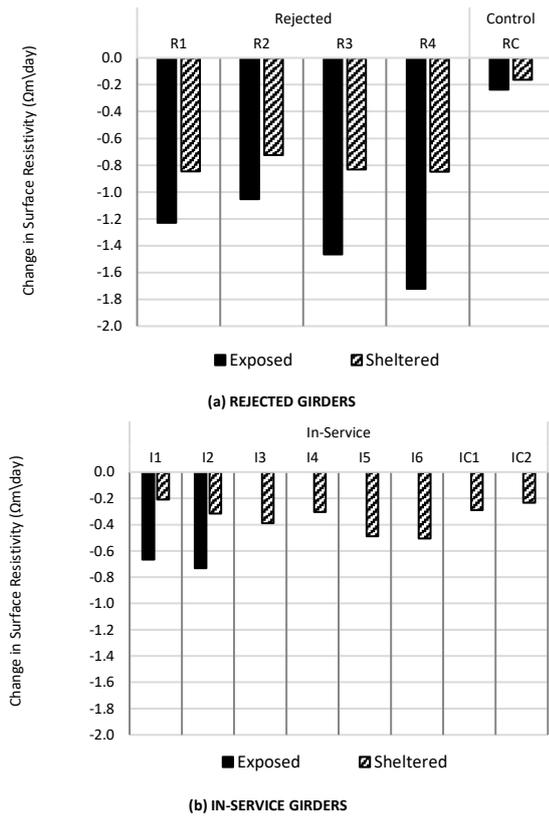
**Fig. 12.** Effect of Exposure Conditions on Change in Surface Resistivity

Figure 12 shows the change in surface resistivity for all girders. The decrease in surface resistivity was higher for the exposed sides than the sheltered sides in all cracked rejected girders, which suggested that there were more cracks (i.e., damage) in the exposed sides than the sheltered sides. The decrease in surface resistivity in the exterior side of the in-service girders (I1 and I2) was higher than the sheltered sides of those girders and the interior in-service girders in the bridges, indicating that the exterior sides of the in-service girders had more defects than the sheltered sides of the girders and the interior girders. This contrasted with the change in average crack width and cracking index results (Figs. 10b and 11b), and thus the surface resistivity results indicated that the paint on the exposed side of the exterior girder did not have a major effect on the surface resistivity. The results from the change in cracking index and average crack width results for the exterior sides of the in - service girders (Fig. 10b and 11b) suggested that there was a decrease in cracking, but the surface resistivity results for these same girders indicated that the decrease in surface resistivity of the exposed side was higher than the sheltered side, indicating a higher loss of corrosion resistance. As such, the paint appears to be only preventing cracks from being observed and not the formation of cracks. If paint played a significant role in preventing the formation of cracks, this would have manifested as a lower decrease in surface resistivity in the exposed sides of the in-service exterior girders.

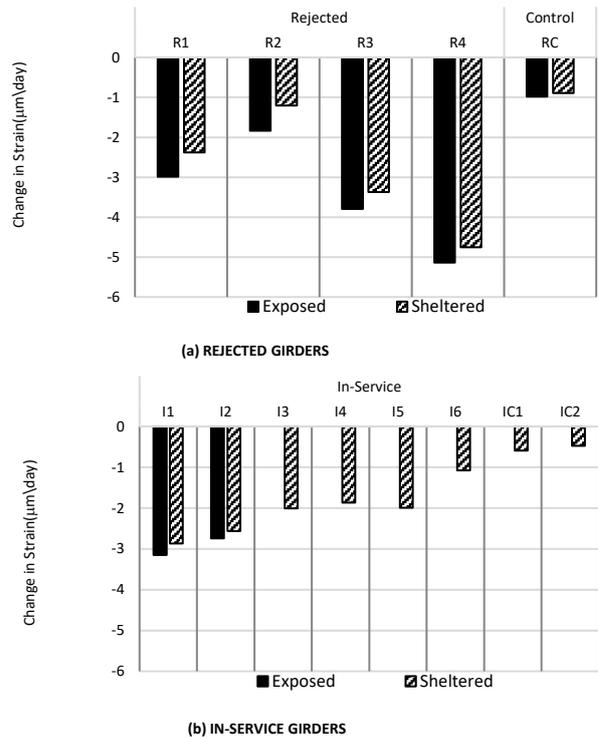
**Fig. 13.** Effect of Exposure Conditions on Change in Strain

Fig. 13 shows the change in strain for all girders, with negative values indicating volumetric shrinkage and positive values indicating expansion. As such the results show that the girders predominantly exhibited

volumetric shrinkage. The shrinkage was higher for the exposed sides in all cracked rejected girders. Higher shrinkage was also measured in the exterior side of in-service girders (I1 and I2) as compared to the sheltered sides and the interior in-service girders. While this contrasted with the change in average crack width and cracking index, it was in line with the change in surface resistivity values. This showed that there was shrinkage in the exterior girders, further supporting the theory that the paint was only preventing cracks from being observed and not the formation of cracks. The rejected control girder exhibited lower shrinkage on the exposed side and an even lower shrinkage on the sheltered side. The in-service control girders had shrinkage values comparable to the rejected control girder, while still being lower than that of the cracked in-service girders.

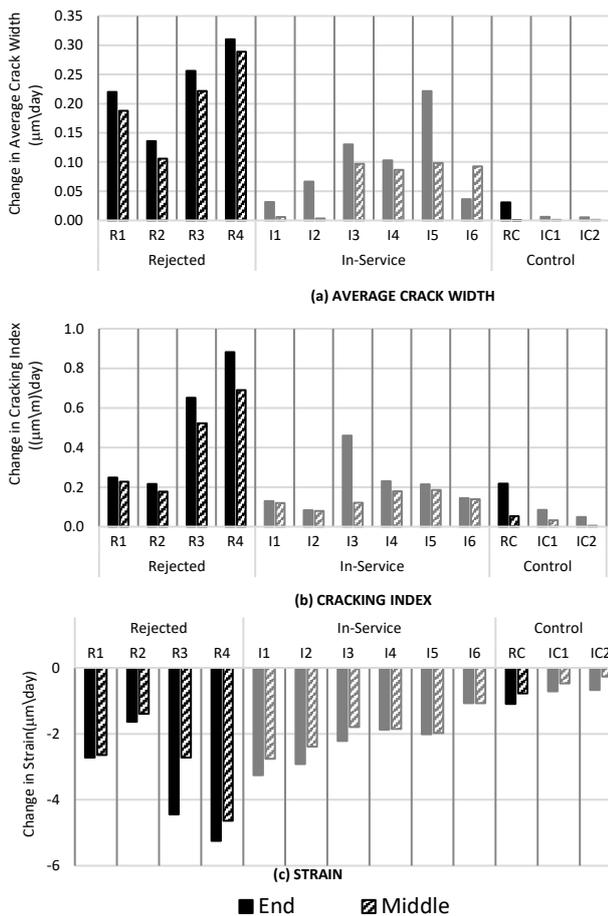
**Fig. 14.** Effect of Pre-Existing Cracks on (a) Cracking Index, (b) Average Crack Width, and (c) Strain. Change in Rejected girders are shown in black, whereas in-service girders are shown in grey.

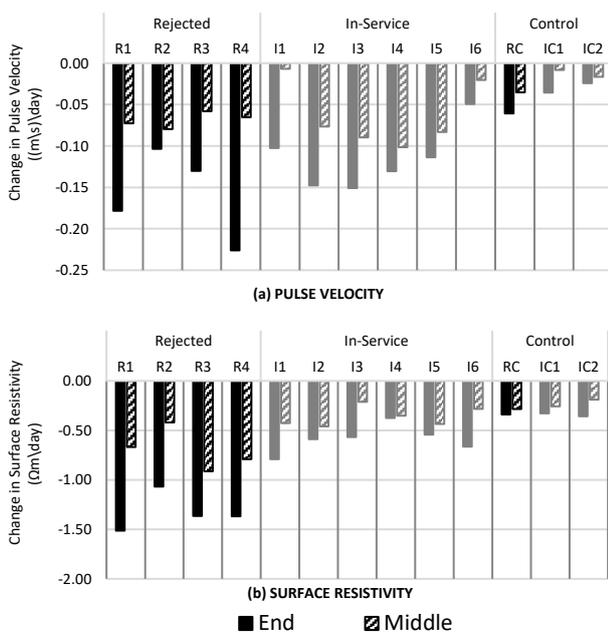
**Fig. 15.** Effect of Pre-Existing Cracks on Change in (a) Pulse Velocity and (b) Surface Resistivity. Rejected girders are shown in black, whereas in-service girders shown in grey.

Figure 15 shows the change in (a) pulse velocity and (b) surface resistivity for all girders. Presence of pre-existing cracks had the same effect on the decrease in pulse velocity and surface resistivity as it did on the increase in cracking. The decrease in pulse velocity and surface resistivity was higher in the end sections in all cracked and un-cracked rejected girders when compared to the middle sections. The decrease in pulse velocity and surface resistivity in the end sections of all cracked and un-cracked in-service girders was higher when compared to the middle sections. The decrease in pulse velocity and surface resistivity in the end sections of all control (rejected

and in-service) girders was comparable to that of the in-service cracked girders. This further supports the premise that the presence of pre-existing cracks proved to be a major factor affecting the integrity of the girders, and suggests that a more significant reduction in modulus of elasticity (as indicated by the decrease in pulse velocity) and corrosion resistance (as shown by the decrease in surface resistivity) occurred in the end regions of the girders as compared to the middle sections.
