Unmanned Aircraft Systems in Road Assessment: A Novel Approach to the Pavement Condition Index and VIZIR Methodologies

Article

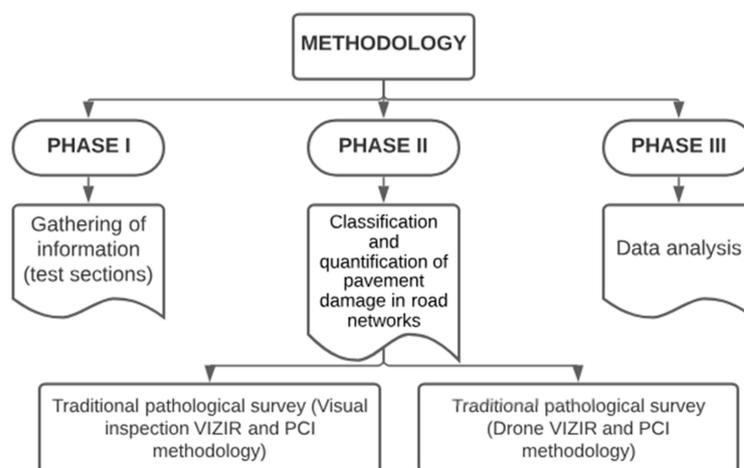
Figure 1. Methodology followed in this study for phases I, II, and III.

The final phase was dedicated to data analysis. The objective was to compare the results derived from field measurements with those obtained from the orthophotos, thereby assessing the congruence between the two data collection methods. Figure 1 summarizes the methodology followed in this study.

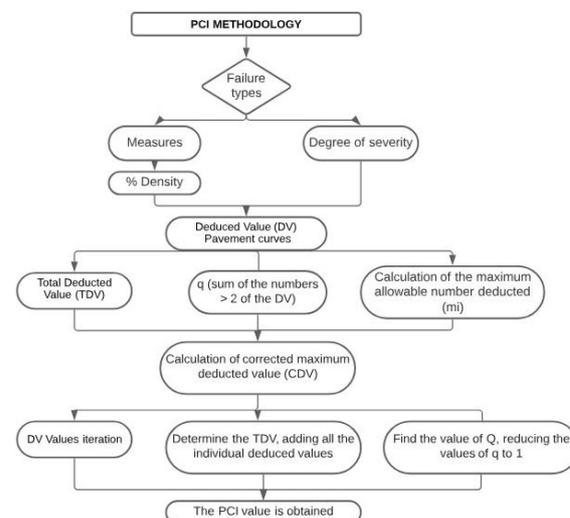
Figure 2. Summary of PCI methodology.

Finally, the PCI is computed by iterating through deduced values and calculating the Corrected Deduct Value (CDV) for each of them. This process involves using specific PCI curves to obtain the final Pavement Condition Index (PCI) score, which is adjusted based on the maximum total deducted value (HDV). Figure 2 provides a visual summary of the PCI methodology. The complete process to follow when applying the PCI methodology is presented in the 2023 version of the standard ASTM D6433-23 [15].

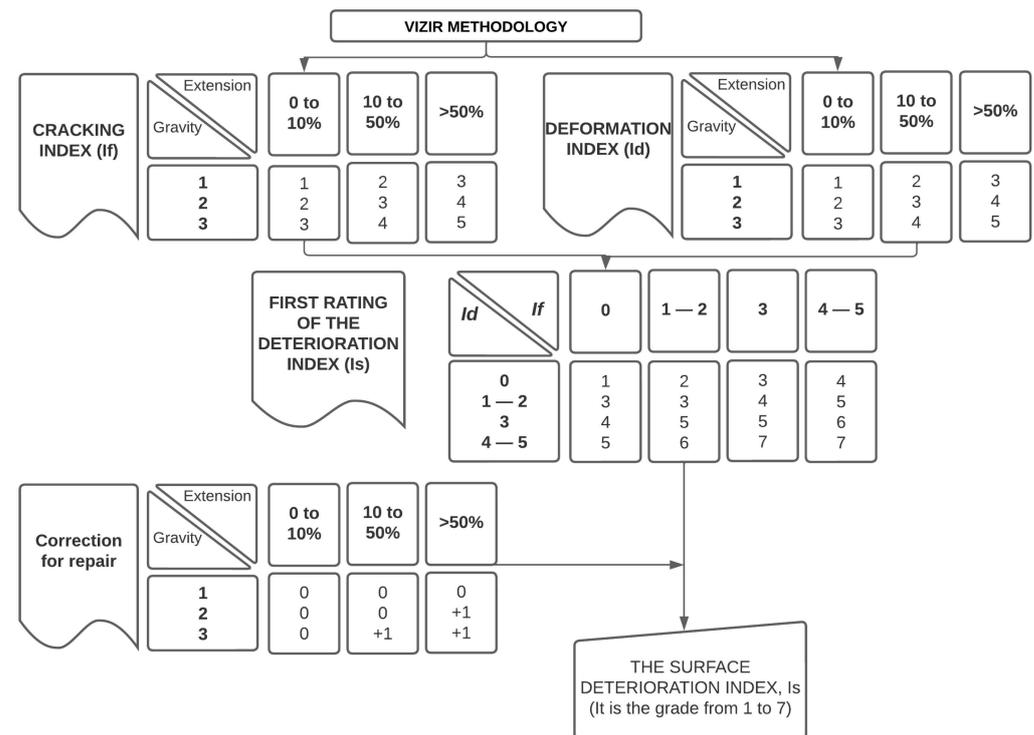
Figure 3. Summary of VIZIR methodology.

The VIZIR methodology defines pavement damage conditions based on the Surface Deterioration Index (Is). This index is calculated from the percentage of affected area over a defined linear length of the road under study. The value is 1 for a perfectly maintained condition and 7 for a completely deteriorated or destroyed flexible pavement structure. VIZIR primarily evaluates two main types of damages: Type A, which considers structural damages based on the pavement’s structural capacity deficiencies, and Type B, which accounts for functional damages related to operational and road safety.

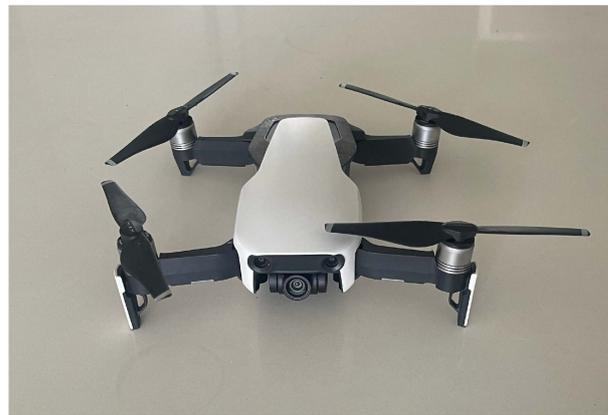
Figure 4. DJI Mavic Air used in this study.

Using an Unmanned Aircraft System (UAS), specifically the DJI Mavic Air, was fundamental for collecting imagery data. This UAS is equipped with a 1/2.3" CMOS sensor capable of capturing 12 MP images, with a lens offering a wide 85° field of view, an f/2.8 aperture, and a shooting range from 0.5 m. The UAS also incorporates sensors to enhance its flight stability: infrared sensing system for precise hovering and landing, inertial measurement unit (IMU) with accelerometers and gyroscopes, and global position system (GPS) for navigation. Figure 4 illustrates the UAS used in this study.

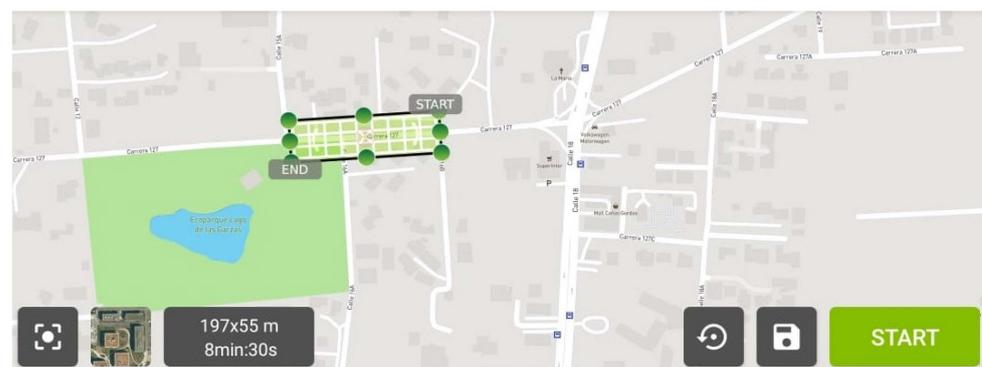
Figure 5. Flight plan over the study area at an altitude of 5.00 m (16.40 ft).

The procedure for data acquisition involved planned flights over the study area created automatically using flight planning software—Pix4D—with a frontal (along-track) and lateral (cross-track) overlap of 80%, as presented in Figure 5. The overlap was chosen to be higher than the recommended by the literature (70%) [28] and based on past flight experience from the authors. Lower overlap would reduce image quality for post-processing applications.

The UAS was flown at altitudes ranging between 3.00 m and 5.00 m (9.84 ft–16.40 ft). The DJI Mavic Air's camera has the following specifications: the sensor width of the camera is 6.16 mm (actual width size obtained from 1/2.3" and not a direct inch-to-millimeter conversion [29]), the focal length of the camera is 4.5 mm (most sources list it as 24 mm, but this is an equivalent measure for the 35 mm/full frame [30]), and a maximum resolution of 4056 × 3040 pixels [31]. The projected ground sample distance (GSD) based on the previous parameters was 0.10 cm per pixel for 3 m and 0.17 cm per pixel for 5 m. The achieved GSD was 0.11 and 0.18 cm/pixel, respectively. Higher altitudes would increase GSD and reduce image quality.

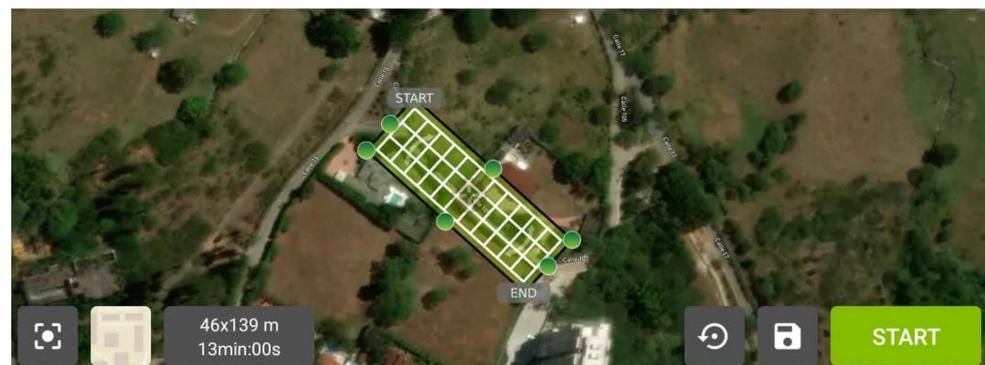
Figure 6. Flight plan over the study area at an altitude of 3.00 m (9.84 ft).

The UAS inspection process started with the creation of the mission file with the geographic information. Ground control points were placed in the study area. Ground control allows for improved efficiency in the execution of the flight plan and geolocation. The control points were distributed evenly across the project area to ensure consistent measurements, and checkpoints were selected to test the measurement differences across the flight path. Finally, post-processing was conducted using the data collected to produce orthophotos that allow for 2D measurements. This process involved measurements of various pathologies, as presented in the Results and Discussion section. This step enabled the determination of relevant measures, showcasing the significant advantage of UAS-based inspection over manual methods in coverage and efficiency. Figure 6 presents a flight plan over the study area.

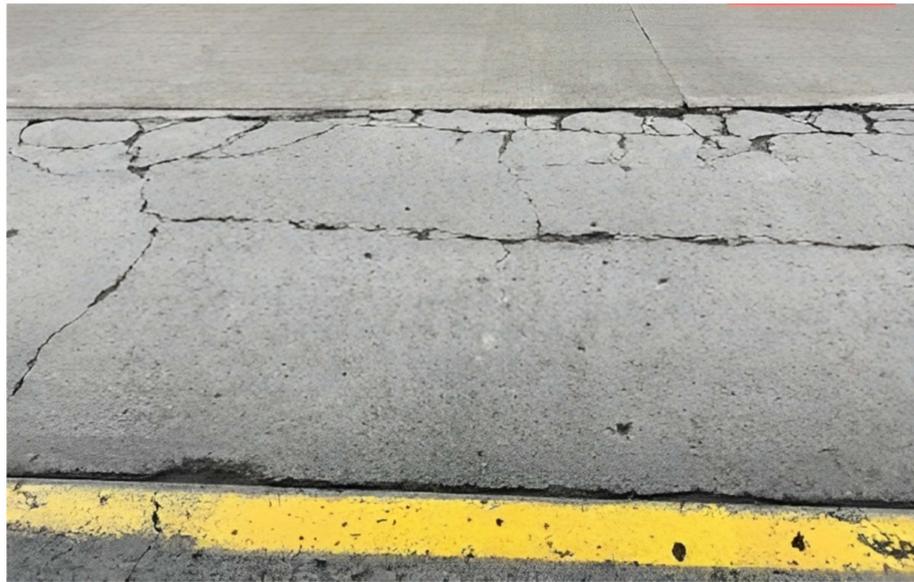
Figure 7. Pavement section captured from traditional visual inspection.

The information was analyzed using visual and UAS inspection's VIZIR and PCI methodologies. Figure 7 shows an example of a pavement section captured during a traditional visual inspection. Figure 8 shows orthophotos generated using images captured by the UAS.

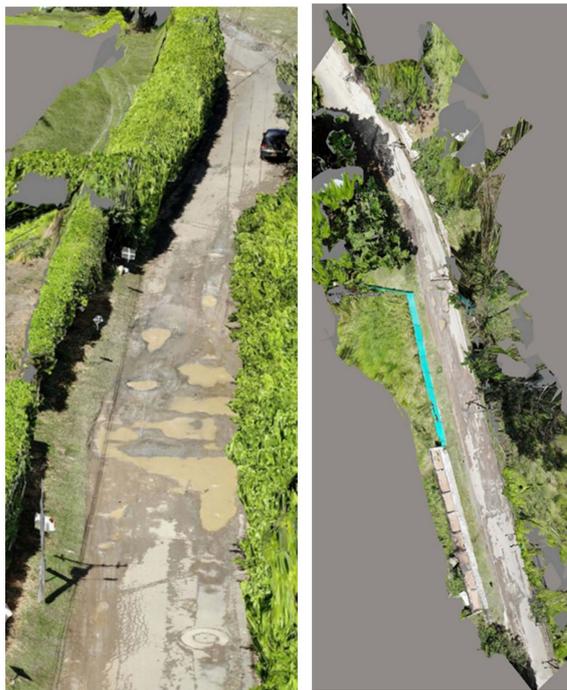
Figure 8. Three-dimensional models of the area of study generated by images captured by UAS.

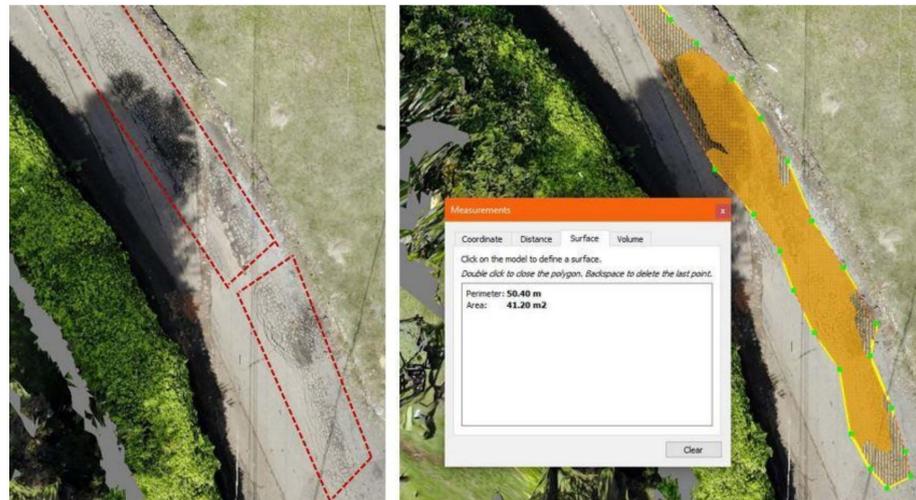
Figure 9. Measurement comparison using traditional tools (left) and computational tools (right). The measurements to the right show a perimeter of 50.40 m and area of 41.20 m².

The observed difference comes from the methodology used in measuring field deteriorations. Considering the reliability of data obtained from UAS and the measurements in the orthophotos, it can be seen that the photogrammetrically derived from UAS VIZIR and PCI assessment offer a comprehensive review of the road’s condition. Figure 9 compares the measuring procedure (red dotted line) of a pavement section measured in the field (left) and using computational measuring tools on an image captured by a UAS (right).

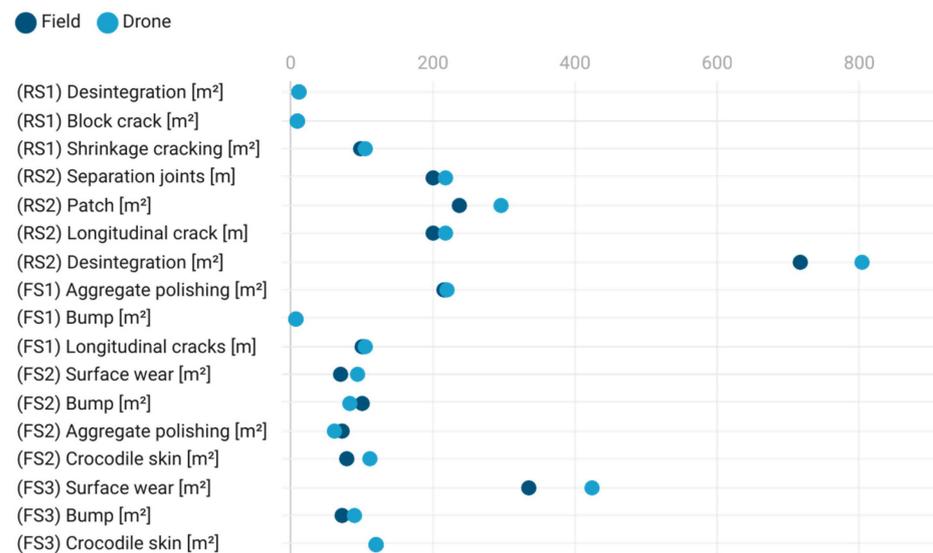
Figure 10. Defect comparison between visual and UAS inspection measurements.

Figure 10 offers a visual representation of the defect measurements captured by both field and UAS inspections, as outlined in Tables 6 and 7. The scatter plot clearly shows the comparison across various defects such as disintegration, crack blocks, and shrinkage for sections RS1 and RS2, as well as aggregate polishing, bumps, and crocodile skin for sections FS1, FS2, and FS3. Notably, the UAS measurements for disintegration in section

RS1 and patch areas in RS2 appear slightly lower than field measurements, indicating a more conservative estimation of affected areas. However, UAS data for surface wear and crocodile skin, especially in section FS2, exhibit a higher value, suggesting that UAS may capture a broader extent of these defects. The data points for longitudinal cracks and bumps also demonstrate proximity between the two methods, with UAS data providing a marginally increased quantification in most cases. This graphical analysis underscores the meticulous detail offered by UAS inspections, which can enhance or contrast the field data, providing a nuanced perspective on road surface conditions.

This study also highlights discrepancies between PCI scores from field measurements and those derived from UAS-captured orthophotos, as seen in Figure 10. This difference underscores the improved precision of photogrammetry-based data in reflecting the condition of roadways. Although the PCI method effectively assesses structural and functional damage, it exhibits limitations in its current application to local and collector roads. Interestingly, while the overall condition rating may be similar, data from photogrammetry provide a comprehensive representation of the pavement's actual state.
