Load-bearing Capacity of Corroded Reinforced Concrete Structures Caused by Carbonation and Exposed to XC4

E. Sistonen

Aalto University, Department of Civil Engineering, Aalto, Finland

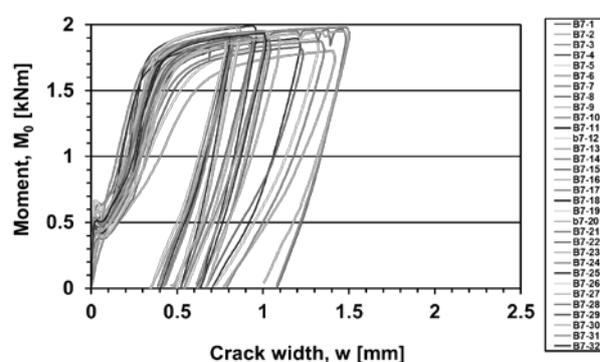
Fig. 1. Example of making cracking of beams before durability tests: cold-worked ribbed steel bar (B7)

concrete specimens. The cracks in the beam specimens were made by three-point bending so that the bars yielded with different loads (Fig. 1 and Fig. 2).

Load-bearing tests were performed on all beam specimens exposed to tap water. These were done in order to accurately determine the effect of corrosion on the developed cracks and the extent of cracking developed further due to corrosion. Examples of crack width-moment curves after 16 years of exposure are presented in Fig. 6, and Fig. 7. These examples are comparable to Fig. 1 and, Fig. 2, respectively.

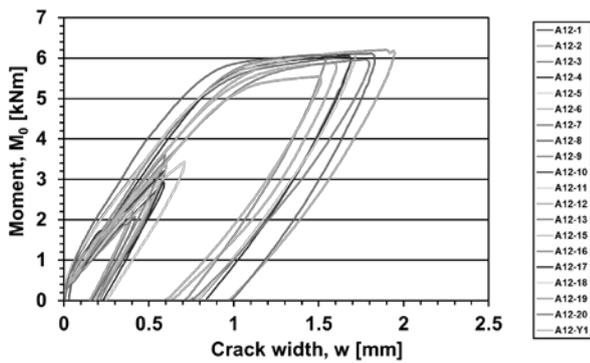
Fig. 2. Example of making cracking of beams before durability tests: weldable hot-rolled ribbed steel bar (A12)

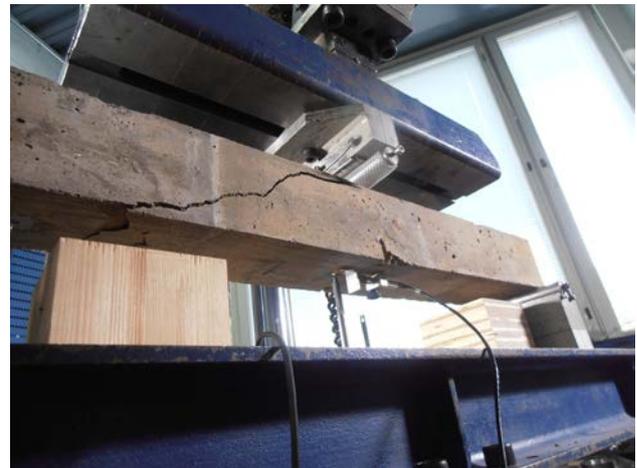
Fig. 3. Example of load-bearing capacity test by three-point bending: weldable hot-rolled ribbed steel bar, hot-dip galvanised (A8Zn-13), failure by shear

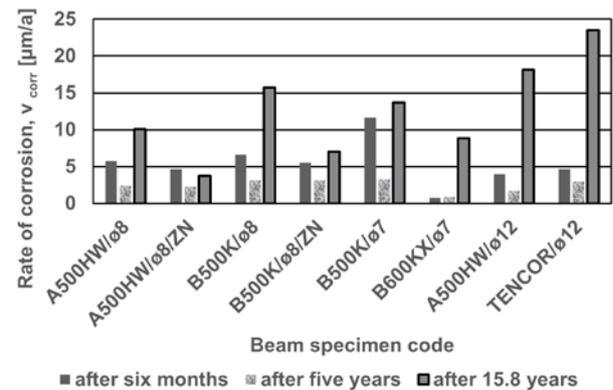
The electrochemical measurements of the beam specimens were performed after approximately six months, five years, and 15.8 years of exposure. The rates of corrosion were calculated according to the corrosion current values and are shown in Fig. 4.

Fig. 4. Rate of corrosion of the beam specimens exposed to tap water

The hot-dip galvanised steel showed a lower rate of corrosion in comparison with ordinary steel. The comparison of the measured crack width and rate of corrosion values generally showed no correlation independently of the exposure duration. However, beam specimen types A12 and C12 showed strong correlation between increased crack width and rate of corrosion as a function of time. The rate of corrosion was found to be the highest in the case of weathering steel (type C12) in tap water beam specimens.

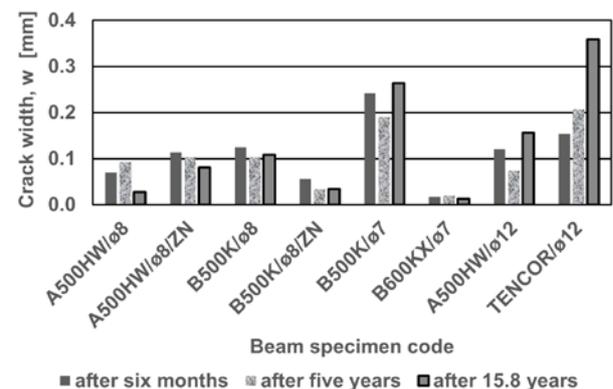
The crack widths of the beam specimens were measured in the context of the electrochemical measurements. Measured crack width values are shown in Fig. 5.

Fig. 5. Crack width of the beam specimens exposed to tap water

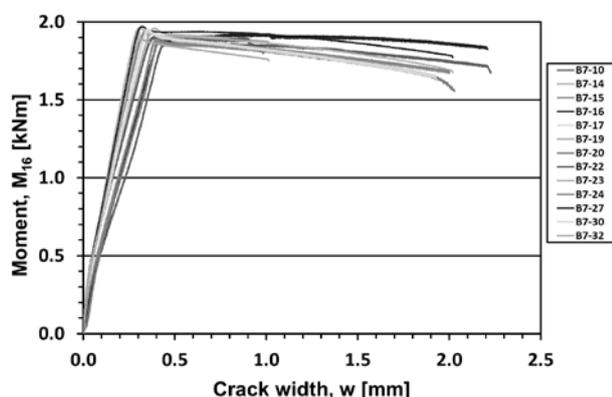
Fig. 6. Example of load-bearing test result of beams after durability tests: cold-worked ribbed steel bar (B7), failure by bending

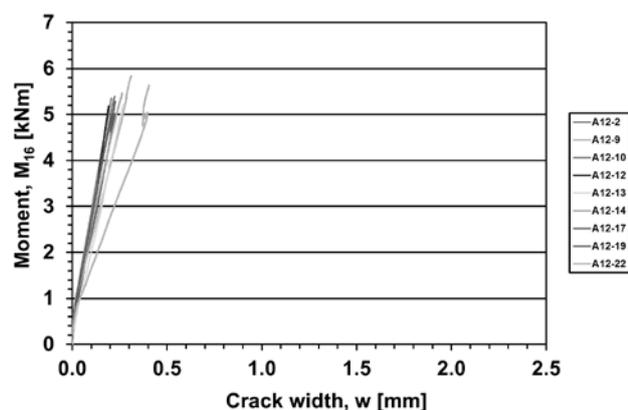
Fig. 7. Example of load-bearing test result of beams after durability tests: weldable hot-rolled ribbed steel bar (A12), failure by shear

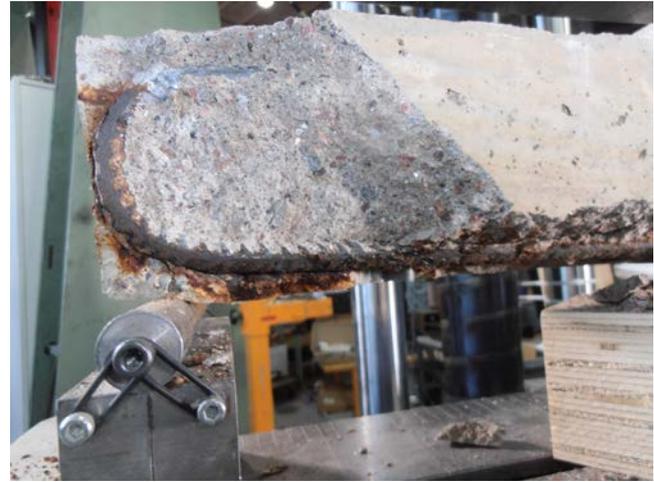
Fig. 8. Example of severe corroded beam after load-bearing capacity test by three-point bending: weldable hot-rolled ribbed steel bar (A12-22), failure by shear and anchorage

Failure mechanisms of beams based on load-bearing tests is presented in Table 4. Bending was realised in 62 % of beams tested, and shear failure in 38 %, respectively. Totally, 22 % with dimension 12 mm bars (types A12 and C12) were also failure by anchorage (Fig. 8). That was strongly affected by the recognised longitudinal cracking that also influenced on transversal crack width and rate of corrosion values.

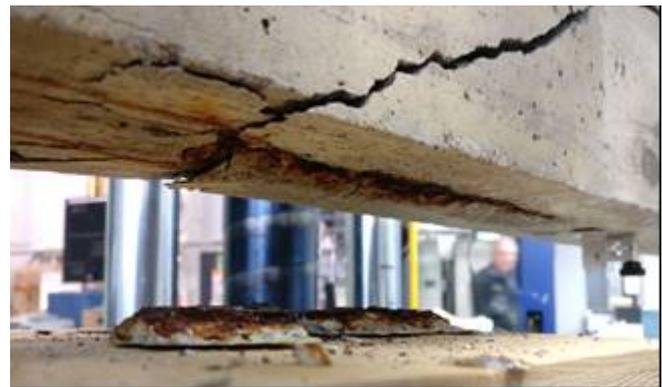
Fig. 9. Example of longitudinal cracking of severe corroded beam after load-bearing capacity test by three-point bending: weldable hot-rolled ribbed steel bar (A12-17), failure by shear

Example of longitudinal cracking of severe corroded beam after load-bearing capacity test by three-point bending is presented in Fig. 9. As a logical result, that cracking is concentrated on types A12 and C12 beams that produce more spalling forces to the concrete cover. In addition, hot-dip galvanised beams did not cause longitudinal cracking. The main corrosion product of zinc, zinc oxide (ZnO), occupies 1.5 times the volume of the original zinc (Yeomans, 2004; Porter, 1991). However, the volume of zinc oxide is approximately 1/3 less (Yeomans, 1993) than the volume of the corrosion products of ordinary steel. Corrosion products are friable, loose, and powdery minerals. The products are able to migrate away from the bar and into the adjacent porous concrete matrix, where they fill small voids and micro-cracks (Hoke *et al.*, 1981; Yeomans, 1993). In that case the local tensile stresses in the concrete are also lower and zinc corrosion products do not exactly cause the concrete cover to deteriorate. That was realised afterwards with opened beams (Fig. 10).
