*THE EFFECT OF CONCRETE STRENGTH
ON THE SHEAR STRENGTH OF
REINFORCED CONCRETE BEAMS
WITH BAR CUTOFF*

by
J. G. BORCHELT

*PURDUE UNIVERSITY
LAFAYETTE INDIANA*

Final Report

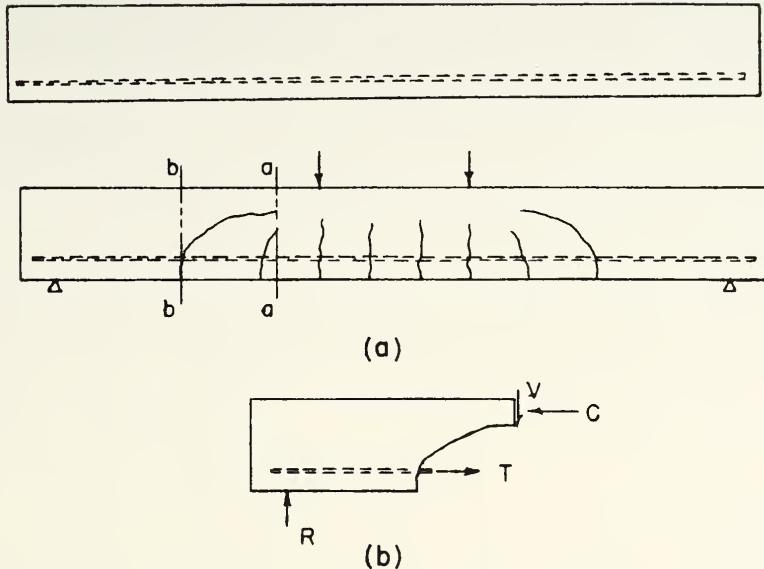
FIGURE 1. BEAM WITH DIAGONAL CRACK

A beam with no web reinforcement which has a diagonal tension crack is shown in Figure 1a. Figure 1b illustrates the section of the beam to the left of the crack. After

the crack has formed the concrete above the crack is assumed to resist the entire shear force although a small portion of the shear is transferred by dowel action of the longitudinal steel. In order for the beam to adjust to this new form the steel at section b-b must be capable of resisting the moment at section a-a. This will cause an increase in stress of the steel at section b-b. If the beam is not able to reach a force equilibrium the steel will yield and cause a spontaneous collapse.

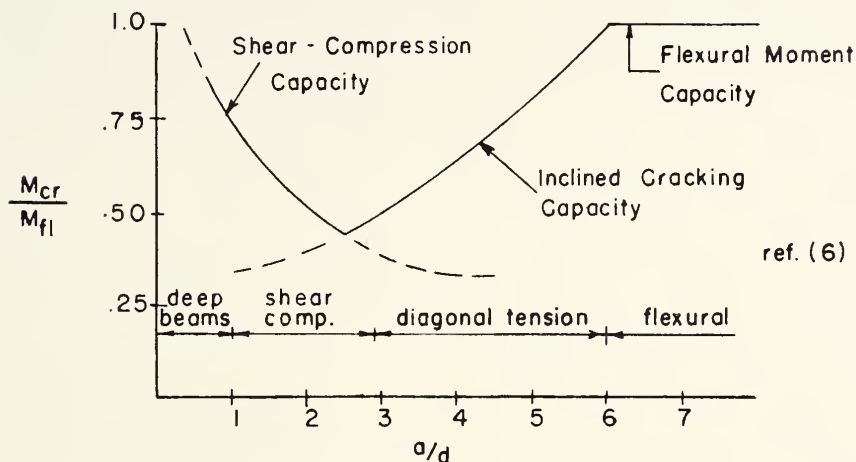
FIGURE 2. BEAM CAPACITY VS. A/D RATIO
FOR SIMPLY SUPPORTED RECTANGULAR BEAMS

The effect of the shear span to depth ratio on the shear capacity of rectangular beams with all other variables

constant can be illustrated as shown in Figure 2. This clearly shows two separate effects governing the ultimate capacity, shear compression and inclined cracking.

Once the inclined crack has developed failure may occur in one of two primary ways: (1) a crushing of the concrete at the end of the crack; and (2) anchorage failure due to loss of bond of the tension reinforcement. As noted in Figure 2 a shear compression failure always has a reserve strength after the formation of the inclined crack.

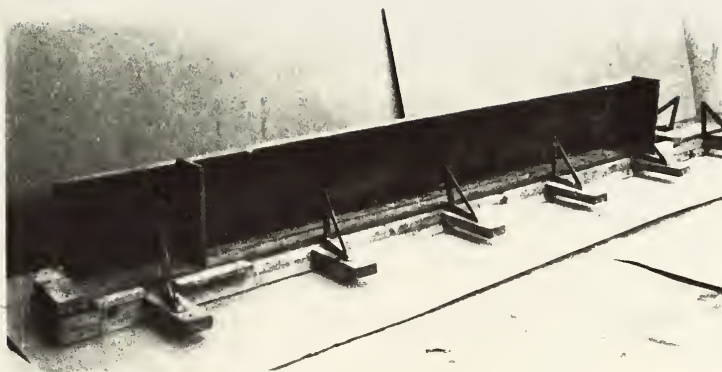
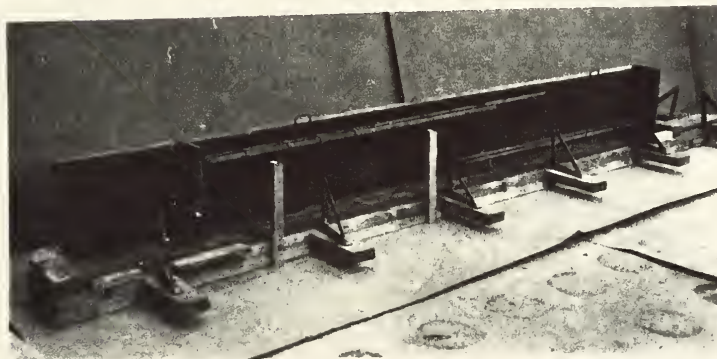
FIGURE 4.
FORMS PRIOR TO CASTING

All specimens were cast in 3/4" plywood forms which were treated to reduce deterioration due to the repeated wetting and drying. The forms are shown partially assembled in Figure 4. Bracing was supplied by the 1" x 1" angles bolted to wooden 2 x 4's. Tie rods were placed through angles on the bulkheads to keep the bulkheads in place during casting.

The reinforcement was wired into a rigid cage with the stirrups wrapped around the longitudinal steel. A minimum of 1.4" clear between the longitudinal steel was obtained by wiring the bars to the stirrups. Cover of 1.5" was maintained on the sides by using wooden blocks which were removed as the concrete was placed. The reinforcement was placed on rigid steel chairs to provide 2" clear cover on the bottom under the interior load. The steel to resist the negative moment was supported on steel bars fitted through the forms to provide the proper effective depth. These bars were removed after the concrete attained initial set. Handles made from the 1/4" plain bars were wired to the stirrups at each

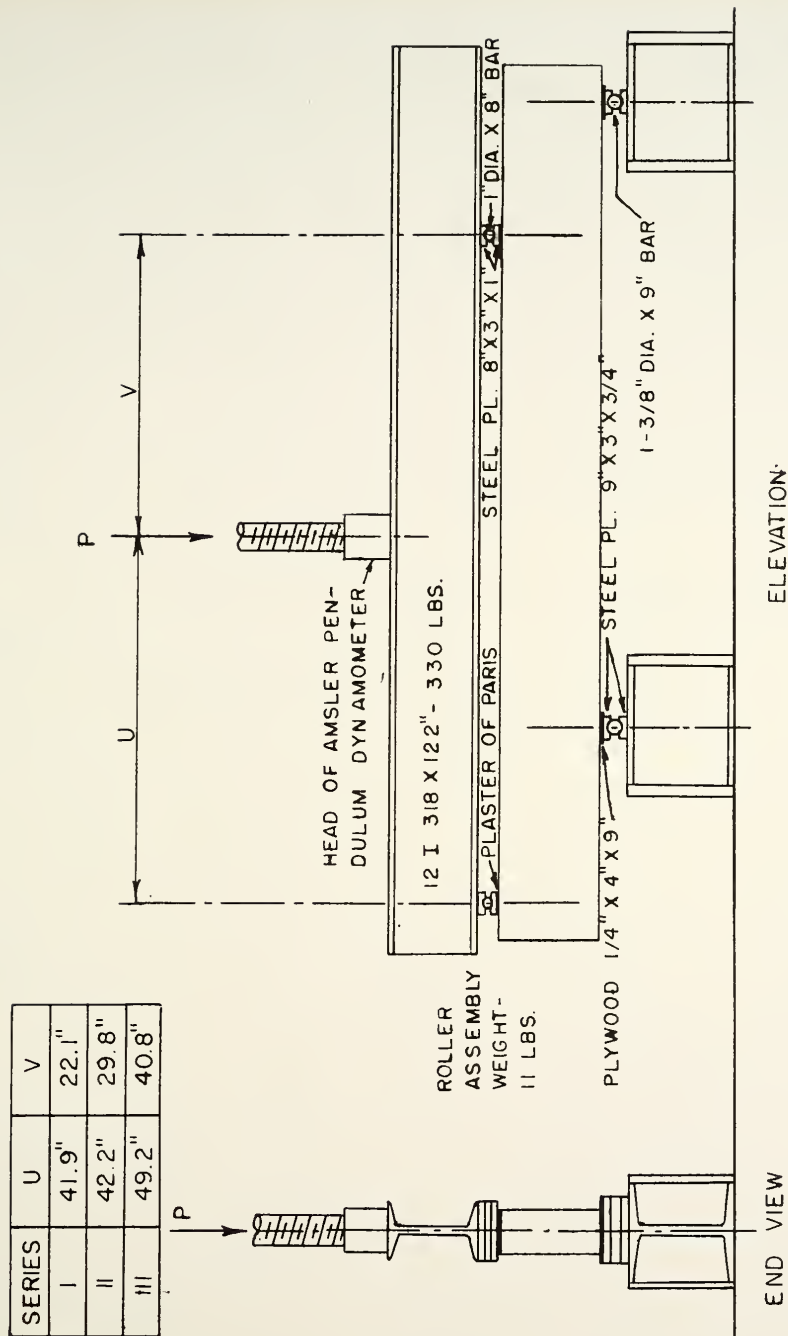
FIGURE 5. TEST SETUP

A Baldwin hydraulic testing machine of 600,000 lb. capacity was used to provide the load for testing the repeats from Harvey's thesis [9], and Wehr's thesis [19]. The load for the specimens from Spanan's thesis [18] and the study of variable concrete strength was from a remote hydraulic jack actuated by an Amsler Pendulum Dynamometer with automatic load maintainer. Figure 5 gives a general view

and details of the setup respectively. Steel strains were measured with foil type electric strain gages (Budd Metal-film C6-141B). The gages were affixed to the reinforcement at prepared locations with Eastman 910 adhesive. The gages and their lead wires were waterproofed and protected with an epoxy compound (Epoxylite No. 222). Strain in the longitudinal steel was measured at the point of maximum moment and in the critical shear span. Strains were also measured on some of the stirrups located within the critical shear span. The actual location of each of the gages is shown on the crack pattern sheets.

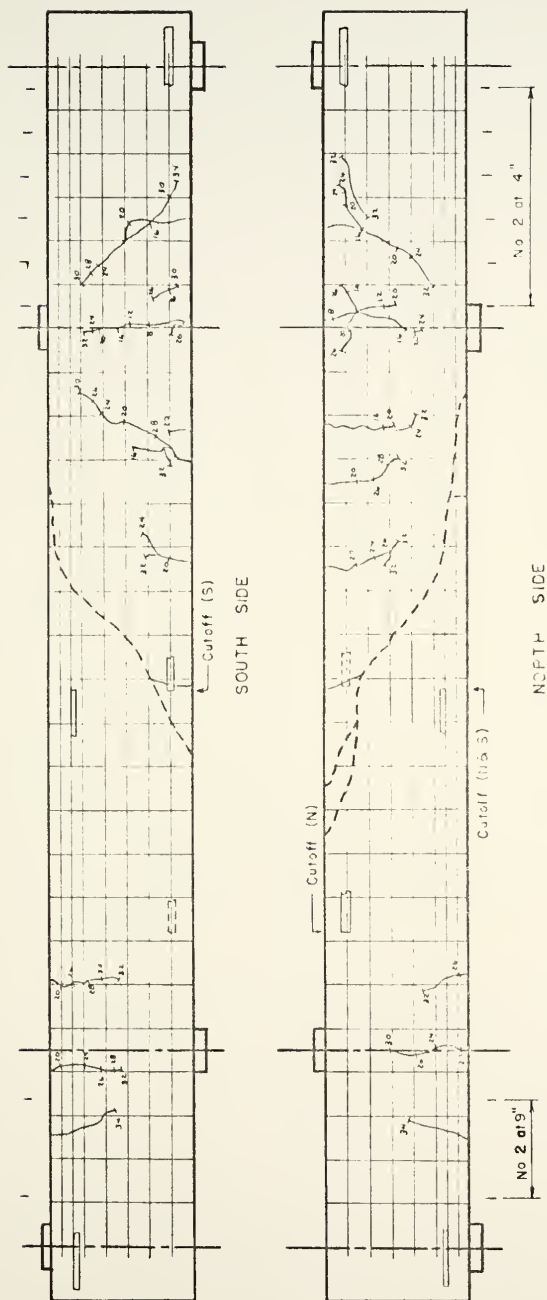
FIGURE 17. BEAM III B-6

Beam IIIB-6 (No Stirrups - AASHTO Cutoff). The failure crack formed suddenly at 34^k and was not visible at 32^k (Figure 17). Complete diagonal tension failure occurred with the appearance of this crack. The critical crack developed from a flexural crack which initiated at the cutoff point of the shorter longitudinal bar. After reaching the compression zone it became nearly horizontal. Splitting along the continuing tension bar was evident.

Both beams IIIB-5 and IIIB-6 failed in nearly the same manner as the original beams at approximately the same loads. In both cases the crack patterns, deflections and steel strains were similar to those of the original.

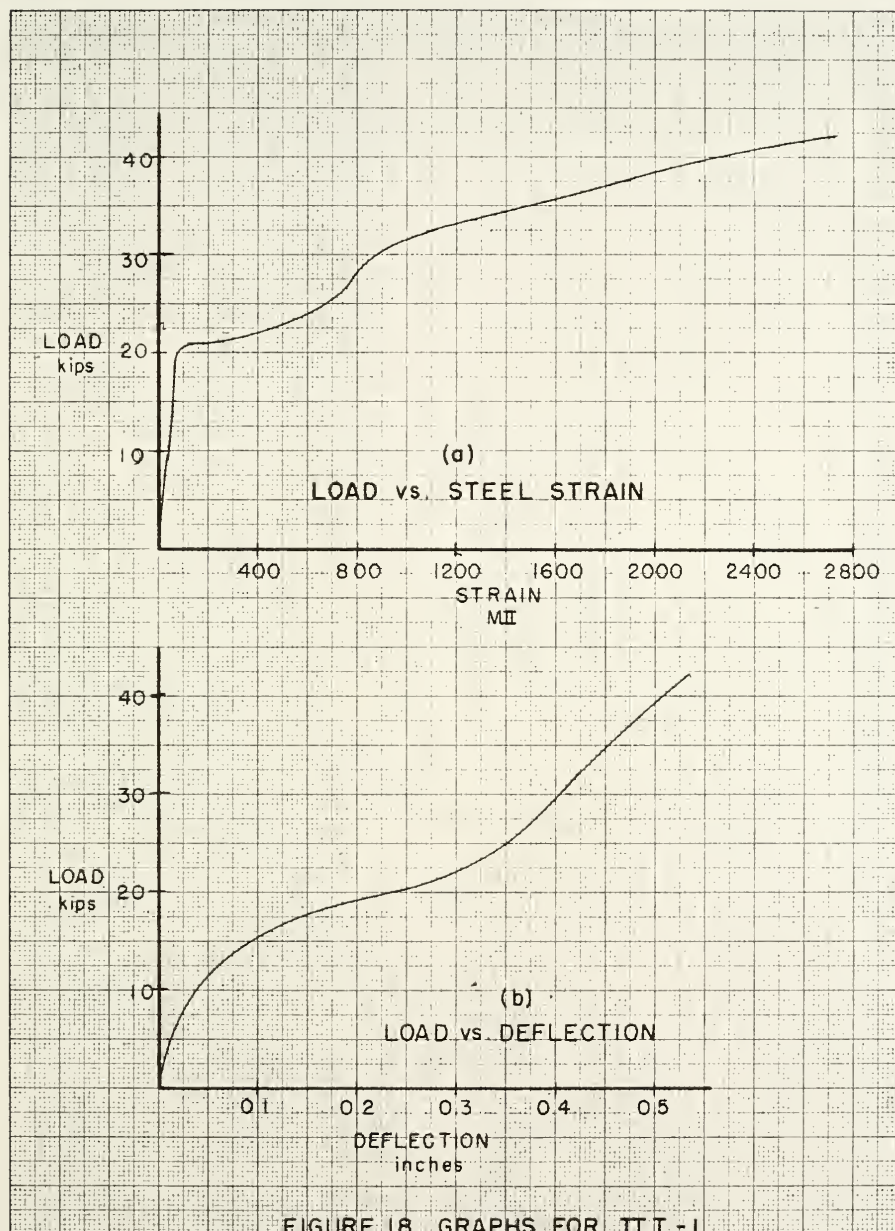
Beam IIT-1 (No Stirrups - No Cutoff). Steel strains and deflection (Figure 18) increased very slowly until the formation of the first tension crack through the flange at 25^k . This crack (Figure 20) penetrated to within 4" of the interior support and opened about $1/4$ ". The first diagonal crack formed at 40^k and on the south side this crack penetrated into the flange. This crack did not open wide at failure but served as the starting point for a crack which formed at 44^k , ran along the chamfer and opened wide at failure. On both sides parallel diagonal cracks opened wide at failure, with the latter splitting along the bottom reinforcement.

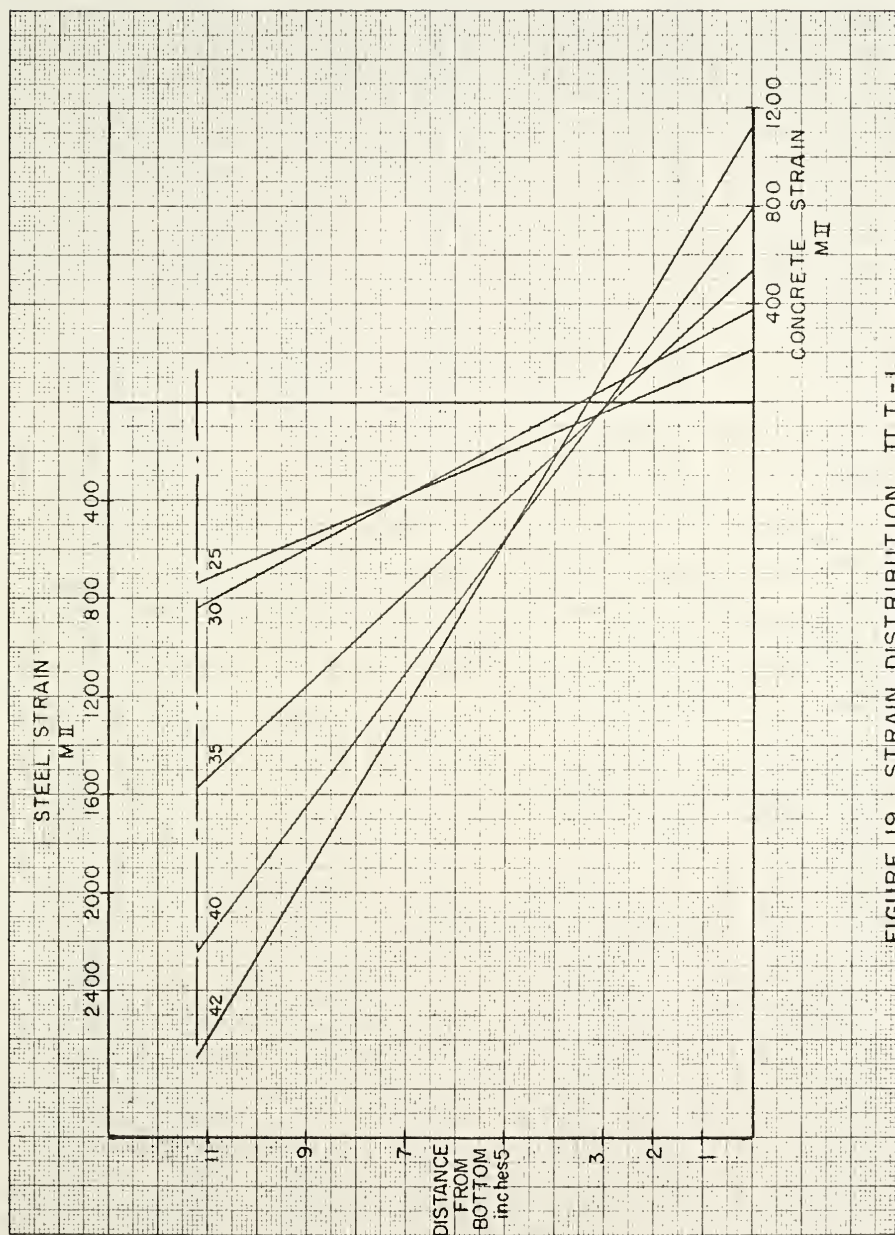
FIGURE 19. STRAIN DISTRIBUTION, II T-1

The strain distribution (Figure 19) shows that the neutral axis is about 3" from the compression face as opposed to 4" in the original beam. The failure cracks in the repeat beam formed farther from the support than that of the original beam even though the behavior and failure loads were similar.

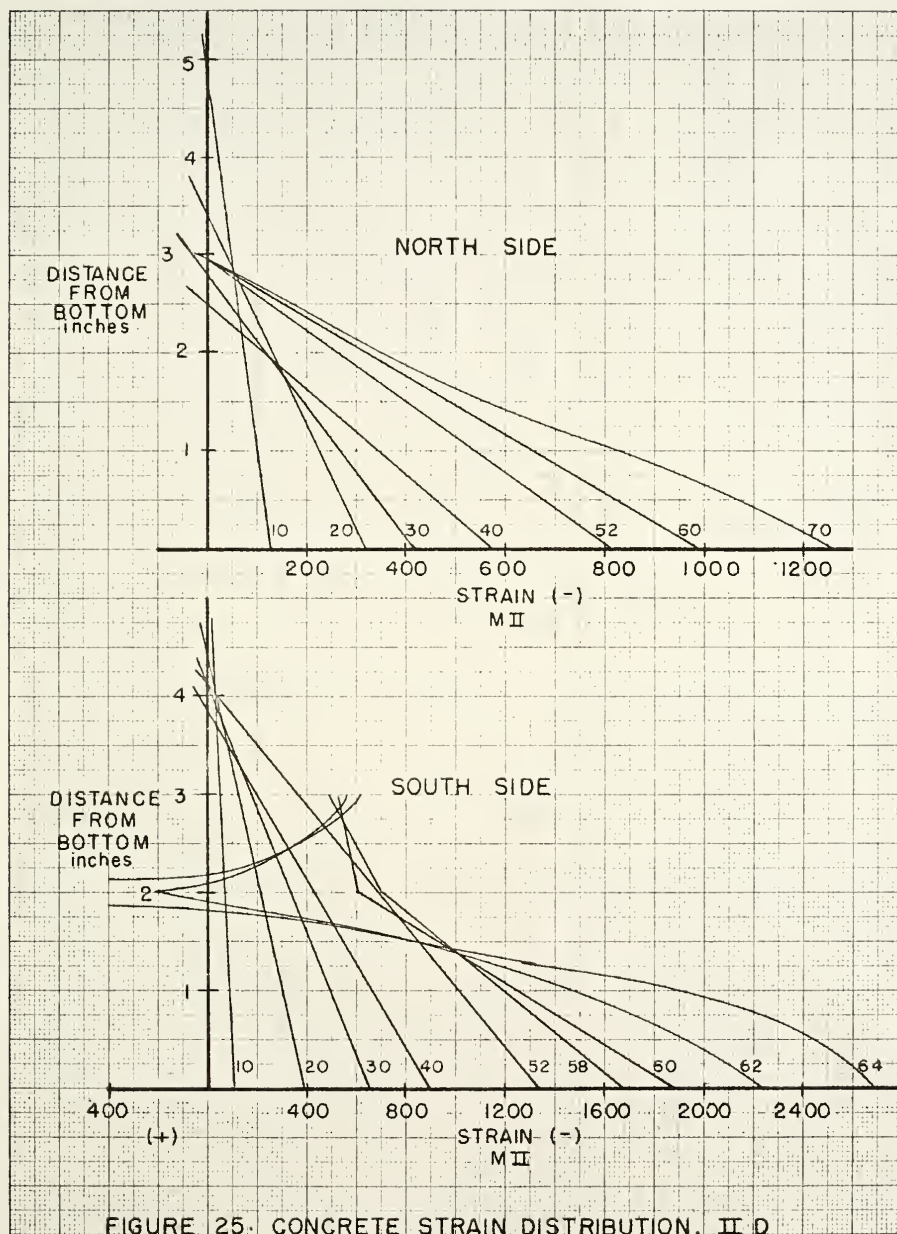
FIGURE 25. CONCRETE STRAIN DISTRIBUTION, II D

The concrete strain distribution (Figure 25) on the south side shows markedly the effect of the diagonal tension stresses beginning at a load of 58^k and continuing to failure. Strain at the third steel gage (Figure 27b) increased rapidly only after the critical crack opened wide.

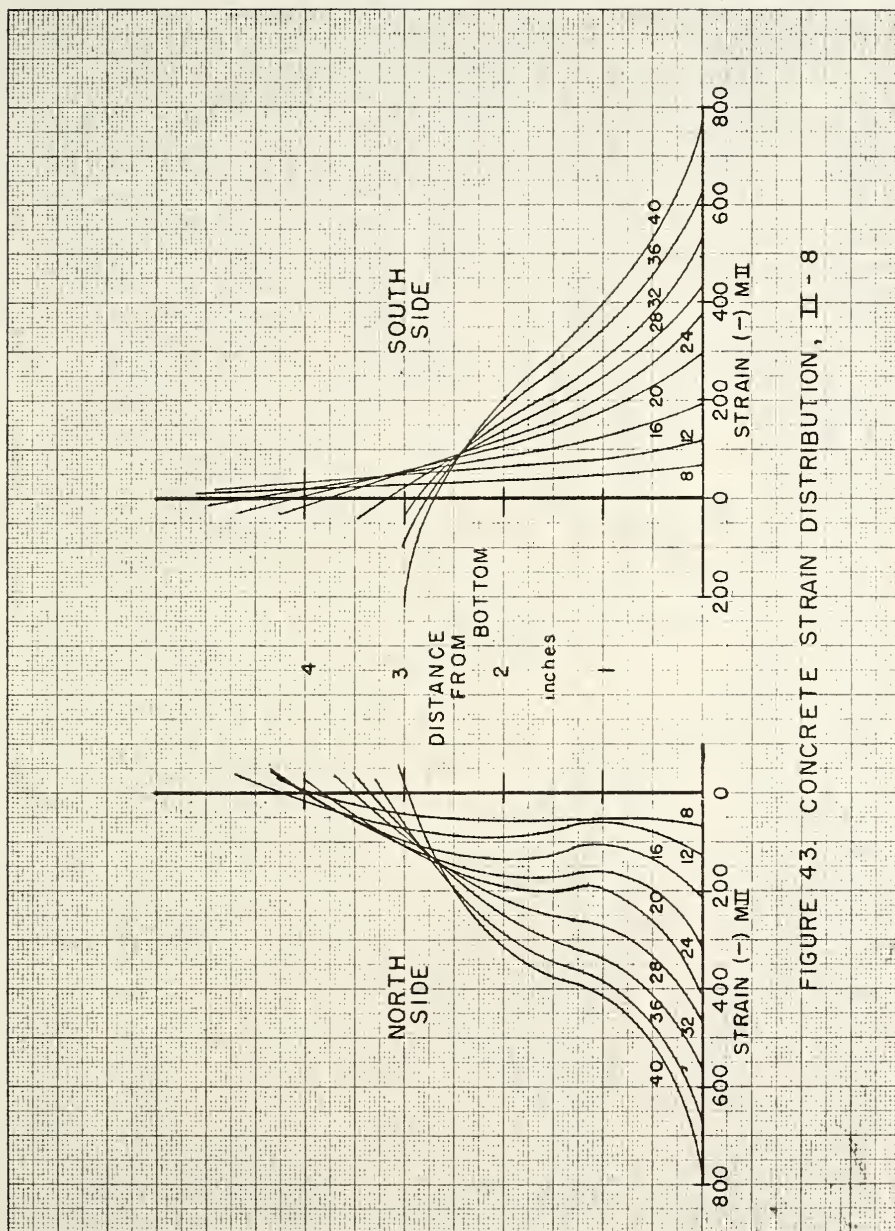
FIGURE 43. CONCRETE STRAIN DISTRIBUTION, II - 8

The concrete strain distribution (Figure 43) was very symmetrical. The deflection (Figure 40c) was essentially linear until failure.

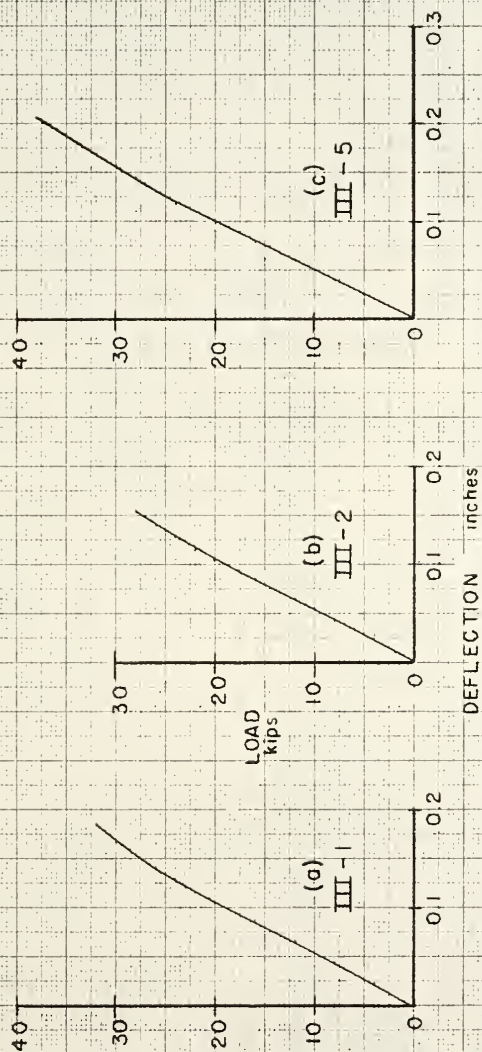
FIGURE 48. LOAD vs. DEFLECTION, SERIES III

The behavior of this beam (Figures 48, 51, 52) was the same as Beams III-1 and III-2.

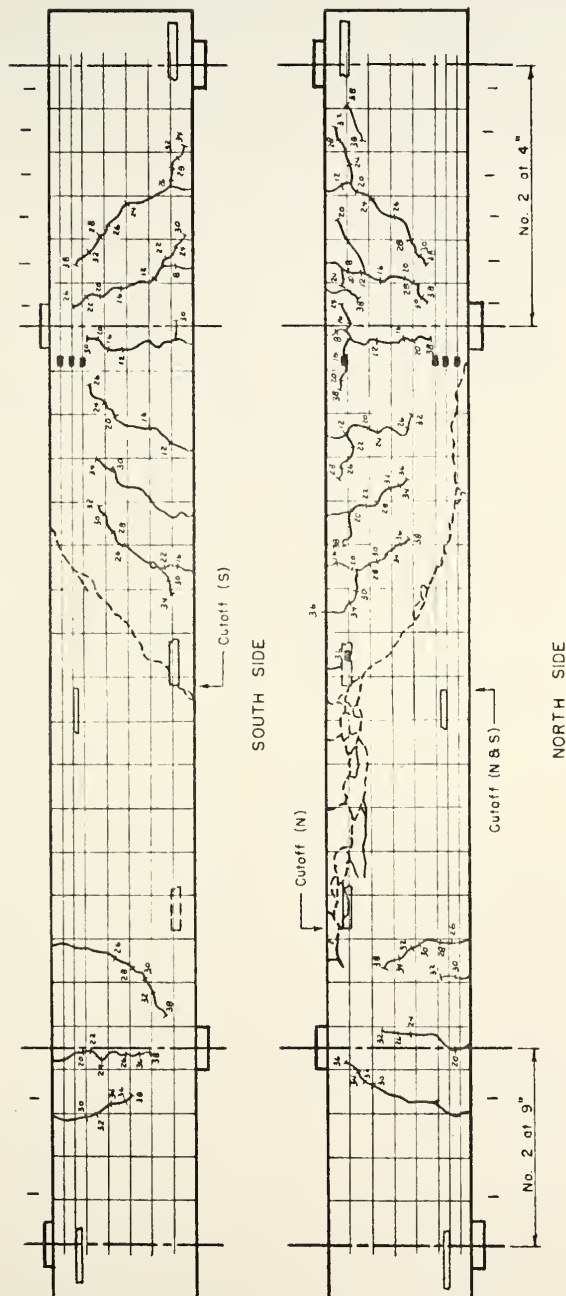
FIGURE 55. BEAM III - 5

Beam III-5 ($f'_c = 6,810$). Failure came suddenly at 40^k when the diagonal tension crack (Figure 55) formed on the south side through the cutoff point of the short bar. This was followed by splitting of the continuing bar and rapid penetration of the diagonal tension crack on the north side.
