Compatibility of R1234yf and R134a and Lubricants used in Automotive Compressors

Christopher Campo, Carolina Solano, Shelby Kent, Christopher Seeton, PhD

Shrieve Chemical Products, Inc.
The Woodlands, Texas, USA
(281-687-0997, ccampo@shrieve.com)

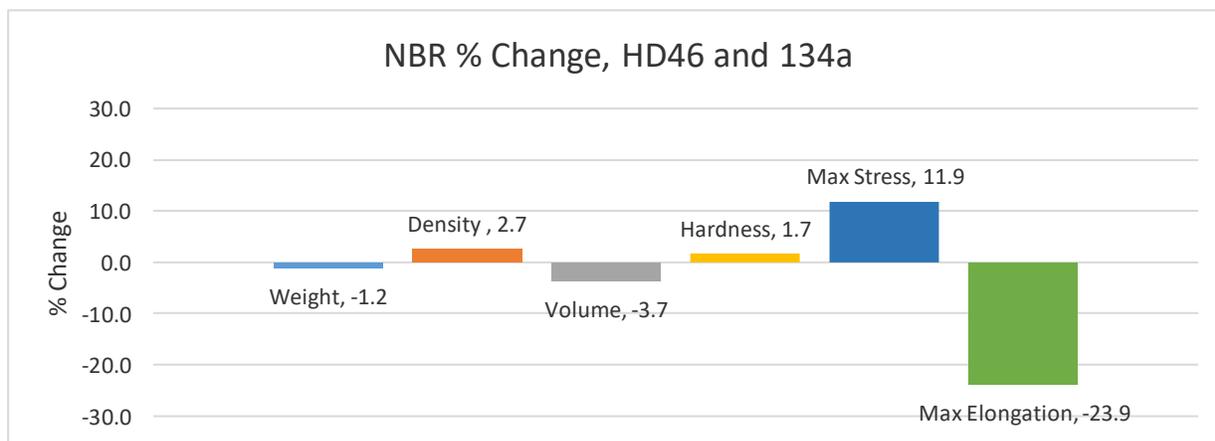
Figure 1: NBR Percent Change after exposure to HD46 and HFC-134a for 7 days at 100°C

Nitrile butadiene rubber (NBR) is an oil-resistant rubber typically used in the automotive industry for fuel hoses and gaskets that are not exposed to refrigerants. Figure 1 shows the percent change in physical properties after the exposure to HFC-134a and HD46 (automotive OEM double end-capped PAG lubricant) refrigerant. The HFC-134a data displays signs of slight hardening and loss of pliability of the elastomeric material shown by the increase in hardness and stress along with the decrease in elongation. The HFO-1234yf exposure in Figure 2 shows a very similar trend as compared to HFC-134a with increase in hardness, stress and decrease in elongation. The NBR material was the only one of the three elastomers tested that had color in the lubricant, which is an indication of leaching. The leaching can be backed up by the slight weight loss and increase of density which indicates a small

amount material loss and some shrinkage. In this application, shrinkage is an undesirable effect of aging being that the sealing material could end up not large enough to fill the gap and could result in the leaking of refrigerant into the atmosphere, therefore, damaging the compressor and its long-term function. Overall the NBR reacts similarly with HFC-134a and HFO-1234yf.

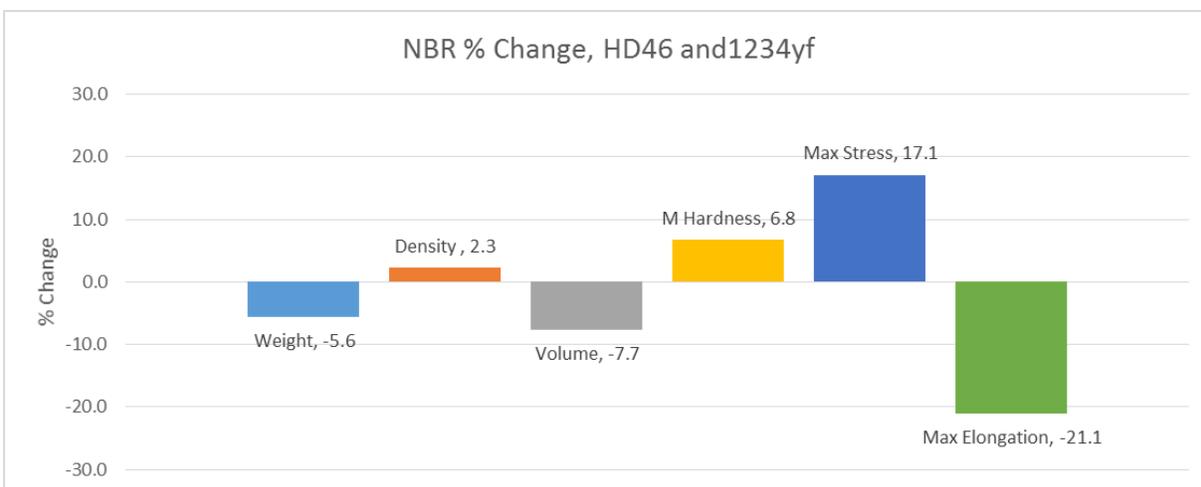
Figure 2: NBR Percent Change after exposure to HD46 and HFO-1234yf for 7 days at 100°C

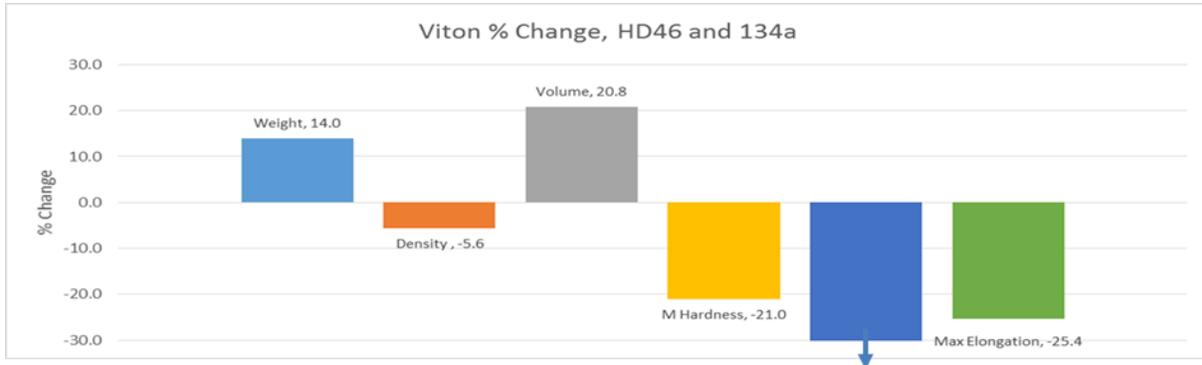
Figure 3: Viton Percent Change after exposure to HD46 and 134a for 7 days at 100°C

Viton is a fluoropolymer that is typically known for its chemical resistance. However, in the HVAC&R application, Viton is inherently incompatible with refrigerants because they are both fluorine containing compounds. The effect of the refrigerant breaking down the fluoropolymer can be seen in the results from the Viton exposure charts below in Figures 3 and 4. Viton had the least desirable results of all three of the materials tested. Viton failed in all aspects of what is ideal for a sealing material in this application. It had the largest increase of volume and had the largest percent loss in tensile max strength and max elongation. The decrease in tensile properties indicate the O-rings inability to maintain its form. The decrease in hardness in conjunction with the large volume increase could be an indication that the O-ring could possibly extrude from the gap and fail to seal the compressor. However, in both instances the elastomer performed the same in either refrigerant.

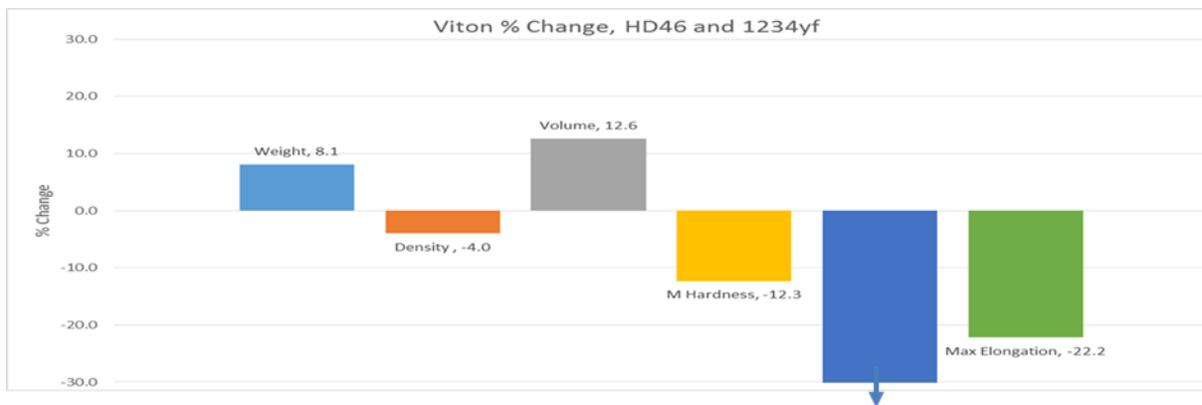
Figure 4: Viton Percent Change after exposure to HD46 and 1234yf for 7 days at 100°C

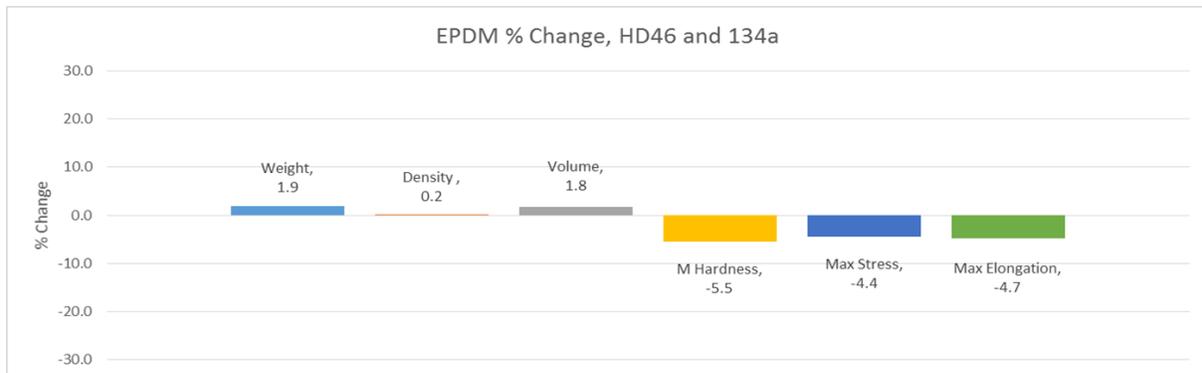
Figure 5: EPDM Percent Change after exposure to HD46 and 134a for 7 days at 100°C

Ethylene Propylene Diene monomer (EPDM) is a very versatile synthetic elastomer that is used in application from roofing paper to automotive applications. However, EPDM is not a typical material used in HVAC&R systems as HCFC-22 typically used mineral oils and alkylbenzene lubricants that dramatically softened the elastomer. However, in the system of HFC and HFO refrigerants with PAG lubricant, EPDM can perform well. The results which can be seen in Figures 5 and 6 show an excellent chemical compatibility for both refrigerants. In both cases the percent change was very minimal. They both had a slight increase in volume which is ideal to further fill the gap; providing a better seal.

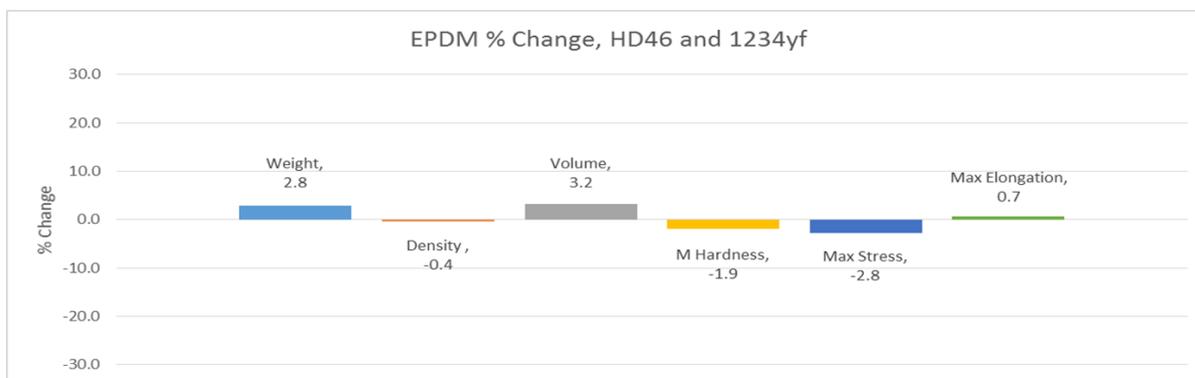
Figure 6: EPDM Percent Change after exposure to HD46 and 1234yf for 7 days at 100°C

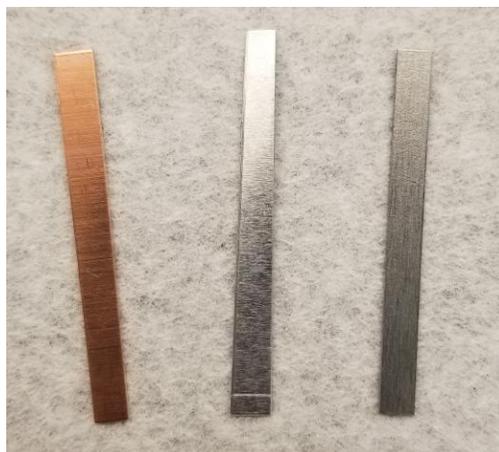
Figure 7: Reference (New unexposed Coupons)

Thermal stability was tested on 6 samples with the formulation displayed in Table 1. Samples 13, 15, & 16 used a POE32 oil with HFC-134a and samples 17, 19, & 20 used POE32 oil with HFO-1234yf. Visual evaluations were done to compare the exposure effects of the two refrigerants on the oil and the metal coupons. The unexposed POE32 is of a clear water-white to slightly yellow color with a low acid number (< 0.05 mg KOH/g). Figure 7 shows unexposed metals as a reference.

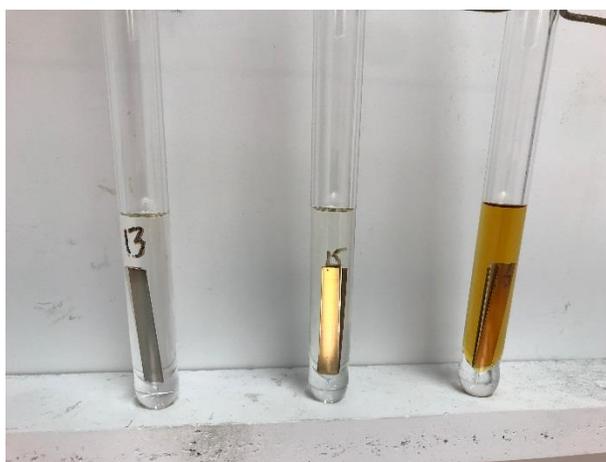
Figure 8: Exposed Oil Samples using HFC-134a (left to right: 13, 15, and 16)

Samples 13, 15, and 16 all used POE32 with HFC-134a, but had different exposure parameters with some containing amounts of water and/or air, Table 1. As can be seen in Figure 8, sample 13 (containing no air or water) had a very faint pale-yellow tint, and sample 15 (containing water) slightly more yellow in color. However, sample 16 (containing water and air) was a very dark yellow/orange color. Acid number on 13 and 15 were relatively low (<0.25 mg KOH/g), while sample 16 had a slightly elevated TAN of 0.33 mg KOH/g. The same parameters were done on a separate set of samples with the same oil, but using HFO-1234yf (samples 17, 19, 20). Figure 9 shows sample 17 (containing no air or water) was colorless, sample 19 (containing water) was a faint pale-yellow color, and sample 20 (containing water and air) was a very dark yellow/orange color. Samples 17 and 19 also had low acid numbers of <0.25 mg KOH/g while sample 20 had an acid number of 1.2 mg KOH/g.

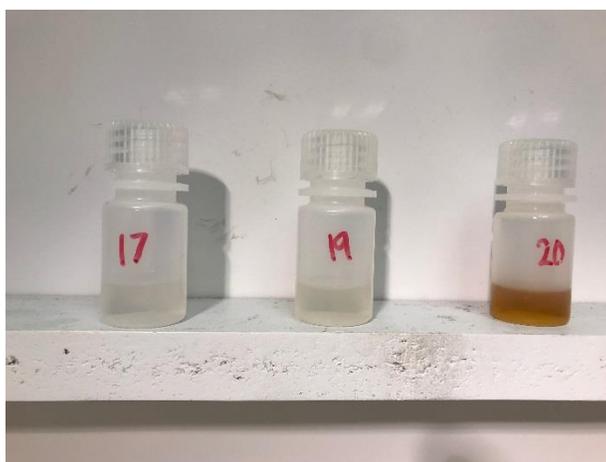
Figure 9: Exposed Oil Samples using HFO-1234yf (left to right: 17, 19, and 20)

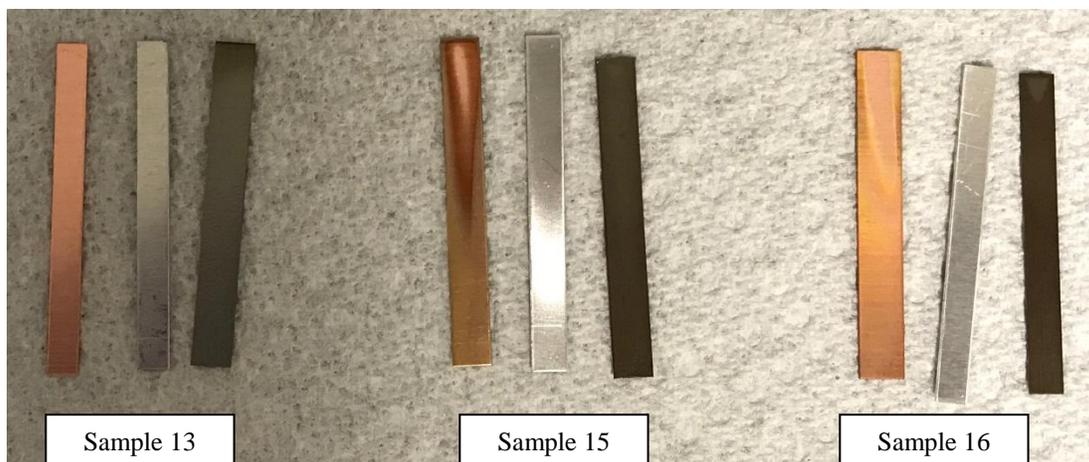
Figure 10: Exposed Metal Coupons using HFC-134a

When looking at the exposed metals of the samples tested in Figure 10, metals from sample 13 showed no change to the aluminum, slight lightening in color of the copper coupon, and a small amount of darkening/copper coloring on the tip of the steel coupon. Sample 15 showed discoloring of copper on both sides of the coupon, no change to the aluminum coupon, and darkening with copper coloring on both sides of the steel coupon. Metals from sample 16 showed discoloring of the copper coupon on both sides, no aluminum change, and a dark copper coloring on the steel coupon. The samples using HFO-1234yf had similar findings. Figure 11 shows metals from sample 17 had no visible changes to any coupons. Sample 19 had minor discoloring to one side of the copper coupon, no changes to the aluminum coupon, and darkening to the steel coupon with what appeared to be a copper coloring. Metals from

sample 20 showed greater discoloring of the copper coupon, discoloring of the aluminum coupon, and darkening as well as color leeching from the steel coupon.

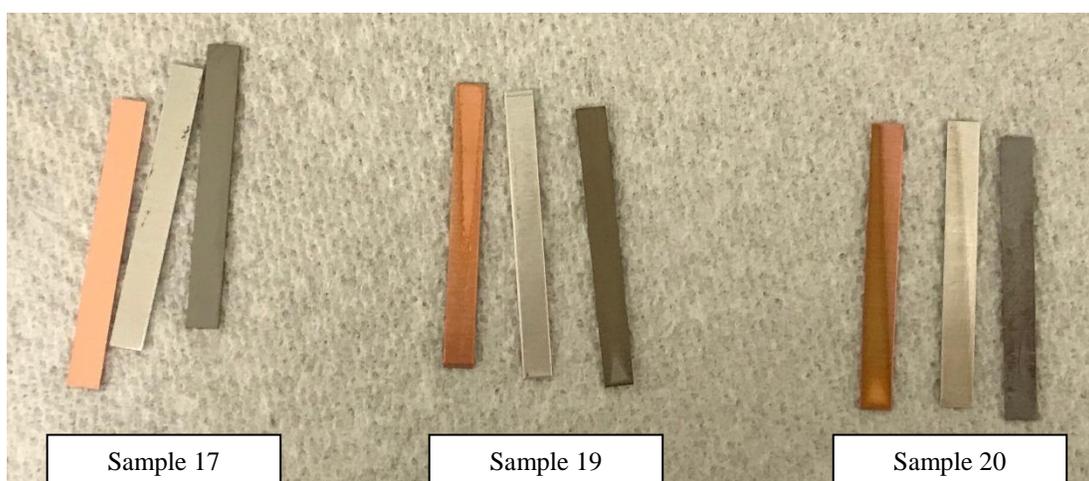
Figure 11: Exposed Metal Coupons using HFO-1234yf
