International Refrigeration and Air Conditioning
Conference

2021

An Evaluation of the Effect of Corrosion Tests on Thermal Performance of Aluminum Heat Exchangers

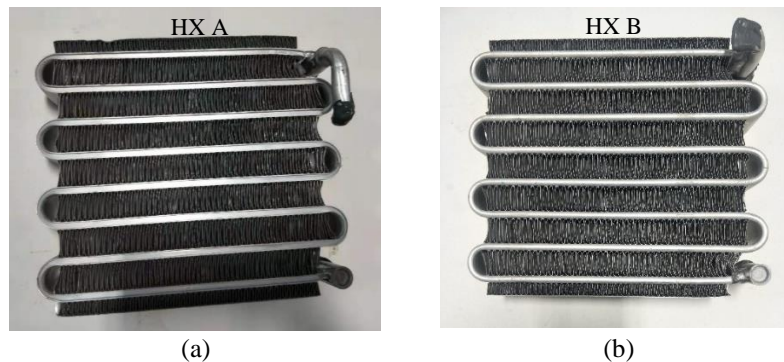
Figure 1: The samples: (a) HX A where degradation of the performance is evaluated with the continuously accumulated deposit; (b) HX B where every performance test was done after cleaning.

The aluminum heat exchanger samples are prepared from an unused automobile heat exchanger. The HX is cut in the middle to form two identical parts, sample A and sample B, as illustrated in figure.1. The dimensions for both samples are 228 mm in width, 228 mm in height, and 51 mm in depth. The current study is focused on changes in thermal performance due to corrosion on the major heat transfer surfaces. Therefore, the HX inlet and outlet tube and serpentine tube U-bends are protected by anti-corrosion tape to prevent possible fast tube perforation at these locations. The inlet and outlet of header tubes are sealed to prevent salt fog from entering the HX.

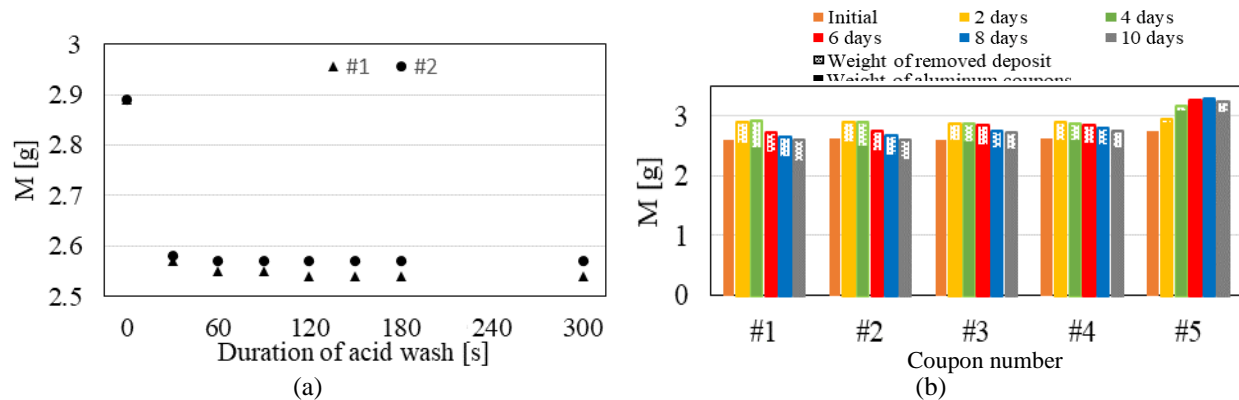
Figure 2: Weight change of aluminum coupons: (a) weight of coupons #1 and #2 (after the 1st two-day of corrosion test) as a function of acid washing time; (b) weight of coupons (#1 to #5) after every two days of corrosion test.

To evaluate the effectiveness of the cleaning, five aluminum coupons were exposed to the corrosion test and then cleaned with different methods. Each coupon has a dimension of around 7.5 cm in length and 2.5 cm in width. All five coupons went through the following testing procedures: the coupons are tested in the corrosion chamber for a total of 10 days, the corrosion test is paused every two days so that the coupons can be taken out for various cleaning procedures. After the salt spray test, the coupons are naturally dried, the weight of each aluminum coupon is then measured. During the cleaning process, coupons #1 and #2 are immersed in the 5% nitric acid solution at room temperature. To determine the proper immersion time, a test was performed after the 1st two-day corrosion test. After immersion for a selected duration, the coupons are taken out and naturally dried, weighted, then sent back to the immersion bath to repeat the exposure. The weights of aluminum coupons #1 and #2 vs. cleaning duration are shown in figure 2(a). Figure 2(a) indicates that a 2-minute acid washing time is sufficient to remove the deposit. The weights of aluminum coupons #1 and #2 during acid wash reduce fast in the first 30 seconds. A longer wash time than 120 seconds does not seem to affect the coupon weights anymore. Therefore, acid washing time is justified to be 2 minutes. Aluminum coupons #3 and #4 are cleaned by rinsing with water and gently brushed to remove the loosely attached deposit. Aluminum coupon #5 is cleaned only by gently blowing dry air. Figure 2(b) presents the weights of all five aluminum coupons before and after each cleaning. It is found that the acid wash leads to more weight loss than the water rinsing method, and coupon 5 shows little change in weight after the air blowing procedure.

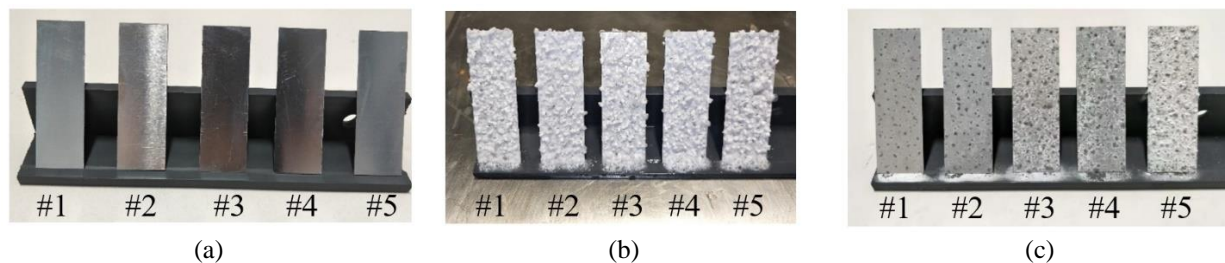
Figure 3: Appearance of aluminum coupons: (a) before salt spray test; (b) after two days of salt spray test; (c) after two days of salt spray test and cleaning procedure.

The appearances of aluminum coupons before and after the corrosion test (the 1st two-day corrosion test) and after cleaning are presented in figure 3(a), 3(b), and 3(c), respectively. Figure 3 shows that coupons (#1 and #2) after the acid wash are visually free of deposits, while the coupons (#3 and #4) after the water rinsing still have visible white deposits on the surfaces, and coupon 5 after air blowing is covered with heavy deposition. Therefore, the authors concluded that diluted acid wash is the most effective method among the three to remove the deposit on the aluminum surface.

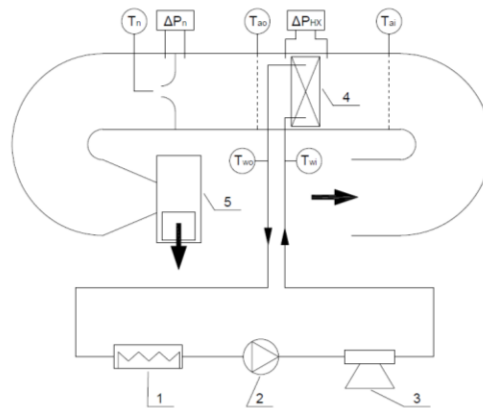
Figure 4: Schematics of the wind tunnel: 1 water heater; 2 water pump; 3 flow meter; 4 heat exchanger sample; 5 blower

The heat exchanger performance is evaluated using a wind tunnel. The airside pressure drop was measured as the representation of the hydraulic performance, and the heat transferred was measured to acquire a product of overall heat transfer coefficient and heat transfer area UA as the representation of thermal performance. A schematic of the wind tunnel facility is illustrated in figure 4. The wind tunnel has an open-air loop and a closed water loop. The tests are performed at given air side flow rates (by controlling blower speed) and a heat load (by a heater in the water loop). The airside pressure differences across the heat exchanger are measured by a differential pressure transducer. The air pressure drop across the nozzles is also measured to calculate the airflow rate. The air temperatures at the heat exchanger inlet, outlet as well as at nozzle outlet are measured with T-type thermocouples. In the water loop, water is heated by an immersed heater, then pumped through the tube side of the heat exchanger. The water temperatures at the inlet and outlet of the heat exchanger headers are measured using type T thermocouples. The mass flow rate of the water is measured by a flowmeter.

The waterside heating capacity is kept at around 1000 W . The water flow rate is maintained at 115 g/s. Three air volumetric flow rates are applied, which are 0.103 (-0.001, +0.005) m^3/s , 0.138 (-0.002, +0.006) m^3/s , and 0.170 (-0.002, +0.007) m^3/s . The airflow rate is calculated based on the temperature and pressure measurements at the nozzles referring to ASHRAE standard 41.2 (ASHRAE 41.2-18, 2018). The airside capacity \dot{Q}_a is calculated using the following equations.

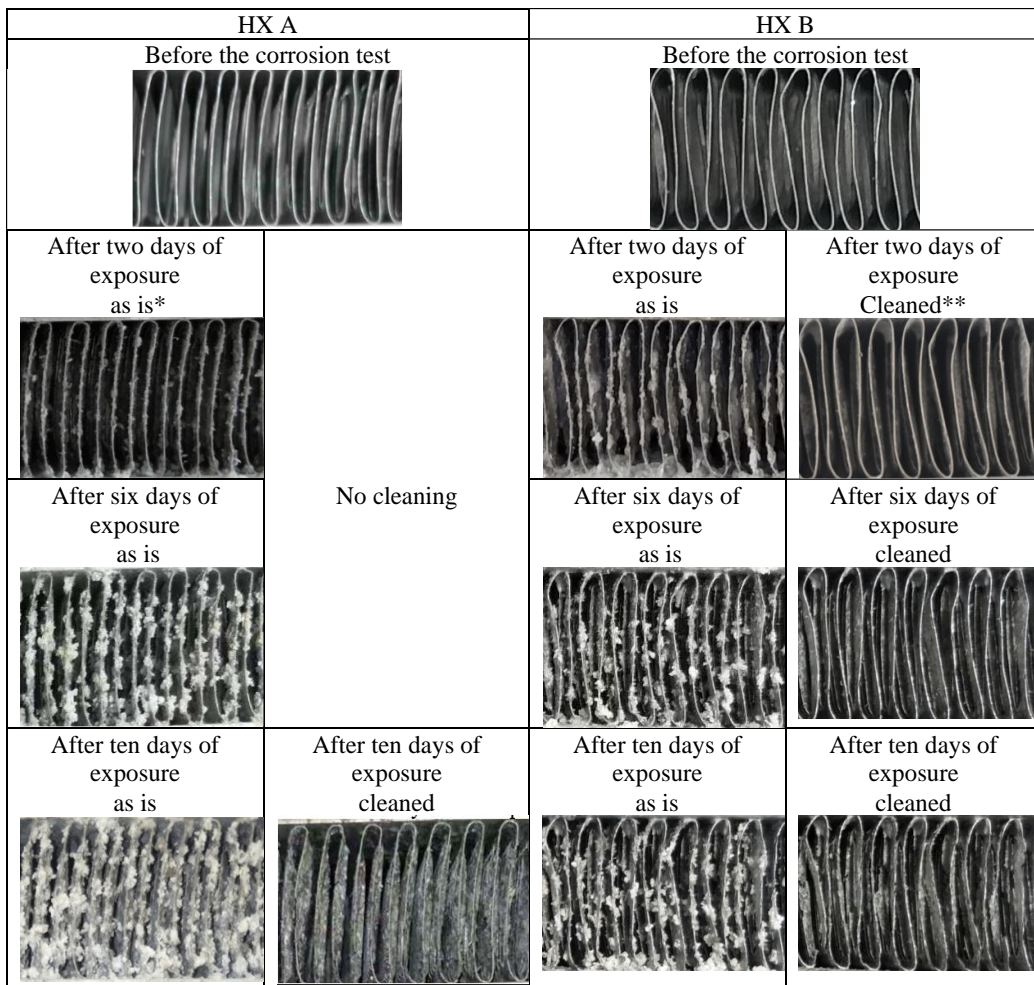
*The heat exchanger sample is dried naturally at room temperature then gently blown with compressed air to remove the loose deposit.

** The heat exchanger sample is dipped in 5% nitric acid, rinsed with deionized water, then dried naturally at room temperature. The deposit is removed thoroughly.

Figure 5: Appearance of the front side of two exchanger samples at various stages of the experiments.

Some general observations on the HX front surface appearance are presented in figure 5.

The deposit on HX A accumulates in time. The accumulated deposit was removed only after a 10-day corrosion test is completed. HX B was cleaned following an acid washing procedure after every two days of the SWAAT test. In figure 5, the photos of cleaned HX B show that the defects on the fins appear and become more severe as the corrosion test time increases.

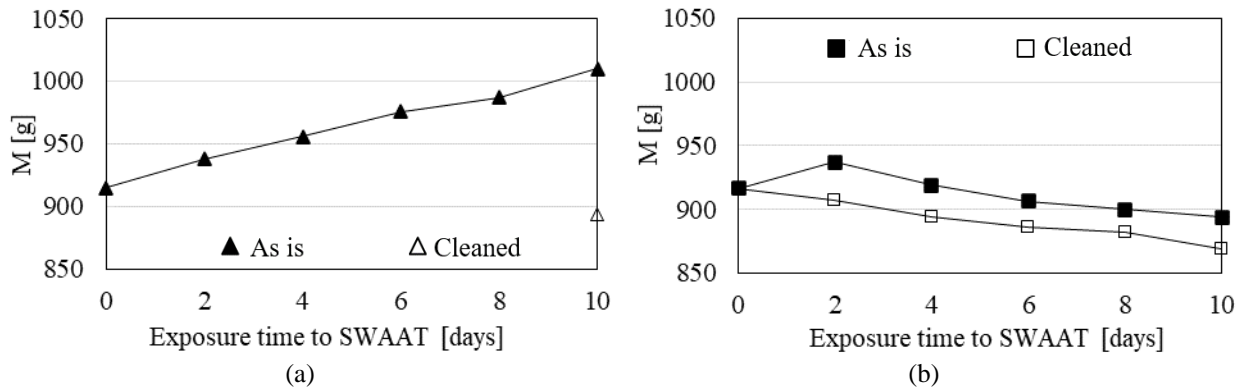
Figure 6: Weights of HXs during the experiments: (a) the weight of HX A continuously increases when the accumulation of deposit was uninterrupted (see the solid triangles); (b) the weight of HX B continuously decreases when thoroughly cleaned after every two days of corrosion test (see the hollow squares). The “as is” and “cleaned” conditions correspond to the definitions listed in figure 5

The weight of HX A increases continuously in time, as illustrated in figure 6(a), confirming continuous deposit accumulation. However, when HX A is thoroughly cleaned by the acid washing procedure after the ten-day corrosion test, we measured a 2.3% weight loss compared to the original HX weight. The slight weight reduction indicates that there is a material loss of the HX due to corrosion. The weight of the HX B before and after the cleaning is presented in figure 6(b) indicated by the solid and hollow squares, respectively. The weight after cleaning decreases continuously at a relatively constant rate throughout the ten days of the corrosion test.

The weight changes of the cleaned HXs (hollow triangle in figure 6(a) and hollow squares in figure 6(b)) indicate that continuous accumulation of the deposit may slow down the corrosion of the heat exchanger. The weight of HX A, only cleaned after the ten-day corrosion test, is reduced by 2.3%, while the weight of HX B, which is cleaned after every two days of the test is reduced by 5.2% after the completion of the 10-day corrosion test. The greater weight loss of HX B indicates a higher corrosion rate on the cleaned surface. It appears that the deposit on the heat exchanger formed during the salt spray test may protect the surface, decelerating the corrosion by blocking the direct contact between the heat exchanger material and the salt fog.

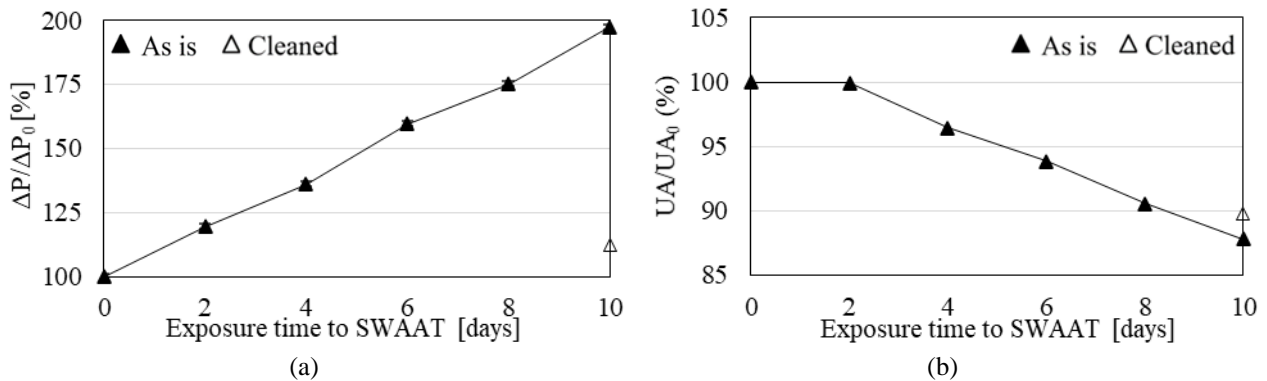
Figure 7: The performance of HX A (continuously accumulated deposit in time): (a) airside pressure drop increases continuously in time, except when the deposit is removed after the ten-day test; (b) UA value decreases as the corrosion test duration increases.

The airside pressure drop of HX A increases linearly in time, as shown in figure 7(a). A linear trend of HX weight increase and corrosion test duration has been previously presented in 3.1, figure 6(a). Visual inspection of the heat exchanger surface (see figure 5: ten-day corrosion test and as-is condition) shows that the accumulated deposit on the heat exchanger surface may have partially blocked the air pass area. Therefore, it is reasonable to believe that the deposit formed during the salt spray test is the dominant cause of the increase of the HX A airside pressure drop when they are not removed from the heat exchanger. When the deposit is not removed, the pressure drop of HX A increased 97% after ten days of the salt spray test. After cleaning, the pressure drop shows an increase of 12% over the initial

value (hollow triangle in figure 7(a)). The relatively small pressure drop increase after the removal of the deposit may be correlated to the fin/tube surface damages caused by the corrosion.

The heat transfer performance of the HX A (represented by the UA value), presented in figure 7(b) shows a continuous decrease in time without cleaning. When the deposit remains on the HX surface, the change of thermal performance is affected by both the deposit (e.g. increased thermal resistance) and the damage due to corrosion. After the ten-day corrosion test, when the deposit is removed from the HX surface, the UA value (the hollow triangle in figure 7(b)) shows a 10% decrease compared to the original HX performance, but a 2.3% increase compared to the HX performance before the deposit was removed. In this case, i.e., when the deposit is removed, the impact due to the surface deposition has been largely eliminated. Therefore, after ten days of corrosion test and cleaning, the 10% decrease in heat transfer performance and the 12% increase in pressure drop compared to the initial value more closely reflect performance degradation due to the damage of the HX surface caused by corrosion.

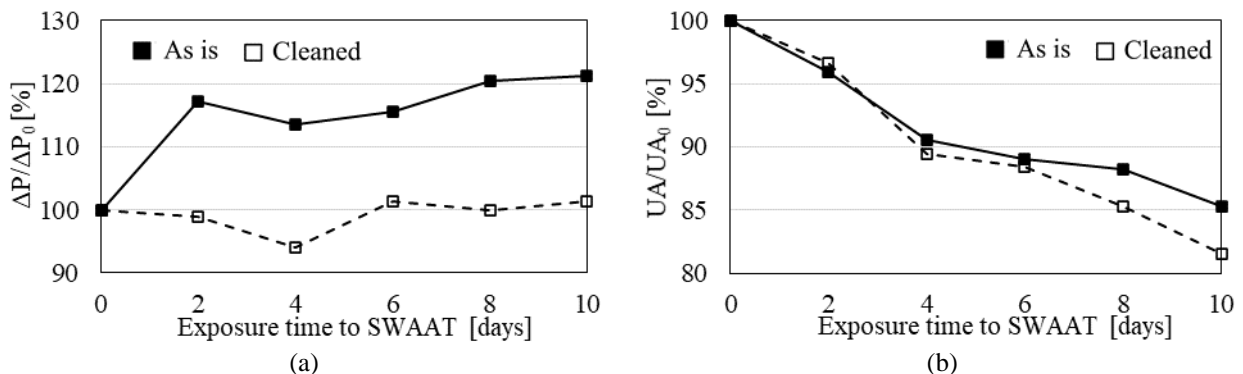
Figure 8: The performance of HX B (thoroughly cleaned after each two-day corrosion test session): (a) the airside pressure drop of the uncleaned HX B is higher than the cleaned HX B; (b) UA values decrease when the corrosion test duration increases, for both uncleaned and cleaned HXB.

For the HX B, which is thoroughly cleaned with the acid wash after every two days of the corrosion test, the change of pressure drop is less significant than the changes measured in the HX A. The measured pressure drop and UA results are presented in figure 8. Figure 8(a) shows that at the given airflow rate, the pressure drop of the cleaned HX B presents very little variation, regardless of the duration of the corrosion tests. The increase of the pressure drop after every two-day corrosion test (without cleaning) over the original pressure drop is in a range between 14.9% and 22.9%. These test results indicate that the deposit on the HX surface is the main cause of the increase of airside pressure drop, which is consistent with the conclusion based on the HX A testing results.

Figure 8(b) shows the UA of HX B vs. corrosion test duration, both before and after the surface cleaning procedure. In general, the UA value of HX B decreases as the corrosion test duration increases. It is interesting to see that the difference between the UAs before and after the cleaning procedure is relatively small, especially for corrosion test durations shorter than six days. After eight days of corrosion test duration, the UA value of the cleaned HX tends to be smaller than the UA value before the cleaning procedure. There are two opposite effects of the surface deposition on the heat transfer performance: (1) the deposit serves as a heat transfer barrier of the metal fins and tubes, therefore, reduces the overall heat transfer coefficient; (2) the accumulation of the deposit also leads to a reduction in the opening between the fins, and thus the increase air velocity at the given airflow rate, so the heat transfer coefficient may be increased. The overall reduction of UA value (the solid squares in figure 8(b)) is the result of both effects. When the deposit is removed from the HX surface, the reduction of the UA value (the hollow squares in figure 8(b)) is dominantly controlled by the level of surface damage, which is more realistically reflecting the heat exchanger performance degradation due to corrosion. Compare figure 7(b) and figure 8(b), it is found that the reduction in UA of HX B is more rapid than that of HX A. After the ten days of the corrosion test and the removal of the deposit, the UA of HX A reduced to 90% of its initial value, while the UA of HX B reduced to 81% of the initial value. This indicates that the heavier deposition on HX A may have mitigated the corrosion on the heat exchanger surface, thus reduced the deterioration of the UA on HX A. In other words, the deposit on the HX surface can slow down the salt spray corrosion and potentially make the corrosion test less efficient.

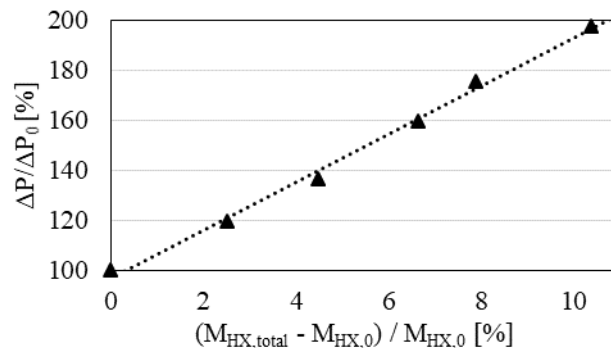
Figure 9: A linear correlation between the relative airside pressure drop and the relative weight change of HX A during the ten-day corrosion test

According to the previous discussion, it can be seen that the thermal performances of aluminum heat exchangers are significantly different if treated with different post-corrosion cleaning procedures. In addition to the corrosion attack, the surface deposit from the corrosion tests plays important role in the heat exchanger performance. Figure 9 shows the “as is” pressure drop of the HX A (relative to its initial pressure drop before the corrosion tests) with a continuously accumulated deposit versus the increased weight of the heat exchanger. A linear correlation was confirmed between the two parameters. Such a linear correlation indicates that the accumulated deposit on the heat exchange surface after the SWAAT test, if not removed, is the dominant cause of the significant increase of the airside pressure during performance evaluation.

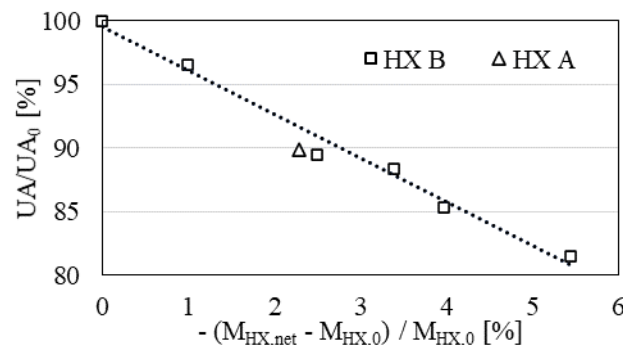
Figure 10: A linear correlation between the decreasing relative UA and the increasing weight loss of cleaned HX A and cleaned HX B during and after ten days of salt spray test

From the results of the performance evaluation of HX B, it is also found that the change of UA value is closely related to the weight loss of the cleaned heat exchanger over the original HX weight. Figure 10 shows the change of UA of the cleaned HX B versus the weight loss of the cleaned HX B throughout the salt spray test. It can be observed that the UA decreases linearly as the weight loss increases. This relation between the UA and weight loss may be explained as follows: The weight loss caused by corrosion indicates the loss of heat transfer area, e.g., fin damages, fin/tube debonding, and subsequently leads to the reduction of heat transfer capability. Therefore, the UA value of a corroded heat exchanger may be reasonably correlated to its weight change due to the corrosion attack, when a proper cleaning procedure is performed after the corrosion test. However, a more in-depth study is needed to verify such speculations and will be performed in future work.
