Experimental Pavement Marking Materials Final Status Report

MICHAEL BREACH
Traffic Division, IDOH

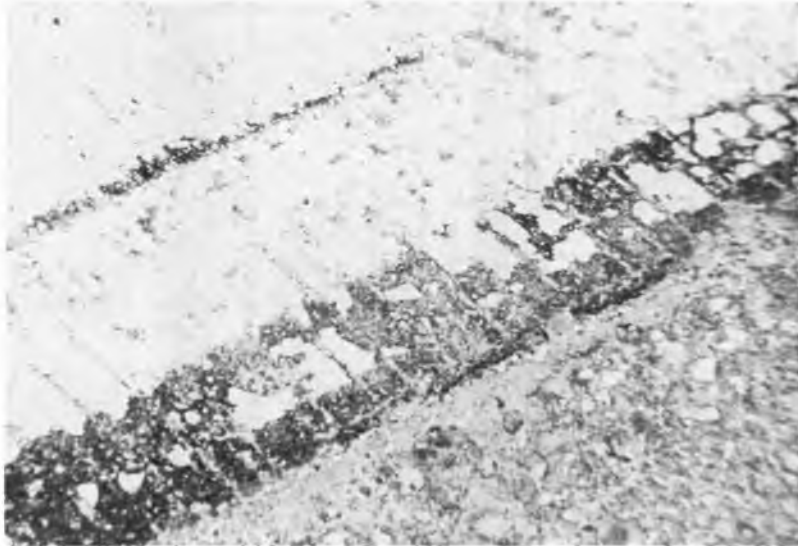
Figure 1.

The district review process revealed several factors that affected the performance of the materials. One problem discovered was failure of the material due to shortfalls in its composition or formulation. This type

of failure, as shown in Figure 1, occurred after the test site was subjected to harsh typical Indiana winter weather. The formulation problem occurred at both the manufacturing level and on site, where machine mixing was required. The second type of failure occurred when the material reacted with previously applied sealant materials. Figure 2 illustrates this

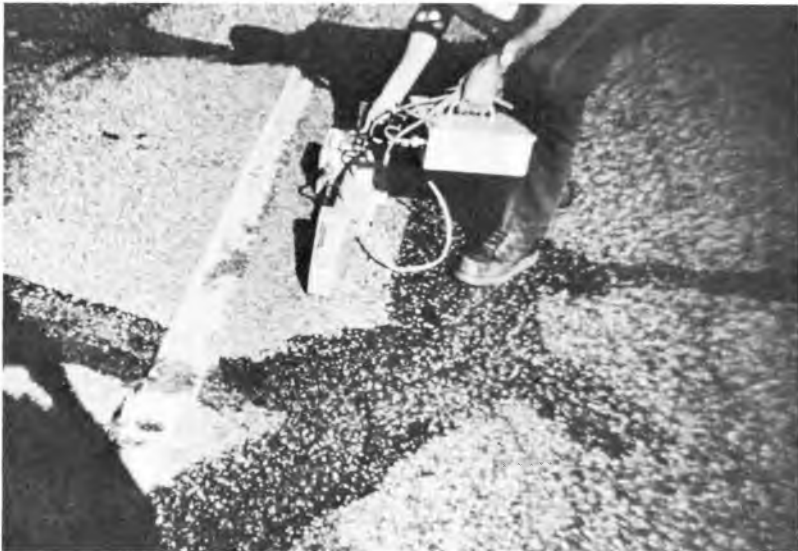
Figure 2.

problem. The third failure type resulted when the material was obliterated through sand sealing, as shown in Figure 3, or resurfacing. This type of failure, although not a material related, still results in repainting and thus is not cost effective.

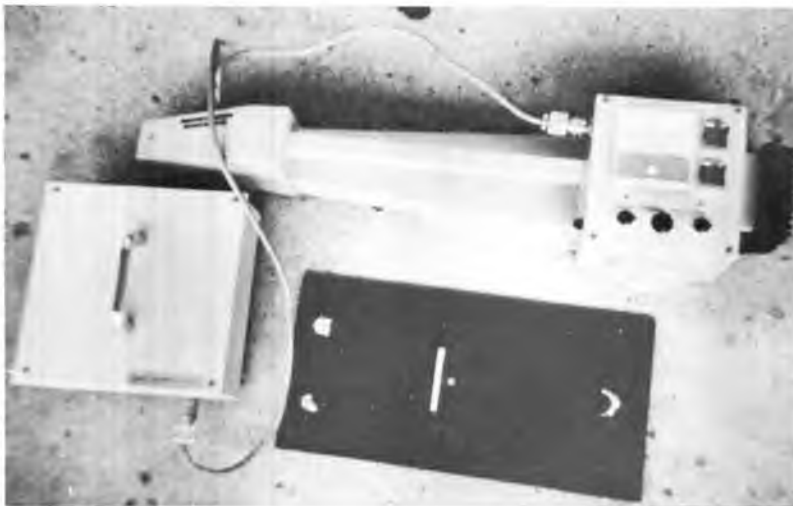
Though the district reviewing process was crucial to the final recommendation, the remainder of this report will discuss the quantitative aspects of the reflective performance testing. Two Ecolux retroreflectometers were purchased by contract, to conduct reflective testing. Figure 4 is a photograph of one of the instruments. Refer to the interim status

During the early stages of the analysis we discovered that the retroreflectance values for each instrument did not closely approximate each other. Each instrument is calibrated using its own specific calibration plate which is shown in Figure 4. However, this calibration does not insure that values obtained from one match those of the other. Test lines of both white and yellow were placed and comparison readings for both instruments were taken. Figure 6* is a graph of the retroreflectance values of the test lines. It demonstrates that readings from instrument 66 are higher than those from instrument 68 when tests were taken at identical locations. Furthermore, this difference is greater for white material than for yellow. This variance must be kept in mind when comparing the various materials.

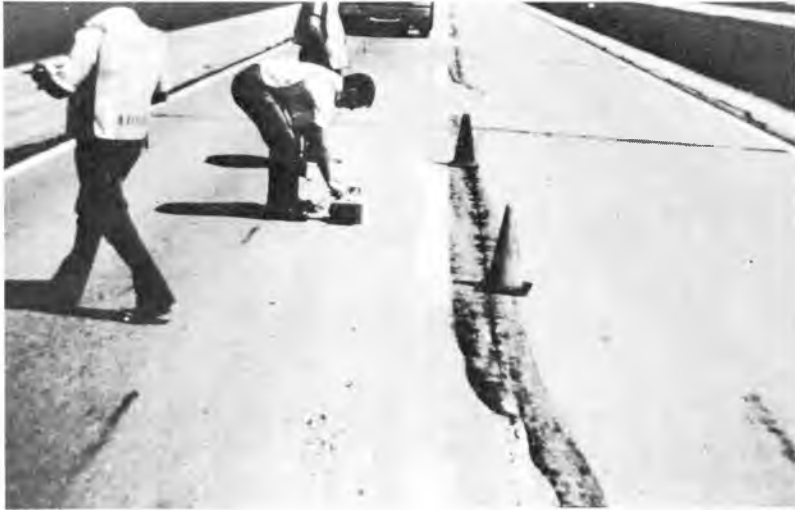
Figure 5.

report for a detailed explanation of the testing procedure. The testing operation involved a two-person team and a district flagging crew. They obtained over 1,800 material readings in the two years of testing. Figure 5 shows a typical operation used to obtain the readings.
