Cold, In-Place Recycling On State Road 38

REBECCA S. MCDANIEL
Materials Research Engineer
Division of Research, IDOH

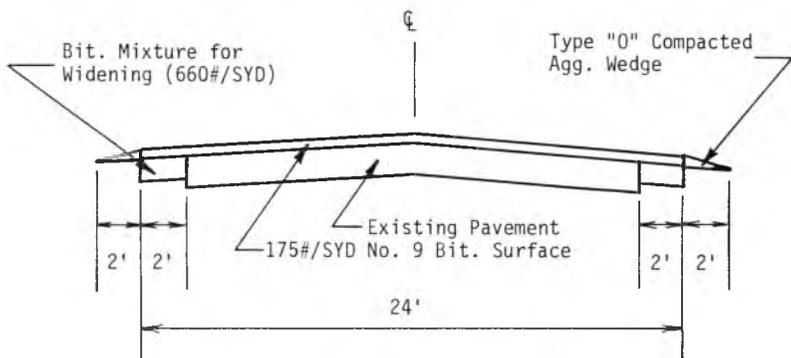
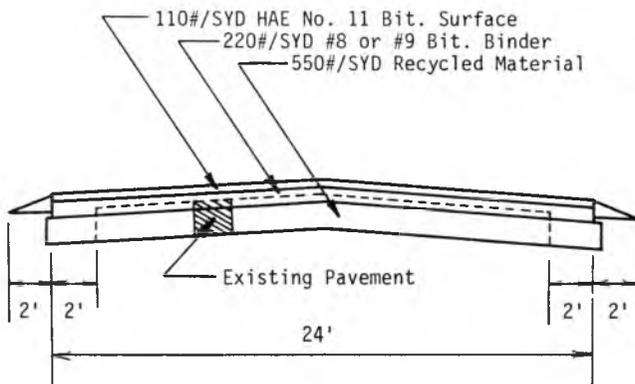
be compared to a pavement with conventional widening and resurfacing. Cross sections of the two pavements are shown in Figure 2.

TYPICAL CROSS SECTIONS

RESURFACED PAVEMENT

RECYCLED PAVEMENT

The western half of the project, from Harding Road to the east side of Mulberry, was widened with 660 #/syd of bituminous base. The pavement was widened from 20 to 24 feet. This half was then resurfaced with 175 #/syd of No. 9 surface.

the east side of Mulberry to US-421. The existing 10 foot wide lanes were milled to a depth of 6 inches. The reclaimed material was crushed to 100 percent passing the 2 inch sieve while asphalt emulsion and water was mixed in. The material was relaid by a conventional asphalt paver in 12 foot wide lanes.

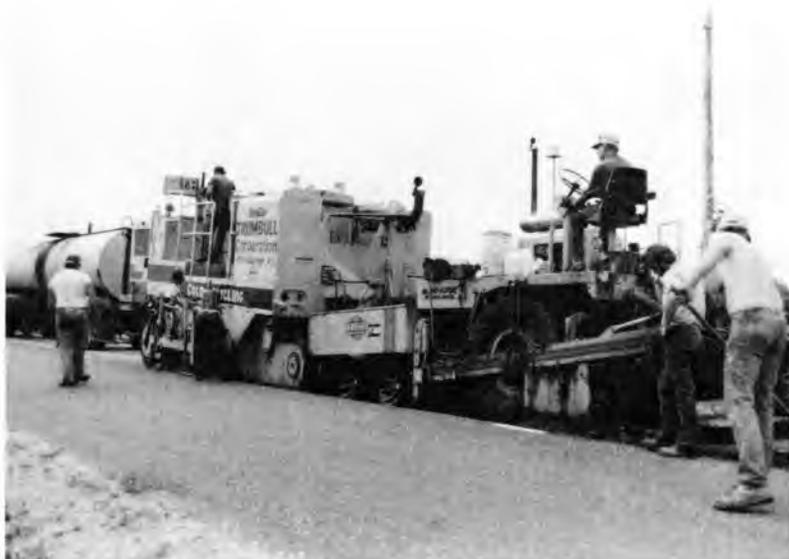
The recycling train consisted of a water wagon, emulsion tanker, recycling machine and asphalt paver. Figure 3 shows the recycling train in action.

Figure 3. The supply trucks, recycling machine and paver work closely together in a recycling train.

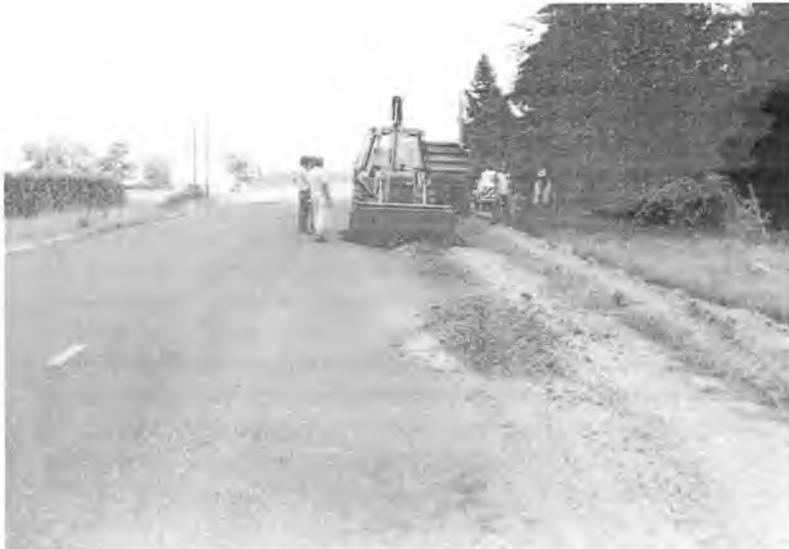
During this time, several “soft spots” appeared in the pavement. The worst of the deteriorated areas is shown in Figure 4. These weak areas were generally in the outer wheelpath. These were cut out and patched with roughly 1 ton of hot mix. The deteriorated areas were generally over soft subgrade in the area near what had previously been the shoulder. The pavement itself did not seem to be failing, but it could not support traffic for weeks over a poor subgrade.

Figure 4. Patching one of the worst deteriorated areas before placing binder and surface.

One basic thing we learned was to use what we already know. Recycling, in this case, was used to widen the road. Our standard specifications require that, when widening a pavement, the subgrade under the widened portion be rolled with a trench roller. When recycling and widening in one step, we should also require that the subgrade be rolled. Compacting the subgrade with a trench roller could have eliminated some of the troublesome soft spots.

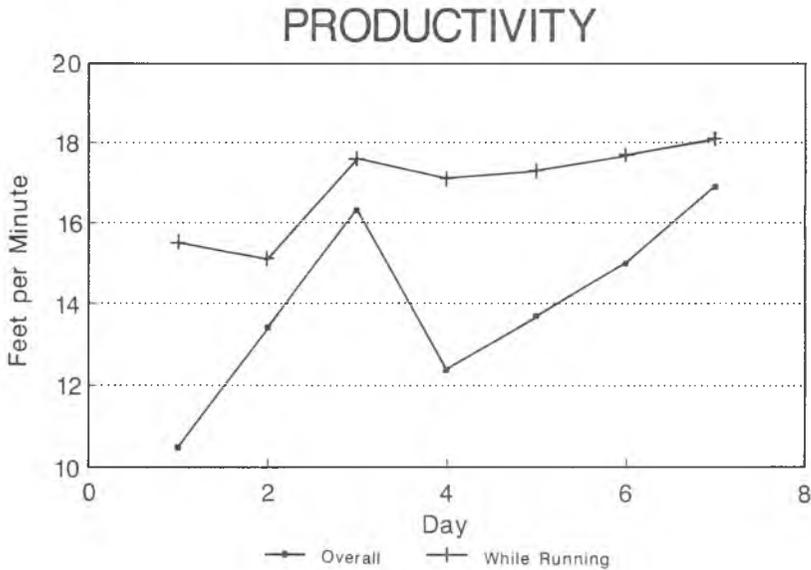
The production rate reflects the learning process that occurred as the local paving crew became accustomed to the method. Productivity is shown in Figure 5. On the first day, overall productivity was just over

10 feet per minute (fpm). By the second day, overall productivity increased to over 13 fpm and by the third day it was over 16 fpm. The next three days of recycling were plagued with equipment malfunctions. The resulting downtime cut the overall productivity by 1 to 4 fpm. On the final day of recycling, the overall productivity was up to about 17 fpm. This is equivalent to about 375 tons per hour.

The productivity while running disregards any downtime and represents the forward progress during recycling. On the first two days of recycling, the forward progress was about 15 fpm. By the third day it increased to about 17.5 fpm. The recycling productivity remained above 17 fpm for the rest of the operation.

The efficiency of the operation is the actual percentag eof time during the working day that recycling is progressing. It is, in effect, the ratio of productivity while running to the overall productivity. The efficiency on the first day was 68 percent. By the last day it had increased to 93 percent.

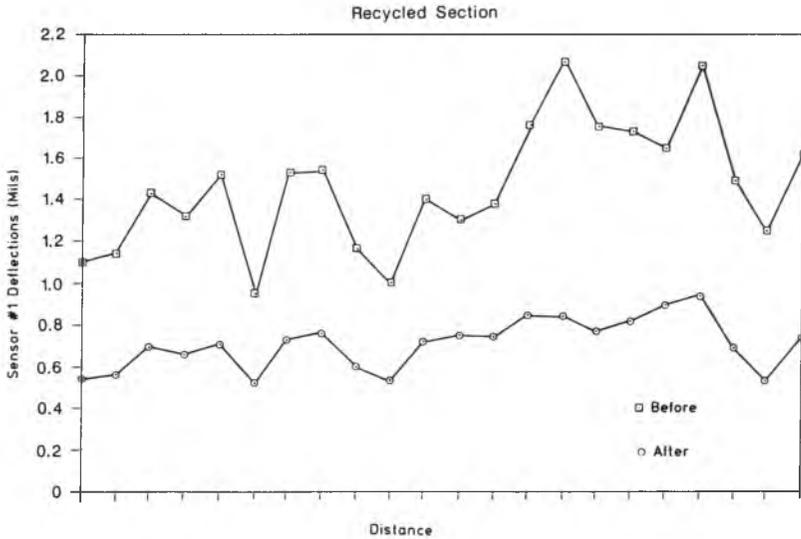
Figure 6. Dynaflect Deflections

Dynaflect deflections were recorded before and after construction on both the recycled and resurfaced sections. Deflections give an indication of the structural strength of the pavement. The Sensor #1 deflection averages and standard deviations are given in Table 1. Figures 6 and 7 show the deflections versus distance.

comparable. This indicated that the sections were about the same before construction and the experiment was not biased. Second, the deflections after construction were about cut in half on both the resurfaced and recycled sections. The standard deviations were also decreased by about half. Third, the deflections on the recycled pavement were slightly lower

than those on the resurfaced section. This is logical since the recycled base had more material placed over it.
