FHWA/IN/JTRP – 2004/4

Evaluation and Repair of Wrought Iron and Steel Structures in Indiana

Mark D. Bowman
Professor of Civil Engineering

School of Civil Engineering
Purdue University

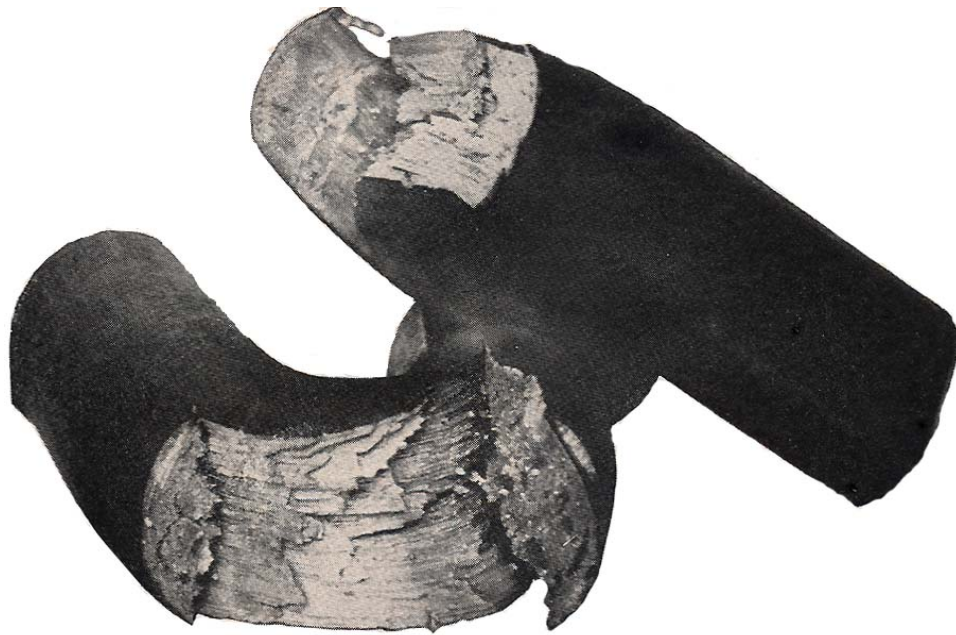
Figure 2.1 Fracture Showing Fibrous Nature of Wrought Iron. (Aston, 1949)

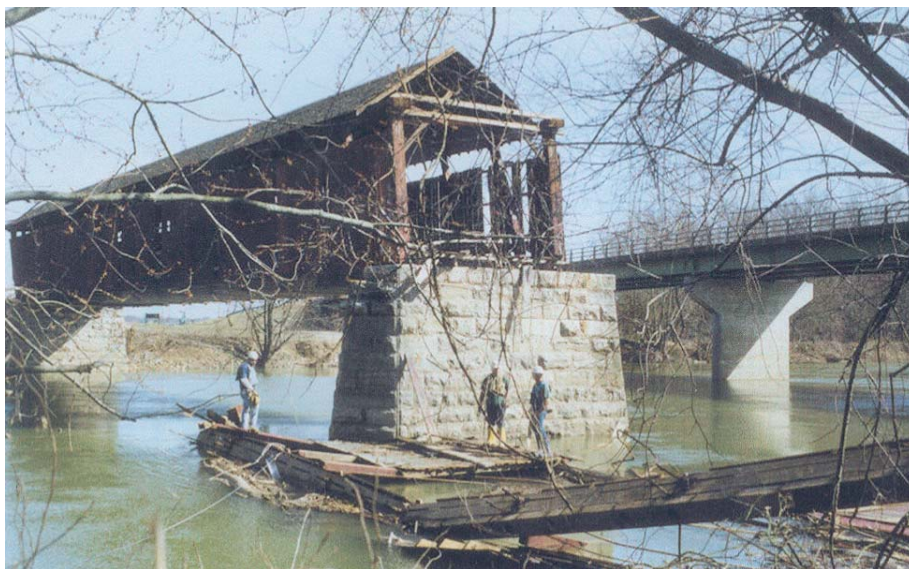
Figure 3.1 Bell Ford Bridge After Collapse of One Span

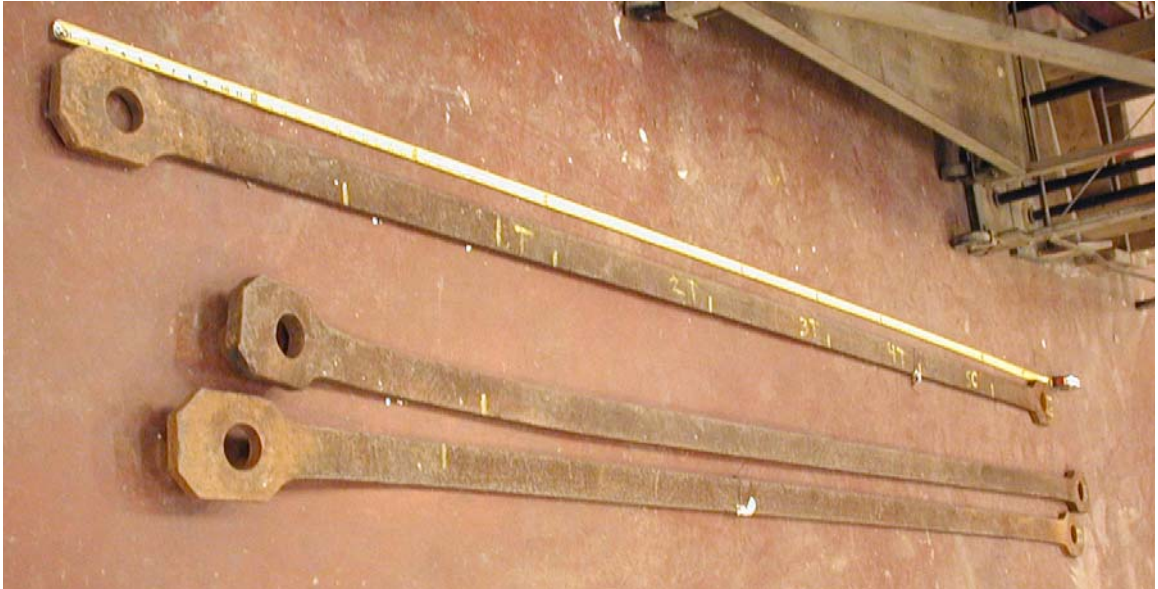
Figure 3.3 Donated Eyebars 4 and 5 Along With a Similar Eyebar that Was Straightened and Used in the Reconstruction of the Bell Ford Bridge

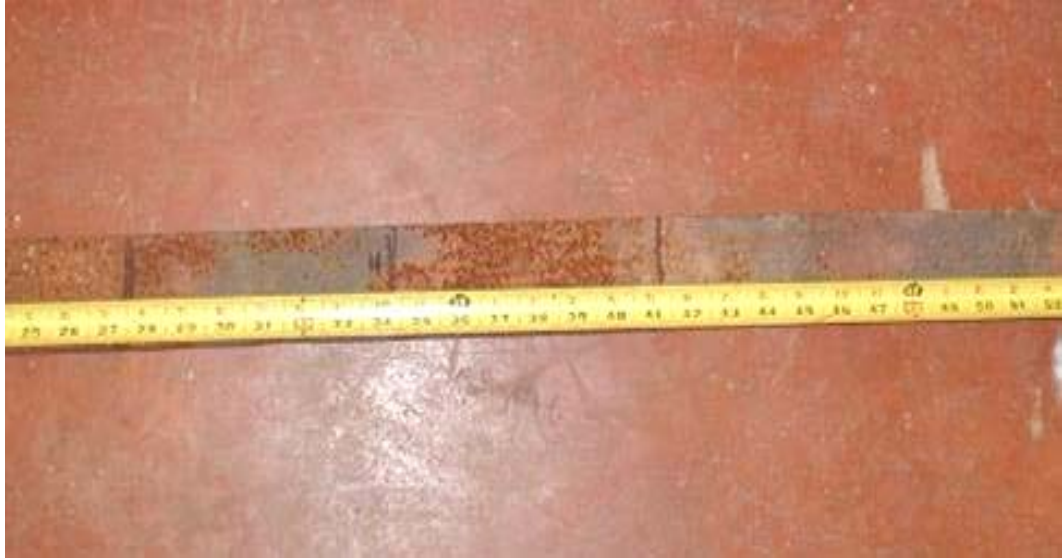
Figure 3.7 Heated Areas in Blue on Eyebar 2

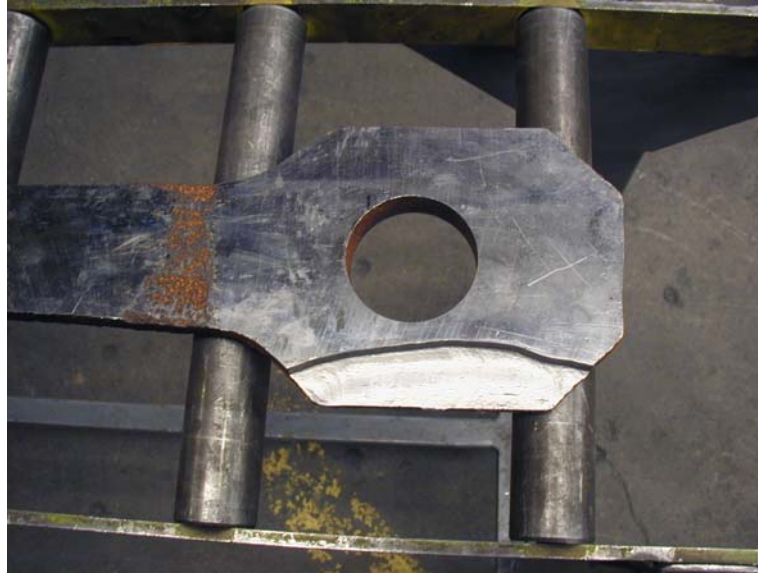
Figure 3.25 Eyebar Connection A After Material Was Removed to Simulate Corrosion

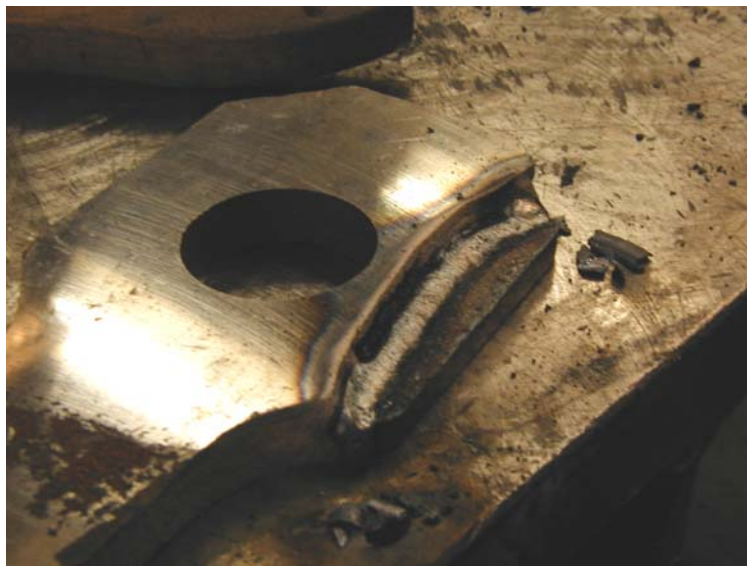
Figure 3.26 Initial Filler Weld Pass on Eyebar Connection A

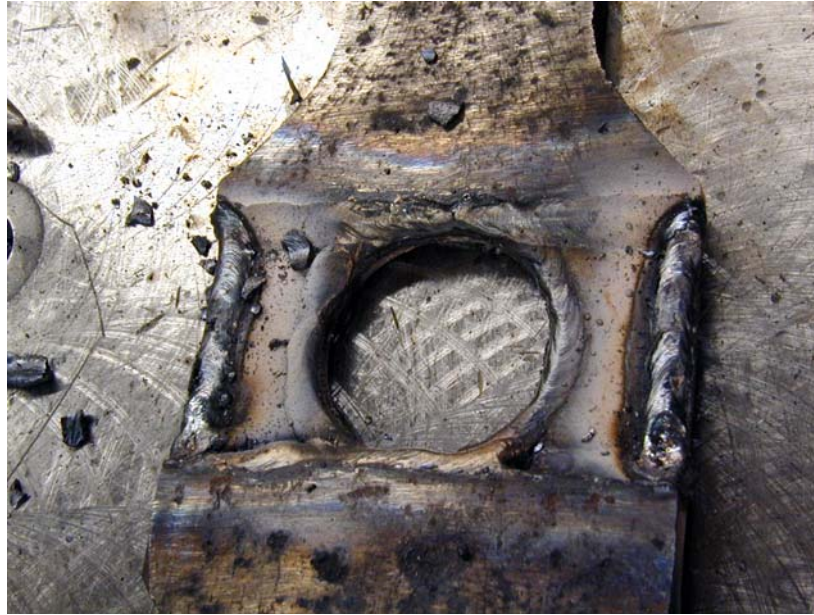
Figure 3.29 Initial Filler Weld Passes on Eyebar Connection B

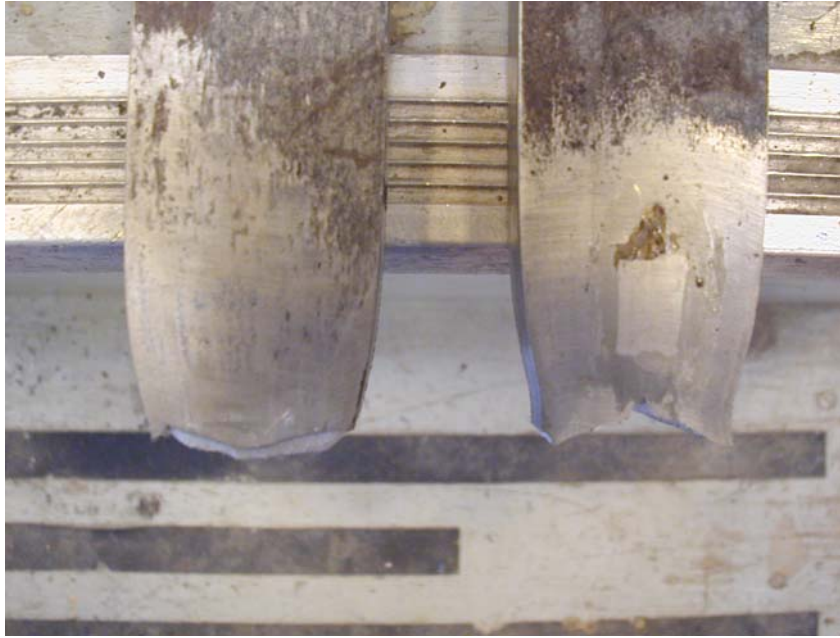
Figure 4.5 Fracture Surface of Ductile Steel

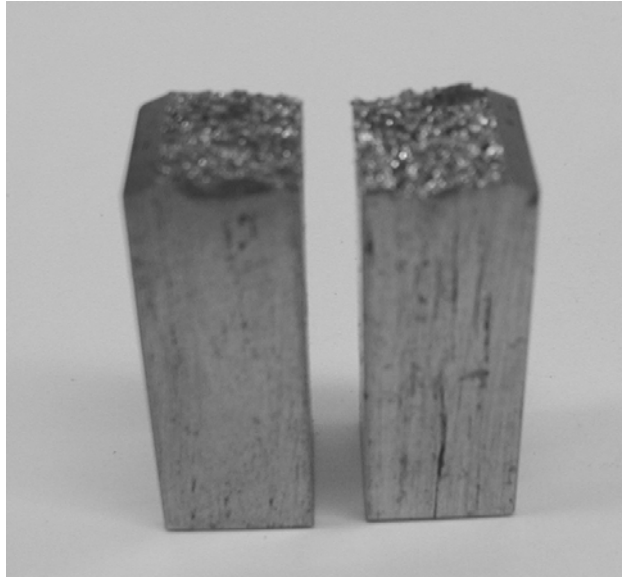
Figure 4.21 Cleavage Fracture of Charpy Impact Specimen (LU, LS Type)

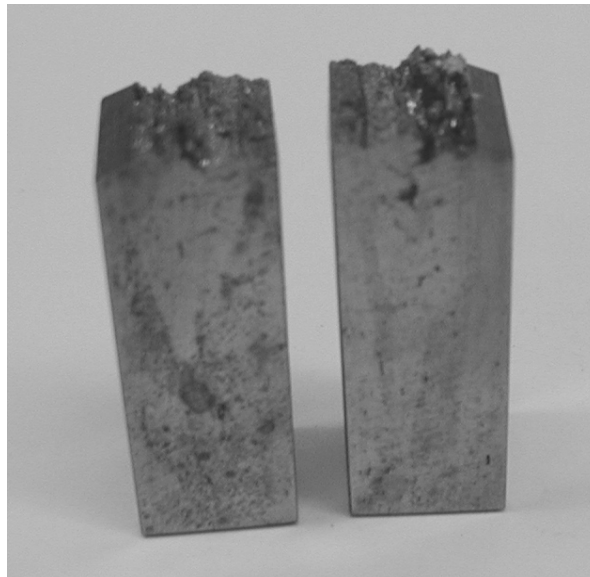
Figure 4.22 Slip Plane Fracture of Charpy Impact Specimen (T Type)

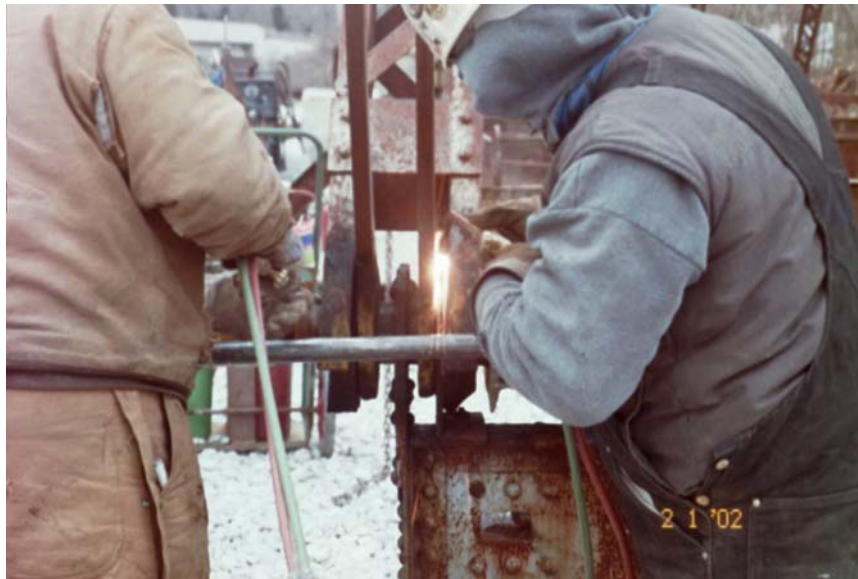
Figure 5.6 Using Heat to Help Remove a Pin During a Rehabilitation of a Bridge In Plainfield, IN.

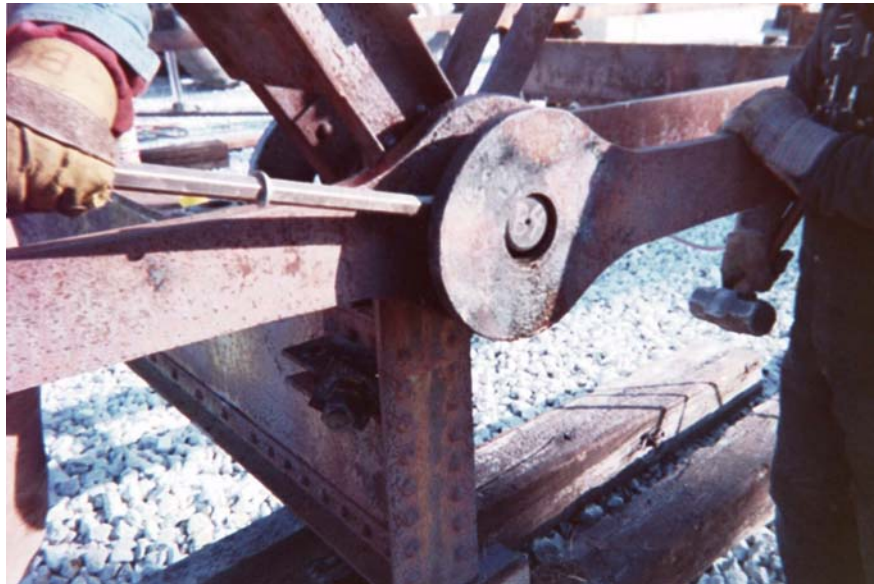
Figure 5.7 Using Force After Using Heat to Disassemble A Pin Connection During a Rehabilitation of a Wrought Iron Bridge In Plainfield, IN.

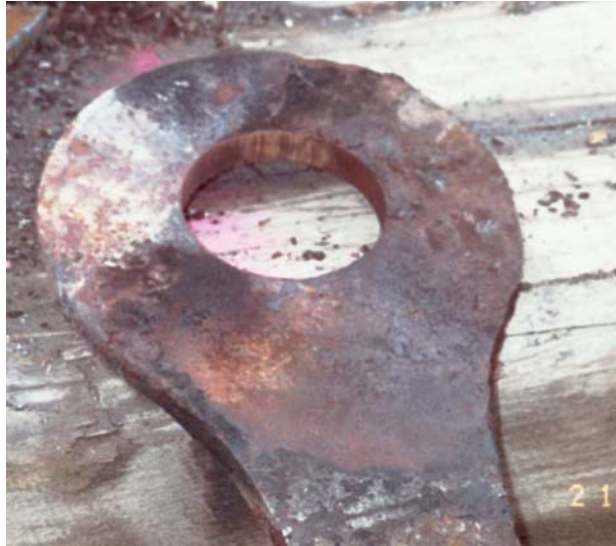
Figure 5.9 Heavy Corrosion in an Eyebar End Connection

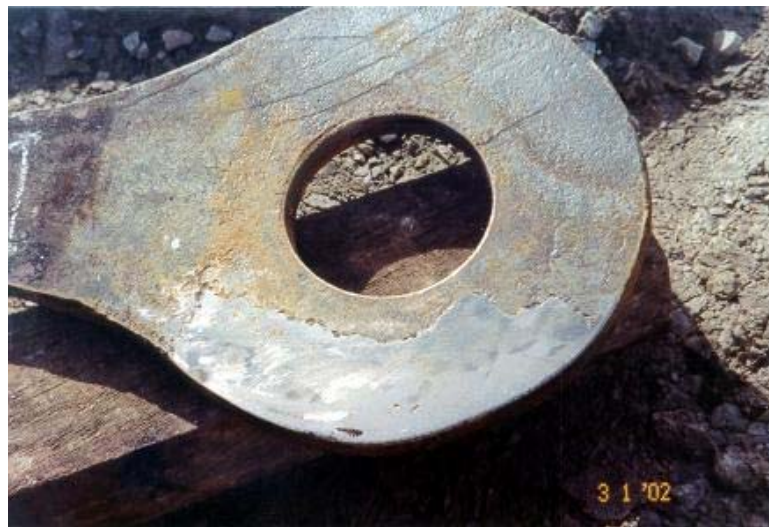
Figure 5.10 Filler Weld Completed in the Field to Repair Corroded Eyebar Connection

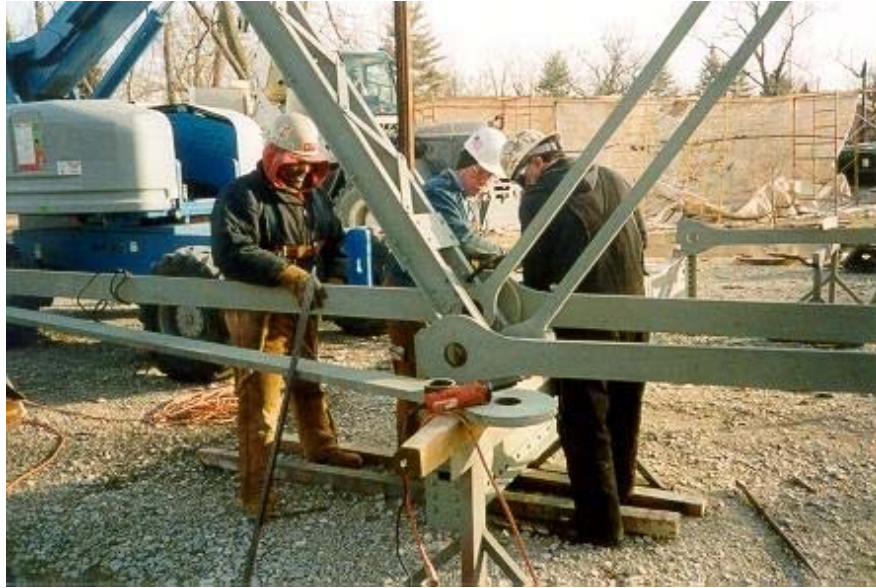
Figure 5.11 Reassembling a Pin Connection After Members Have Been Sand Blasted and Repainted During A Rehabilitation of a Bridge in Plainfield, IN

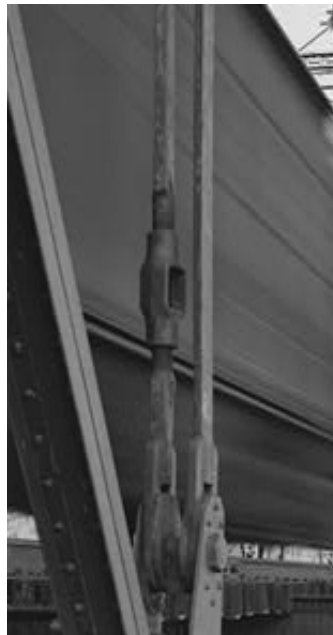
Figure 5.12 Typical Turnbuckle found in and Existing Wrought Iron Bridge (Penn. Railroad, Selinsgrove Bridge, Spanning Susquehanna River, Snyder County, PA - Historic American Buildings Survey/Historic American Engineering Record)

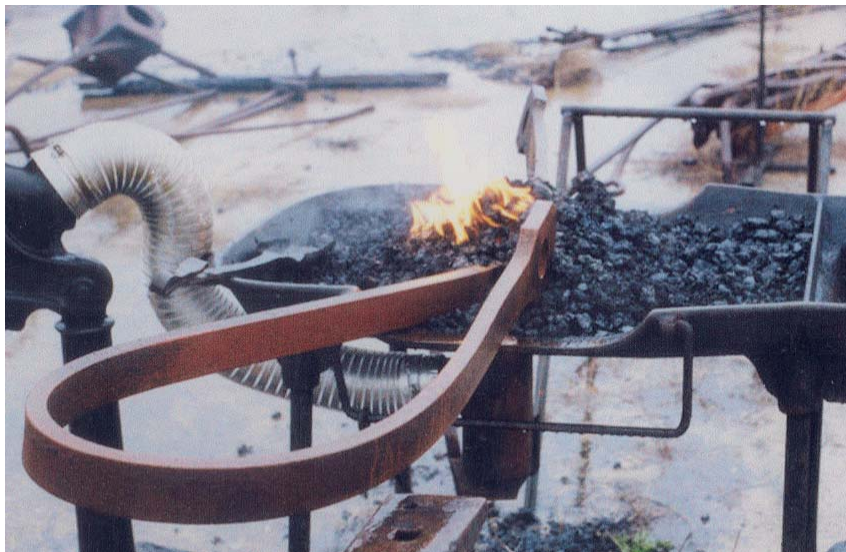
Figure 5.14 Heating and Straightening Damaged Members of the Bell Ford Bridge

Figure 5.14 illustrates the method that was used to heat straighten the eyebars from the Bell Ford Bridge. In this method, the wrought iron is first heated slowly in a

charcoal fire until it is red hot in appearance. When the metal is dark cherry red in color it is typically between 1160 and 1270 °F. After sufficient heating the member is then straightened by bending and/or pounding the surface to work the metal into the desired position. The process may require repeated cycles of heating and pounding to work the metal in the (fluid) red-hot condition. This method is usually performed by a blacksmith and is similar to the original process that was used to form the wrought iron bridge members. To heat the pieces in this manner, the members to be straightened must be removed from the bridge.

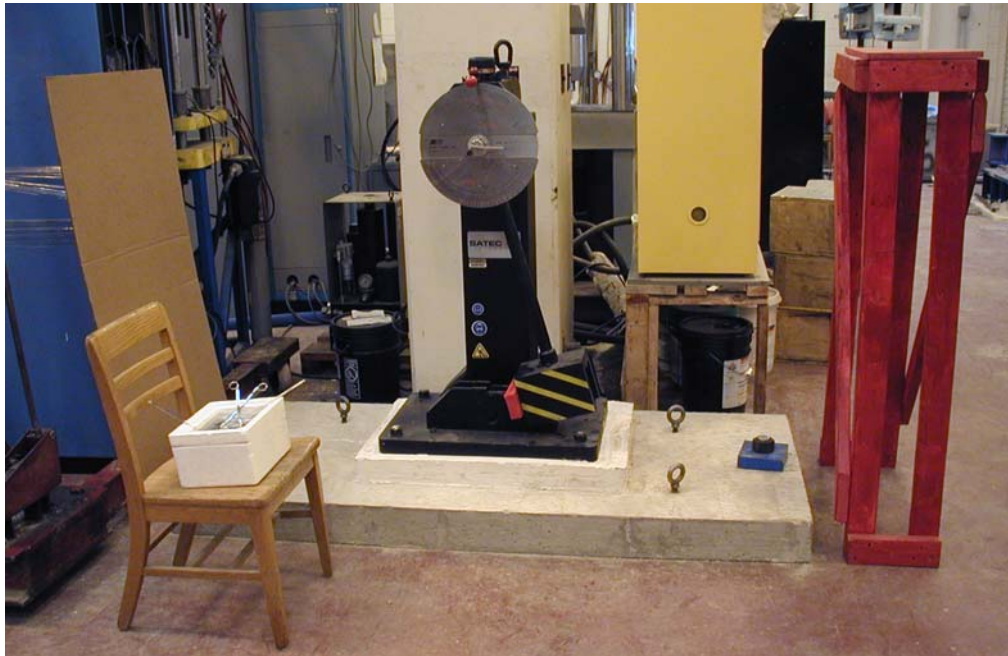
Figure C.17 SATEC Impact Testing Machine Along with Cooling Bath Used in Charpy Impact Testing

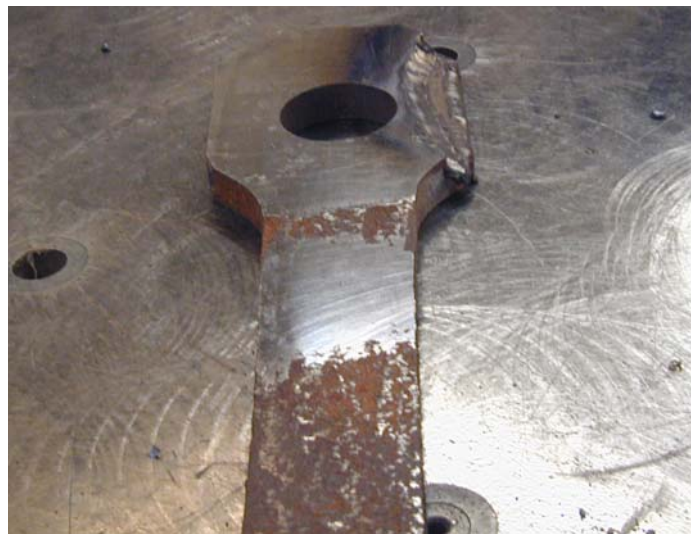
Figure C.26 Eyebar End Connection A after Half of Filler Weld Repair Completed

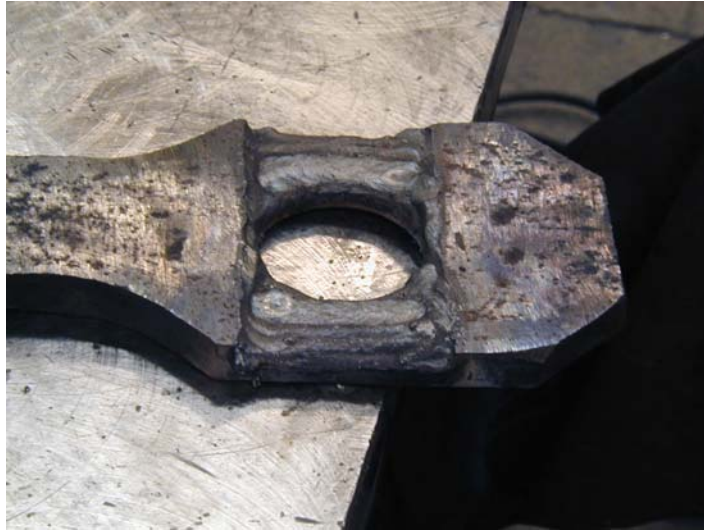
Figure C.27 Eyebar End Connection B after Half of Filler Weld Repair Completed

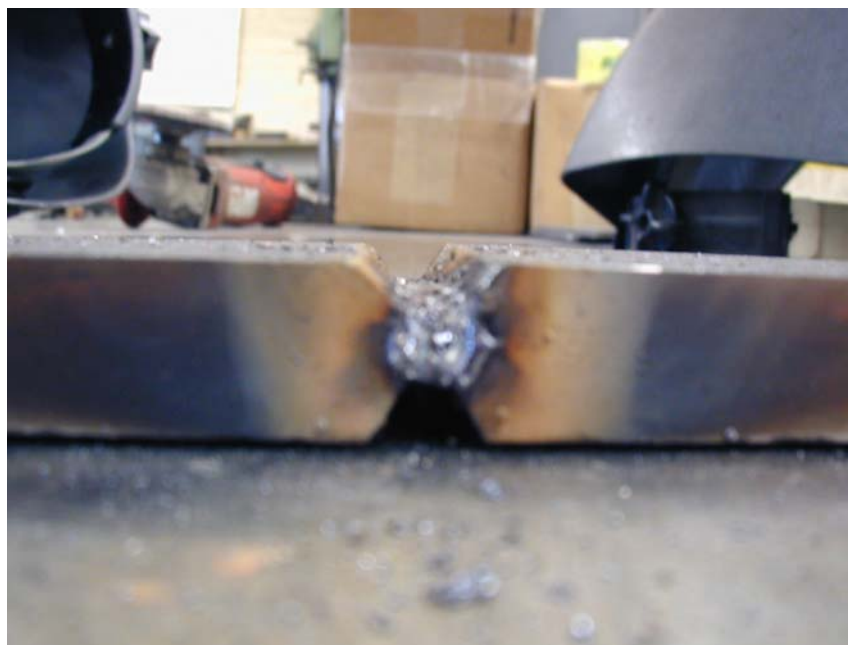
Figure D.2 Weld Joint After Initial Root Pass

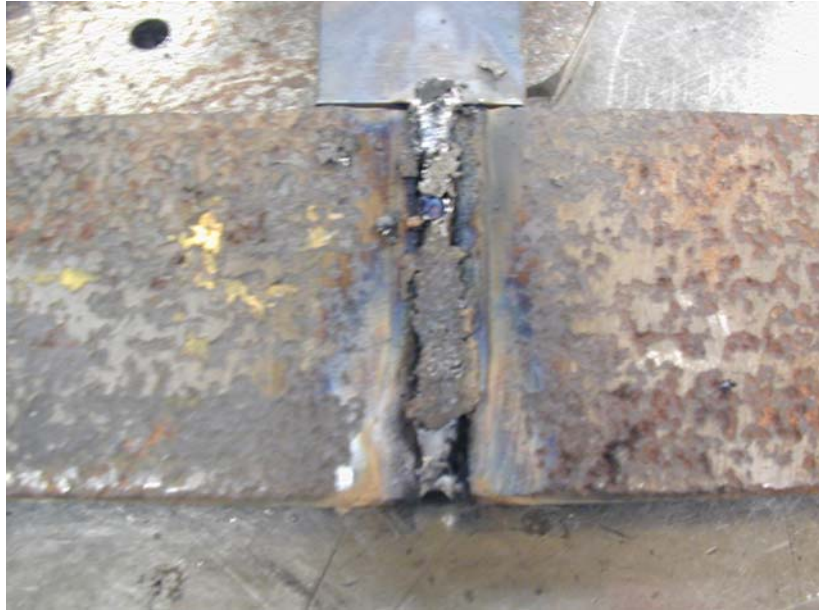
Figure D.3 Surface Impurities or Scale on Surface of Weld
