Sixth International Conference on Durability of Concrete Structures
18 - 20 July 2018
University of Leeds, Leeds, West Yorkshire, LS2 9JT, United Kingdom

Paper Number PSE08

Sustainable Concrete with Seawater and Corrosion Resistant Reinforcement: Results of Monitoring of Corrosion Behaviour

E. Redaelli, M. Carsana, F. Lollini, M. Gastaldi and F.T. Isfahani
Department of Chemistry, Materials and Chemical Engineering, Politecnico di Milano, Italy

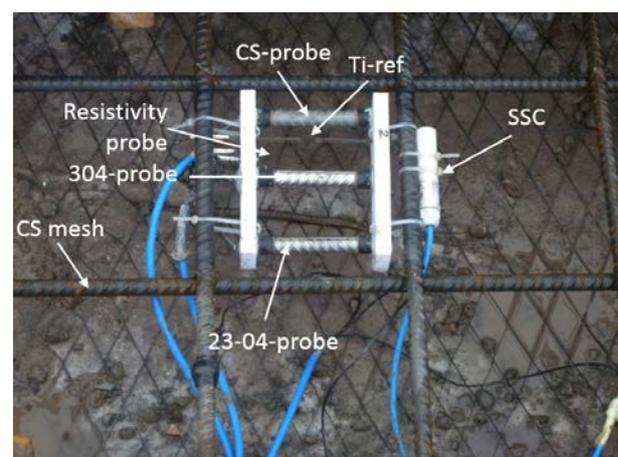
Specific "multi-reinforcement" and resistivity probes were designed and assembled in the laboratory. Multi-reinforcement probe contains segments of CS, SS-304 and SS-23-04 and it was embedded in segments *A*, *B* and *F*, so as to allow those combinations of type of rebar and type of concrete that could not be performed on real scale; resistivity probe consists of two parallel activated titanium wires (length and distance of 10 mm) and it was embedded in all segments. All probes were fixed to the reinforcing mesh and hence they have the same nominal concrete cover (Fig. 2).

Fig. 2. CS mesh, multi-reinforcement probe, reference electrodes and resistivity probe in segment *B* before pouring (activated titanium mesh is also visible at the bottom)

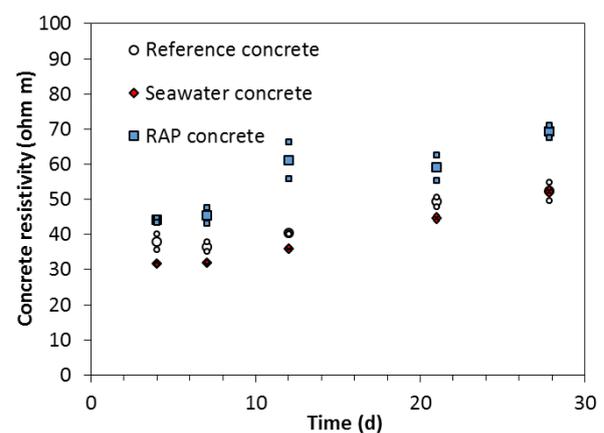
Fig. 4 shows the evolution of the electrical resistivity of concrete measured on the cubes during wet curing: all concretes showed an increasing trend, up to values of about 50 Ω·m for *reference* and *seawater* concretes and 70 Ω·m for *RAP* concrete. The average compressive strength at 28 days was 33 MPa for *reference* concrete, 42 MPa for *seawater* concrete and 32 MPa for *RAP* concrete; densities were 2280 kg/m^3, 2307 kg/m^3 and 2300 kg/m^3, respectively. The initial chloride content was negligible (0.01 %) in *reference* and *RAP* concretes and 0.11 % in *seawater* concrete (all percentages are referred to concrete mass). The latter value is slightly lower than the theoretical chloride content in *seawater* concrete that is 0.16 %. The initial chloride content of RAP aggregate could not be measured, however from leaching tests it was estimated to be lower than 0.01%

Fig. 4. Electrical resistivity of concrete cubes during wet curing (larger symbols indicate average values)

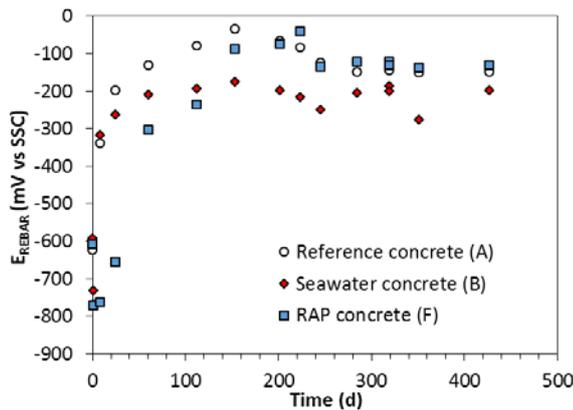
Figure 5 shows the corrosion potential of CS reinforcement measured versus the SSC reference electrode in segments *A*, *B* and *F*: initially, in the first hours after pouring, all potentials were quite low, more negative than -700 mV vs SSC, then they progressively increased – with different rates – and

reached values between -100 and -300 mV vs SSC. The initial increase can be attributed to the passivation of CS, while the subsequent variations are more likely due to environmental variations of temperature and humidity. After about a year, the potential was around -150 mV vs SSC in *reference* and *RAP* concretes and -275 mV vs SSC in *seawater* concrete. Considering CS in *seawater* concrete, similar values of potential were obtained on laboratory specimens in conditions of exposure outdoor unsheltered, and corrosion rate measurements indicated that CS was mainly passive (Lollini *et al.*, 2017).

Fig. 5. Corrosion potential of carbon steel reinforcement measured versus the embedded SSC reference electrode in segments *A*, *B* and *F*

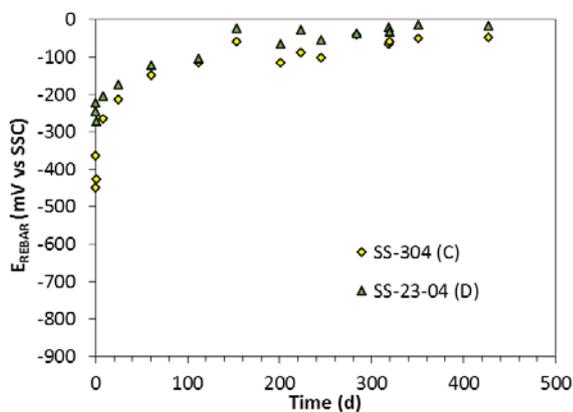
Figure 6 shows the corrosion potential of SS-304 and SS-23-04 in *seawater* concrete (segments *C* and *D*, respectively): the initial values were about -400 mV vs SSC for SS-304 and -300 mV vs SSC for SS-23-04, and also in these cases they progressively increased and reached values between 0 and -100 mV vs SSC. Overall the potential of SS-304 was 50 mV lower than that of SS-23-04; this behaviour was also observed on laboratory specimens (Bertolini and Gastaldi, 2011).

Fig. 6. Corrosion potential of austenitic (SS-304) and duplex (SS-23-04) stainless steel reinforcement measured versus the embedded SSC reference electrode in *seawater* concrete

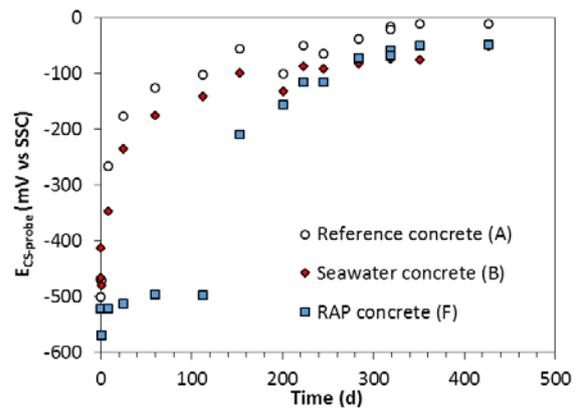
Figs. 7-9 show the corrosion potential of carbon steel, austenitic (SS-304) and duplex (SS-23-04) stainless steel bars of the multi-reinforcement probes embedded in three segments (*A*, *B* and *F*) that are representative of the three types of concrete. For carbon steel (Fig. 7) the trend is very similar to that in Fig. 5, that was obtained on the reinforcement mesh, although all values are slightly higher. This shift towards more positive values may be due to the fact that, unlike the reinforcing mesh (that was used "as received" on site), the multi-reinforcement probes were prepared in the laboratory and the CS bars were cleaned by sandblasting and degreasing.

Fig. 7. Corrosion potential of carbon steel bar of the multi-reinforcement probes embedded in segments *A*, *B* and *F*

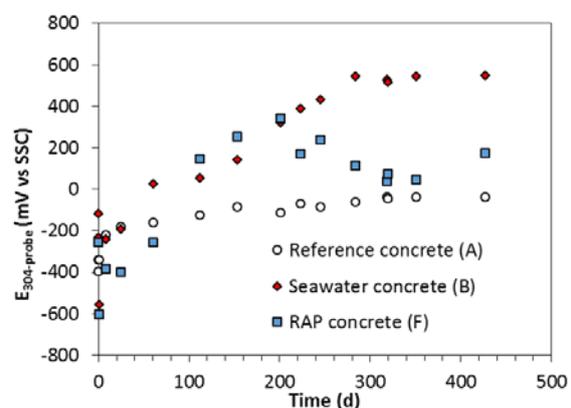
Stainless steel 304 probe (Fig. 8) seems to have experienced some problems with connection in segments *B* and *F*, probably due to pouring and compaction, while in segment *A* the potential after a year was about -50 mV vs SSC. Since this potential is very close to that obtained on the mesh in *seawater* concrete (Fig. 6), it is reasonable to assume that the corrosion behaviour is similar, and this is a further confirmation of the passive behaviour of stainless steel 304 in *seawater* concrete.

Fig. 8. Corrosion potential of austenitic (SS-304) stainless steel bar of the multi-reinforcement probes embedded in segments *A, B* and *F*

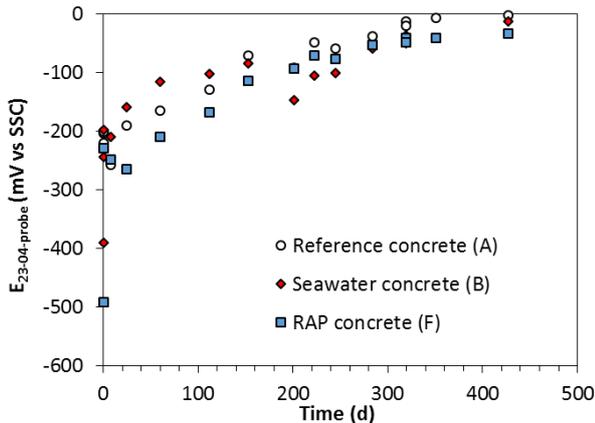
Even duplex stainless steel 23-04 probe (Fig. 9) showed – in all segments – values that are very similar to those measured on the mesh in *seawater* concrete (Fig. 6).

Fig. 9. Corrosion potential of duplex (SS-23-04) stainless steel bar of the multi-reinforcement probes embedded in segments *A*, *B* and *F*

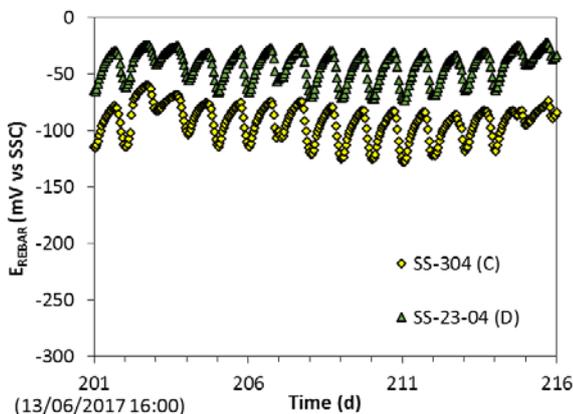
The potential of the metallic reinforcing meshes was also monitored with a data logger: Fig. 10 shows, as an example, the potential of the reinforcing meshes of the two grades of stainless steel in *seawater* concrete measured versus embedded SSC electrode in June 2017. The higher frequency of detection allowed highlighting daily potential variations of the order of 50 mV, with lower values during day and higher values during night. Similar oscillations were observed on segments *A*, *B* and *F*. Besides those measurements that were mainly aimed at checking the data logger system, the data logger will be essential after the end of the project to allow long-term monitoring of the future corrosion conditions minimising the inspections and manual measurements.

Fig. 10. Corrosion potential of austenitic (SS-304) and duplex (SS-23-04) stainless steel reinforcement measured versus the embedded SSC reference electrode in segments *C* and *D*, respectively

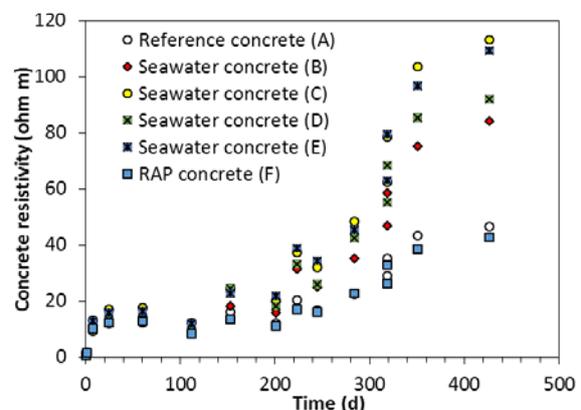
Figure 11 shows the electrical resistivity of concrete that was measured with the probe embedded in the concrete at the depth of the reinforcement. Initial values were very low (1-2 Ω·m) for all segments, then in the first couple of months they increased reaching values around 20 Ω·m. After this, greater variations occurred. Overall, initially chloride-free concrete (i.e. *reference* and *RAP* concrete of segments *A* and *F*, respectively) showed the lowest values (e.g. about 40 Ω·m after a year), while *seawater* concrete (segments *B-E*) showed the highest values (e.g. 75-100 Ω·m after a year).

Fig. 11. Electrical resistivity of concrete measured with the embedded resistivity probe at the depth of the reinforcement

These results are not consistent with those obtained on the cubes (Fig. 4), where *seawater* concrete showed similar or lower values with respect to *reference* concrete, as expected due to the presence of chlorides (Saleem at al., 1996). Nevertheless, the monitoring of the resistivity with embedded probes is expected to highlight possible future variations in the conditions of the concrete at the depth of the reinforcement, in terms of chloride and humidity content.

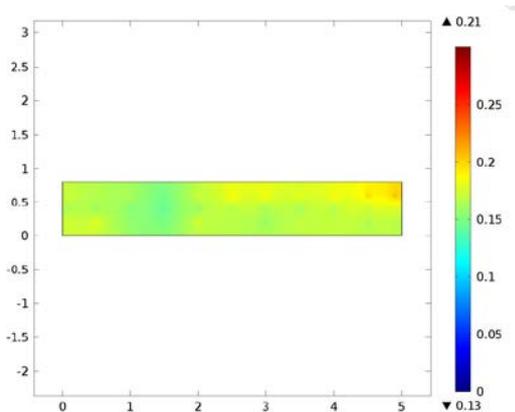
All the electrochemical measurements that are performed by means of the embedded electrodes and probes are representative of the corrosion conditions of steel in a relatively small area localised in the vicinity of the electrodes themselves. Potential mapping, on the other hand, allows highlighting differences in the corrosion behaviour over the surface of the slab. Figs. 12 and 13 show, as an example, the potential mappings that were obtained on carbon steel reinforcement in segments *A* and *B*, respectively. The potential differences between different parts of the reinforcement were relatively small, lower than 100 mV. No substantial potential gradients occurred, so it can be concluded that in each segment the corrosion condition of the reinforcement is still uniform over the whole surface of the slab.

**Fig. 12.** Potential mapping of carbon steel reinforcement in segment *A* (values in -V vs CSE)

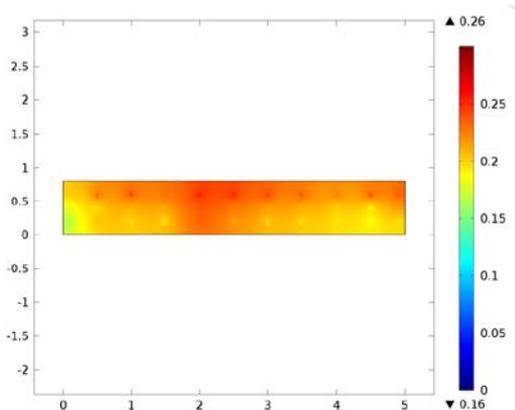
Fig. 13. Potential mapping of carbon steel reinforcement in segment *B* (values in -V vs CSE)

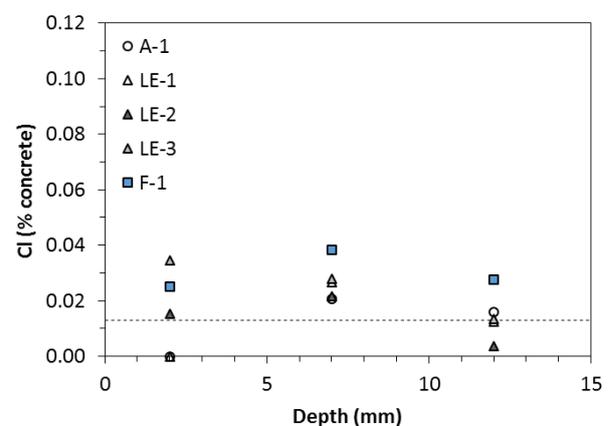
Figures 14 and 15 show the chloride profiles obtained on the cores after 1 year of exposure. Cores taken from concretes that were initially chloride-free (i.e., *reference* concrete of segment *A*, *RAP* concrete of segment *F* and concrete of the lateral walls *LE*) showed an almost flat profile, with chloride amounts close to the initial value, as it can be seen in Fig. 14. *RAP* concrete had a slightly higher chloride content, probably due to the presence of small amounts of chlorides in the RAP aggregate, that diffused inside the cement paste. Anyway, the profile was flat and the chloride contents were negligible. As expected, no substantial chloride penetration occurred during the first year of exposure.

Fig. 14. Chloride profiles in segments *A* and *F* and lateral walls *LE* (dotted line indicates initial chloride content measured in concrete *A*)

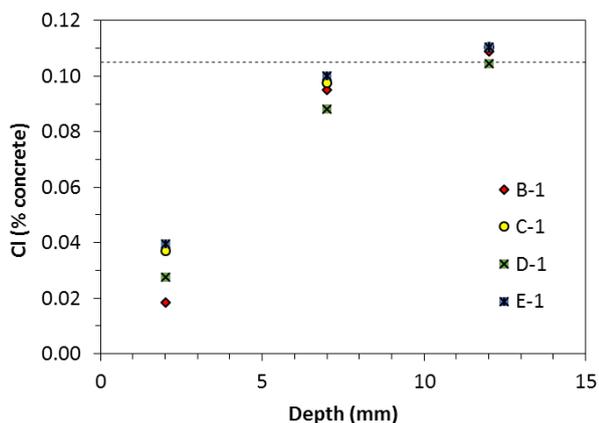
In cores taken from *seawater* concrete, the chloride content in the first layer was lower than the initial value, then the content increased up to the initial value (Fig. 15). This reversed shape of the profile was observed on all segments, and it indicates that not only chloride penetration did not take place, but even chloride leaching may have occurred close to the surface. Chloride leaching can be attributed to wetting with rain water or freshwater, even in the early stages after pouring. It should be mentioned that the whole slab was often wetted with freshwater during inspection.

Given the obtained chloride profiles, and considering that the nominal concrete cover is 30 mm, the chloride content at the depth of the reinforcement is the same as the initial one.

Fig. 15. Chloride profiles in segments *B-E* (dotted line indicates initial chloride content measured in *seawater* concrete)
