Studies of Faults in Used Valves, a Case Studies

R. Dusil

STUDIES OF FAULTS IN USED VALVES. CASE STUDIES

Robert Dusil
Steel Research Center, Uddeholms Aktiebolag, Sweden

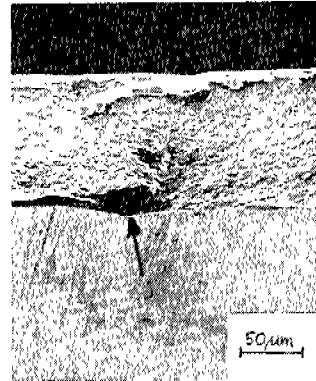
The surface of the valve may contain rolling defects (Fig. 10) rolled-in metal fragments (Fig. 11) and similar defects which may provide starting sites for fatigue cracks. Suction valves shown in Fig. 25 were put into service directly after blanking, i.e. with untumbled edge and surface. Failure was caused by fatigue fracture which started at defects originating from rolling (Fig. 12). The stable growth of the cracks is evident in the pictures.

Fig. 12
Crack initiation and stable crack growth at rolling defect.

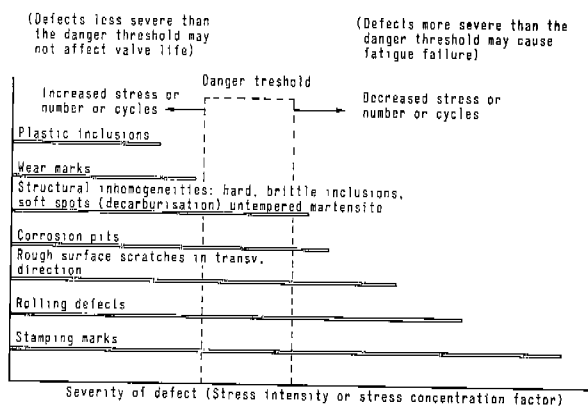
Fig. 28
Graphical representation of the range of relative severities of different types of defects found in valves.

Elongated plastic slag inclusions and defects with well-rounded surfaces, such as shallow grooves caused by wear proved to be less harmful from the viewpoint of crack initiation. Hard oxidic inclusions, on the other hand, are potential fracture crack starters. Their angular morphology gives them higher theoretical notch effect. Compared with other defects, however, the probability of finding an initiating inclusion is very small, while the frequencies of blanking (stamping) marks (Fig. 13, 16) rolling defects, (Fig. 10 - 12) and surface damages of mechanical origin (Fig. 9) are significantly higher. Moreover, these defects occur on the surface, where their damaging effect is greatest.

Removing such fatigue crack starters will prolong the fatigue life of the component. It is therefore important to determine how severe a certain type of defect is. In order to get an idea of the importance of the defect to the function of the component, information on the frequency of occurrence of the defect is also important. The frequency of occurrence of a certain type of defect is affected by many factors, such as the design of the compressor and the valve, choice of material, loading geometry, desired service life etc.
