Rehabilitation of Low rise RCC Structure along 9m High Retaining wall

A. Nakhawa

V.B. Deshmukh

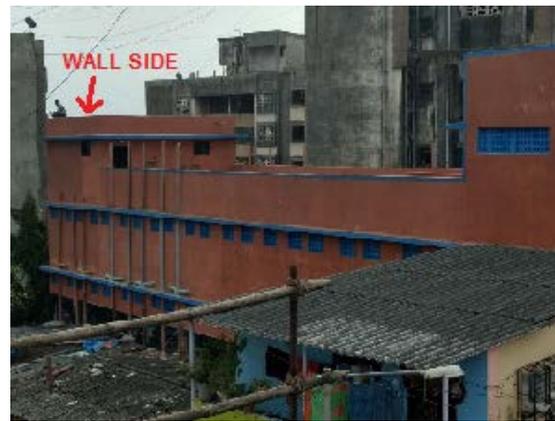
Fig. 1 . View of Toilet Block Structure in Slum

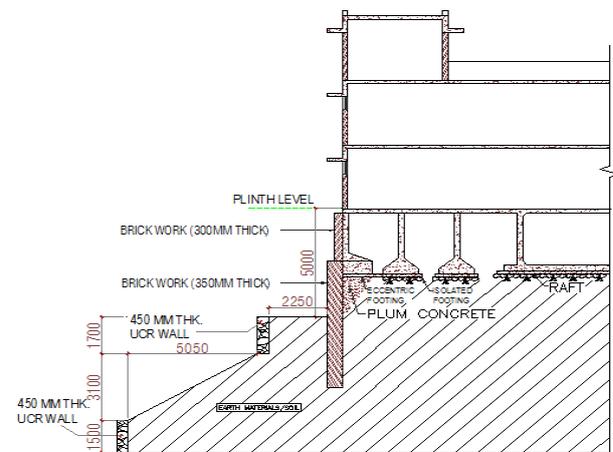
Fig.3. Cross sectional view through the wall and the building structure

The foundations were designed with low bearing capacity of 10 T/m² at 3 m below ground level. The eccentric foundations were placed at 0.15 to 0.6 m away from the inner face of retaining wall. The 9 m high rubble masonry retaining wall was constructed for supporting the corner footing of the structure. The retaining wall was constructed on filled-up soil deposit.

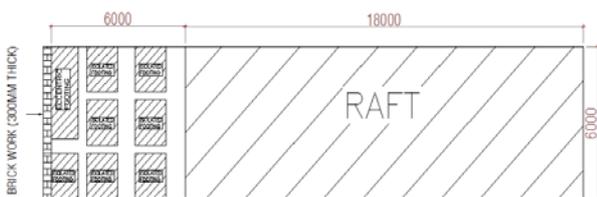
The newly constructed ground plus two storied RCC community toilet block structure is a reinforced concrete Framed G + 2 building constructed with partial raft and open foundations. The raft foundation laid in the areas where the underground water tank and septic tanks are provided (Fig. 4) shows the schematic plan of the different foundations types laid over the plot area.

Fig.4. Schematic plan of the different foundations types laid over the plot area

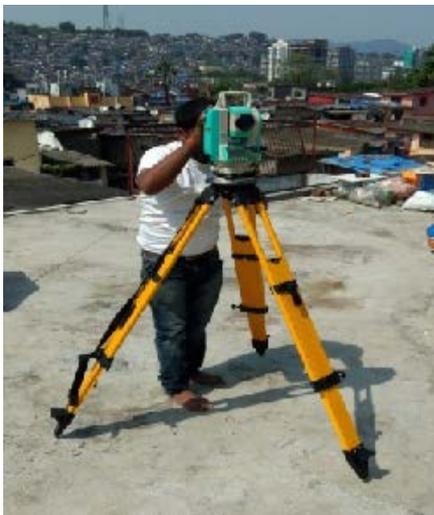
Surveying instrument such as total station is used at top level of the structure to ascertain any temporary and permanent deformations as shown in Fig. 11.

Fig. 11. Total Station Method to observe the actual deflections/settlements

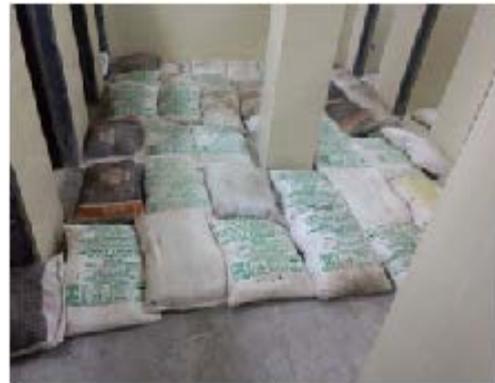
The loading was carried out by sand bags of equal weights as shown in Fig. 12. The loading was done in different phases as directed by the structural consultant. Observation was recorded before and after each phases of loading at various levels with the help of total station survey. After unloading the structure rebound capacity was checked to assess

Fig.12. Loading First slab with sand bags representing the Design load

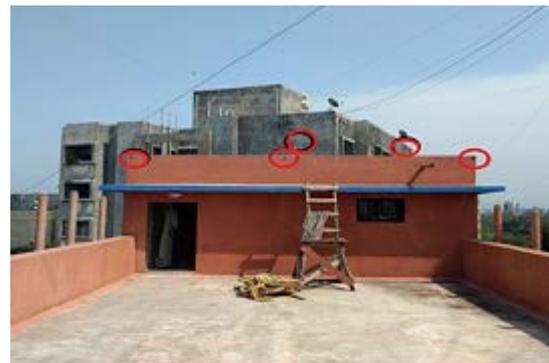
1. On the day 1 before loading the 6 numbers of points on the topmost location of the structure were decided and the existing R.L. of these points were recorded with the help of total station survey (Figs. 13 and 14).

Fig. 13. Six points selected at topmost level where the structure was desired to be tested

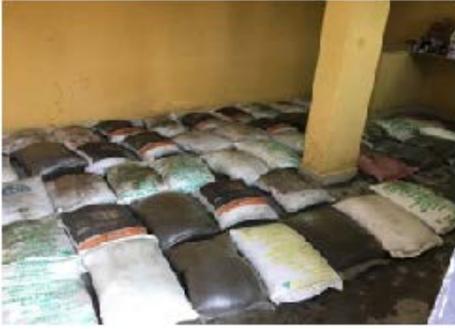
Fig. 15. Loading second slab with sand bags representing the Design load

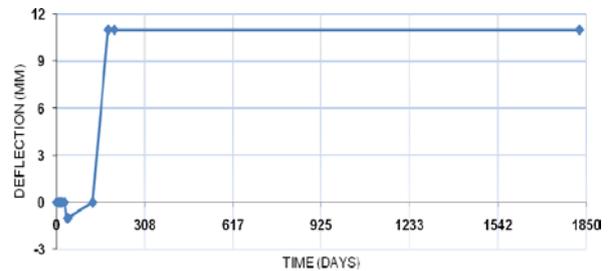
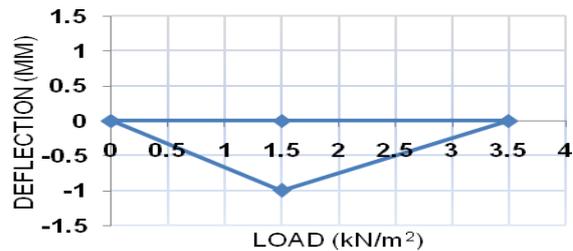
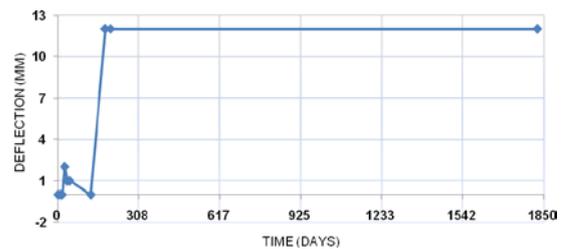
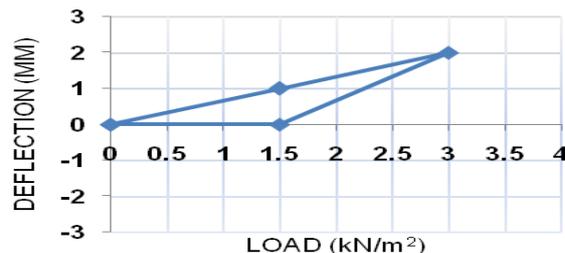
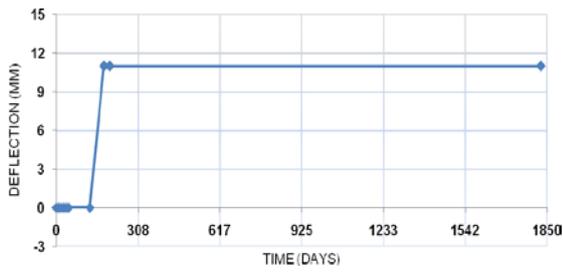
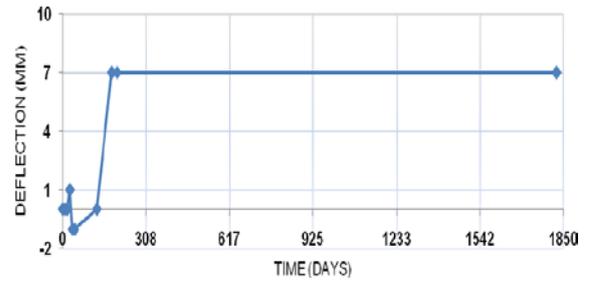
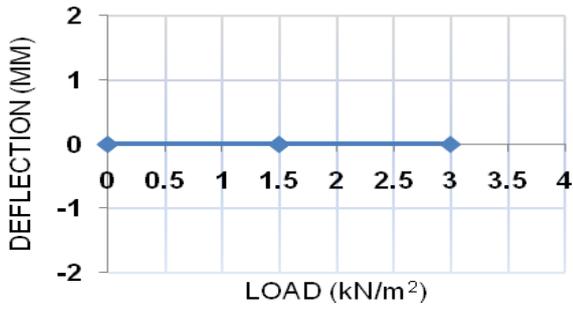
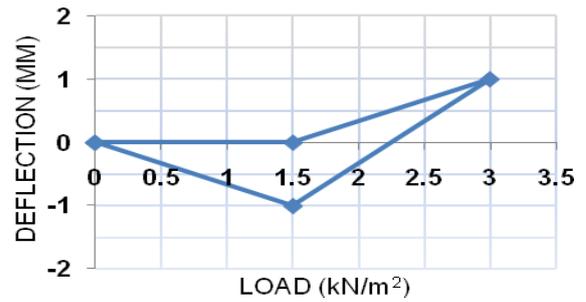
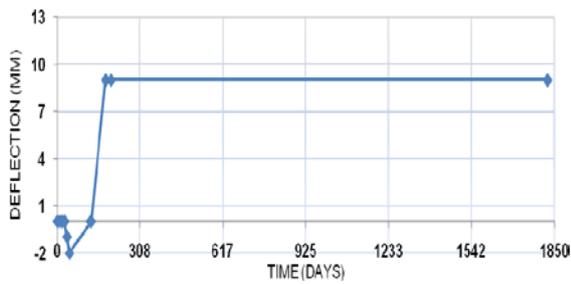
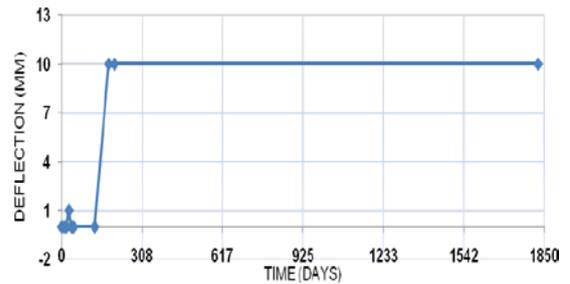
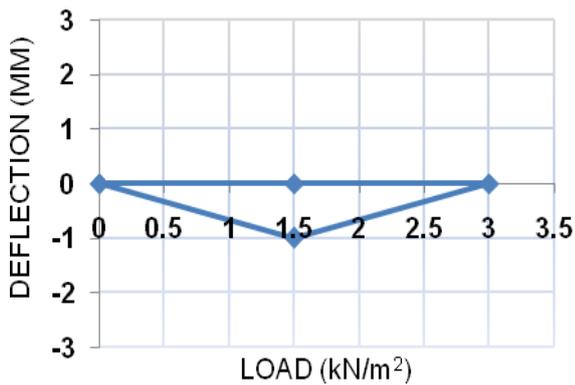
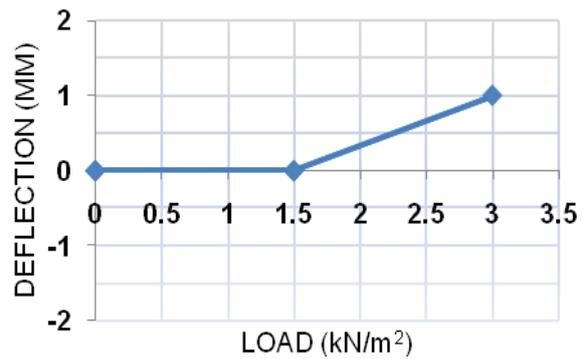
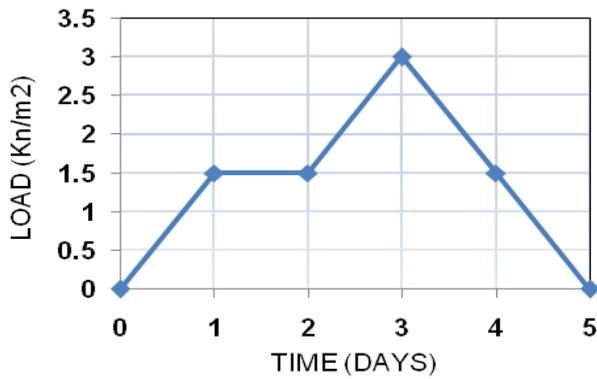
The results of Progressive Load Test carried out at the Design Load are presented in Figs.16 to 28.

It can be seen that for all the six points of observations, the deflection versus time graphs are indicative of resilient properties. The behaviour has shown that it retain its original position after very negligible deflection. All the graphical variations concluded that there are no permanent deformities / deflections in the structure at the Design Load
