~~Cos~~Effectively Extending  
Lives of Severely Deteri  
Concrete Substructure  
Purdue Road School  
March 8, 2011

Siva Venugopalan  
Principal Engineer  
Siva Corrosion Services (SCS)  
[Siva@SivaCorrosion.com](mailto:Siva@SivaCorrosion.com)  
[www.SivaCorrosion.com](http://www.SivaCorrosion.com)

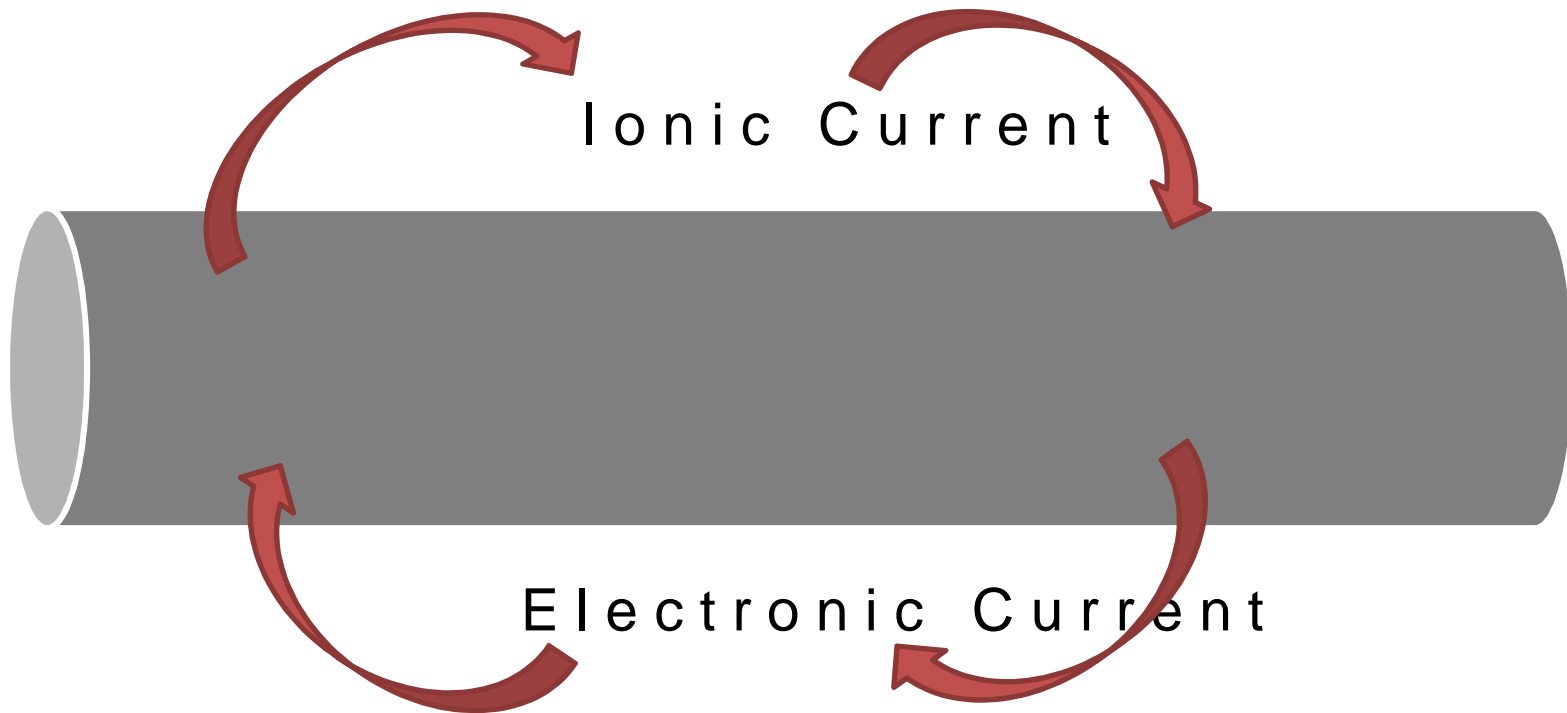
Ionic Current

Electronic Current

The Anode

The Cathode

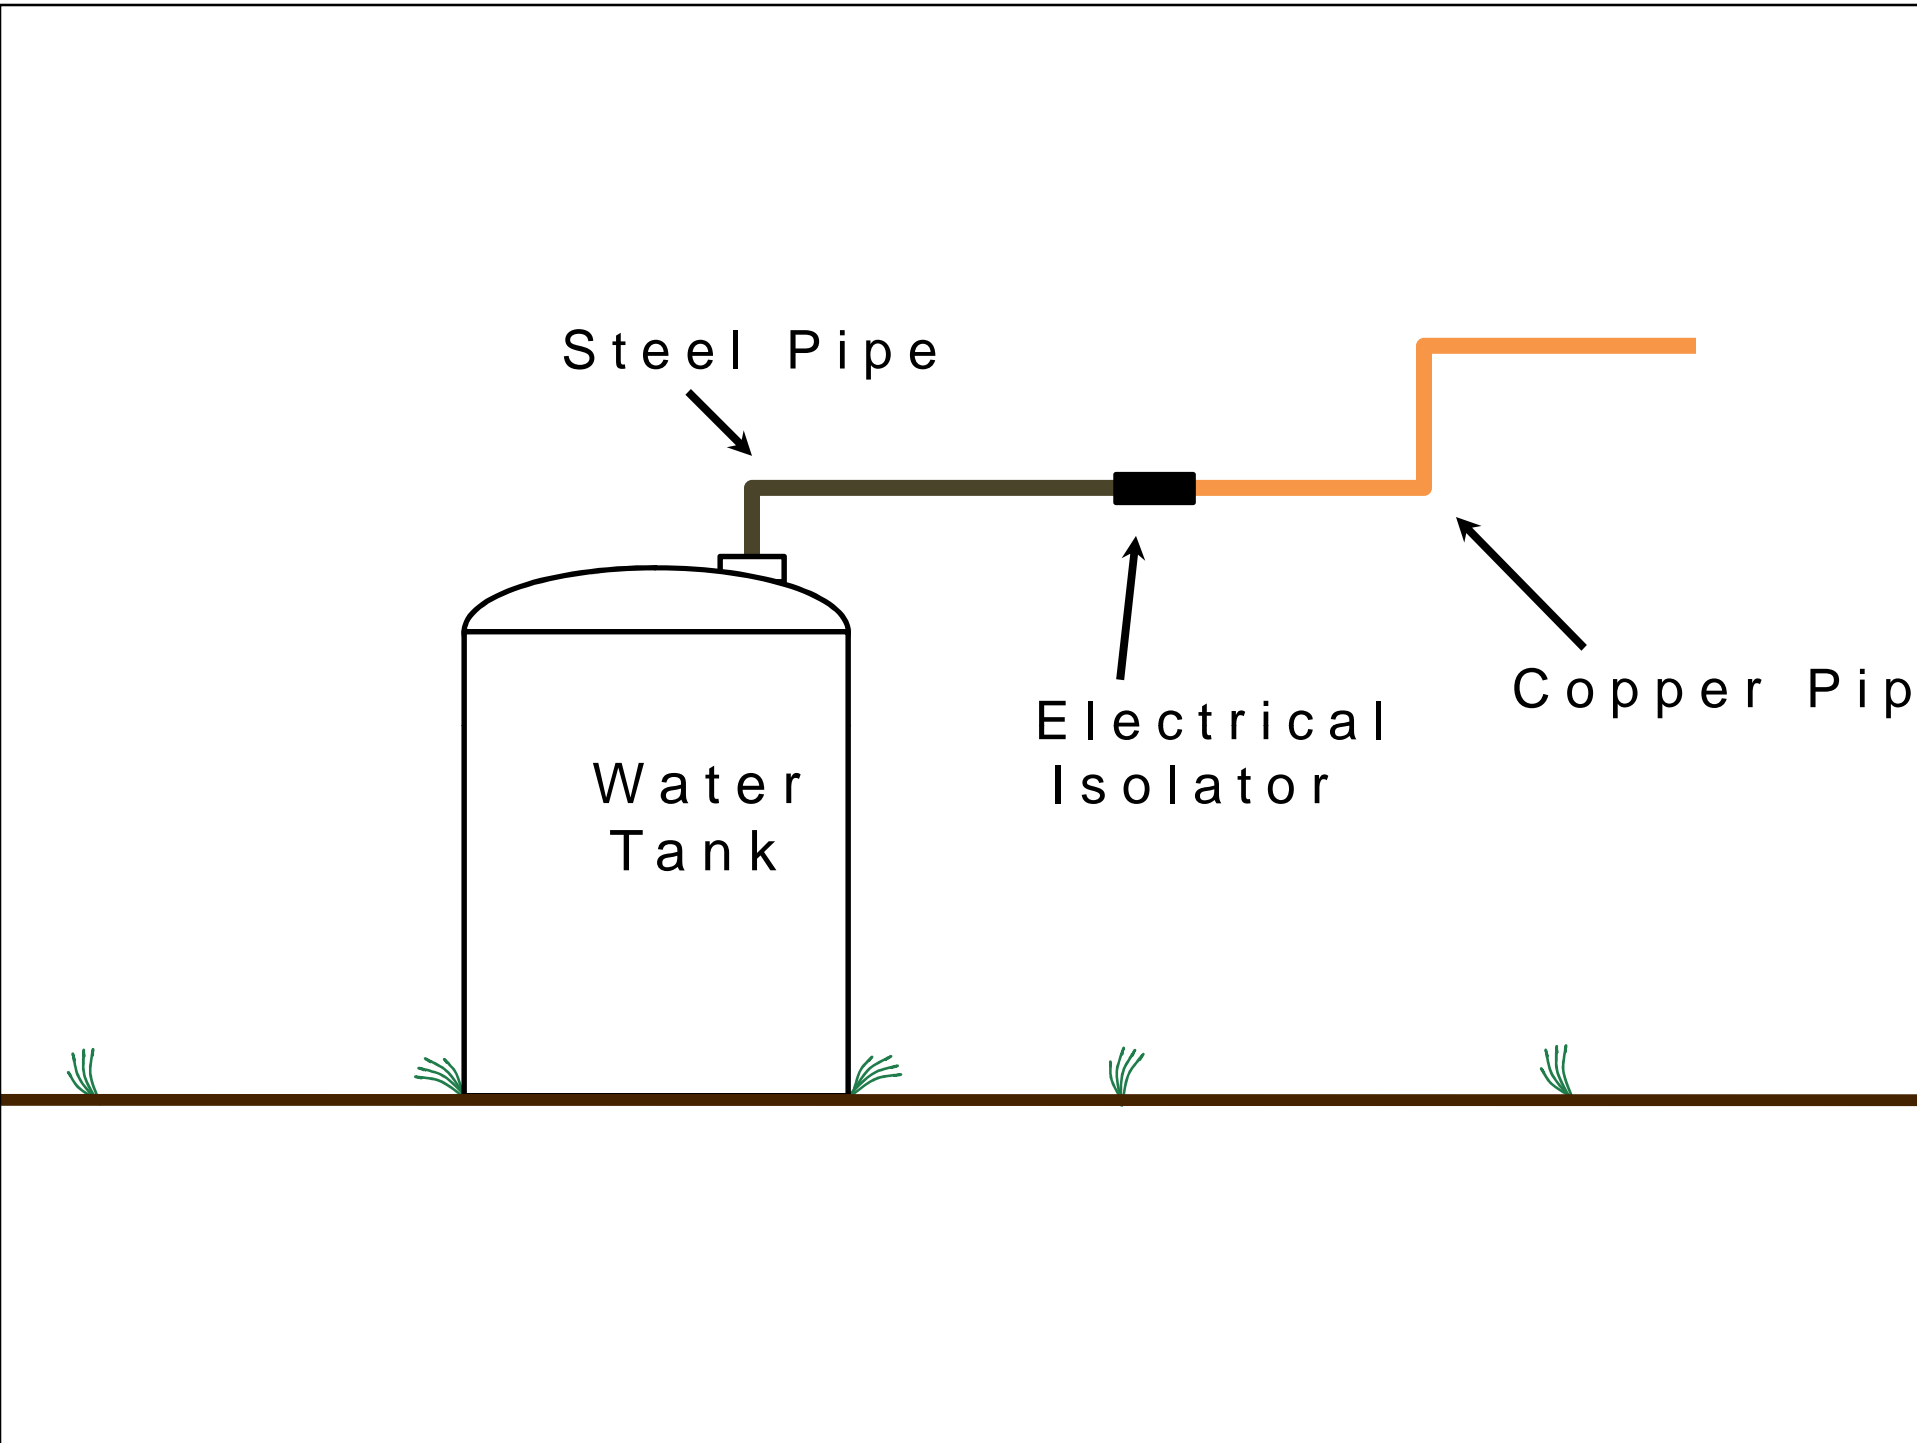
Steel Pipe

Water Tank

Electrical Isolator

Copper Pip

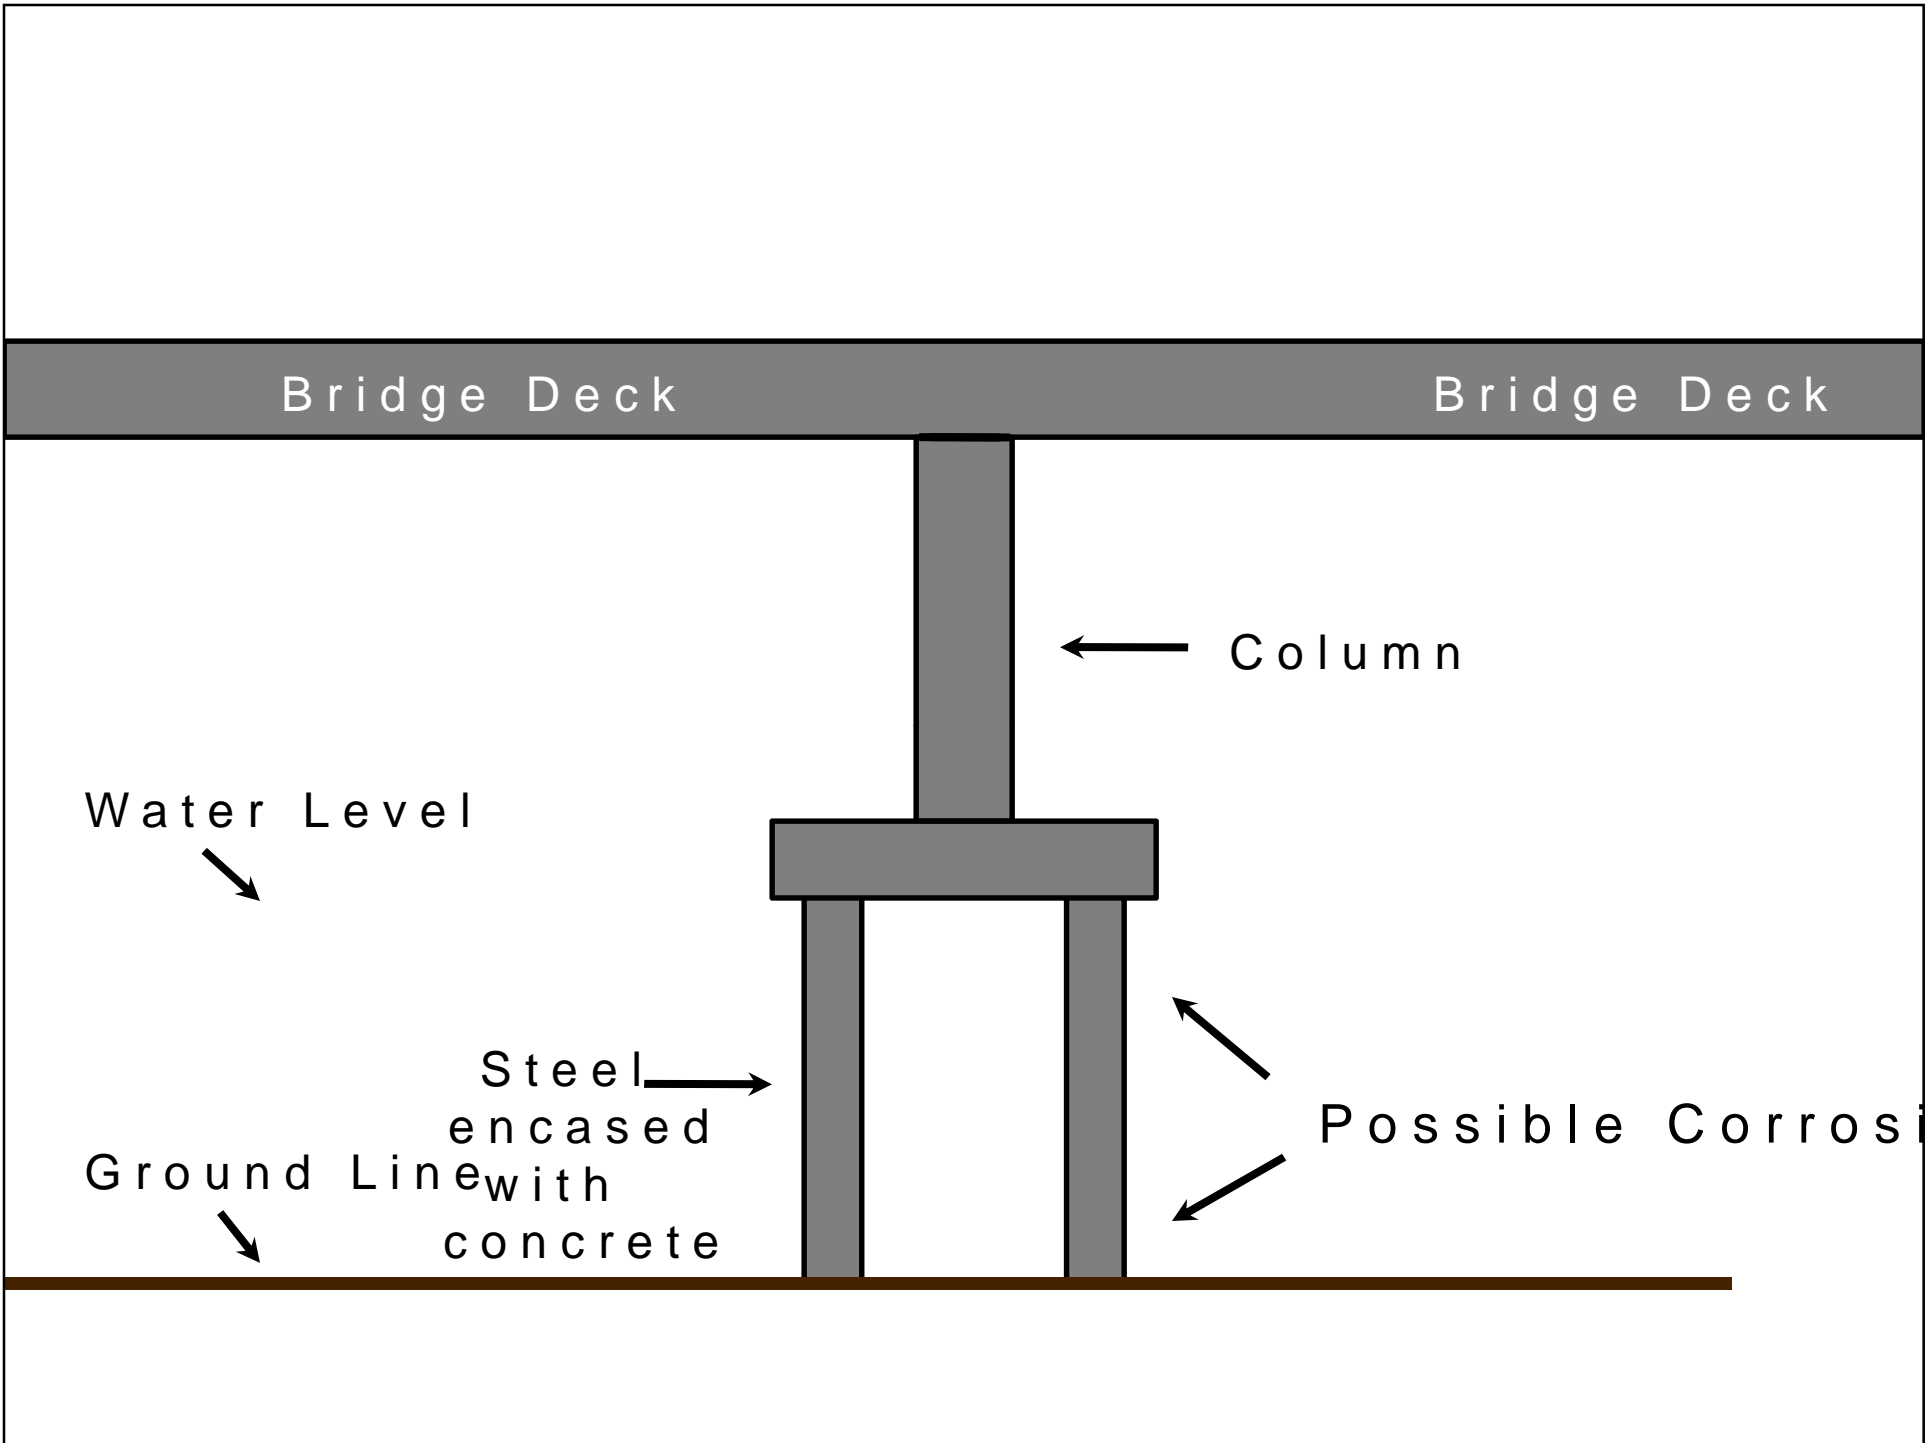
Bridge Deck

← Column

Water Level

Steel  
encased  
with  
concrete

Ground Line

Possible Corrosion

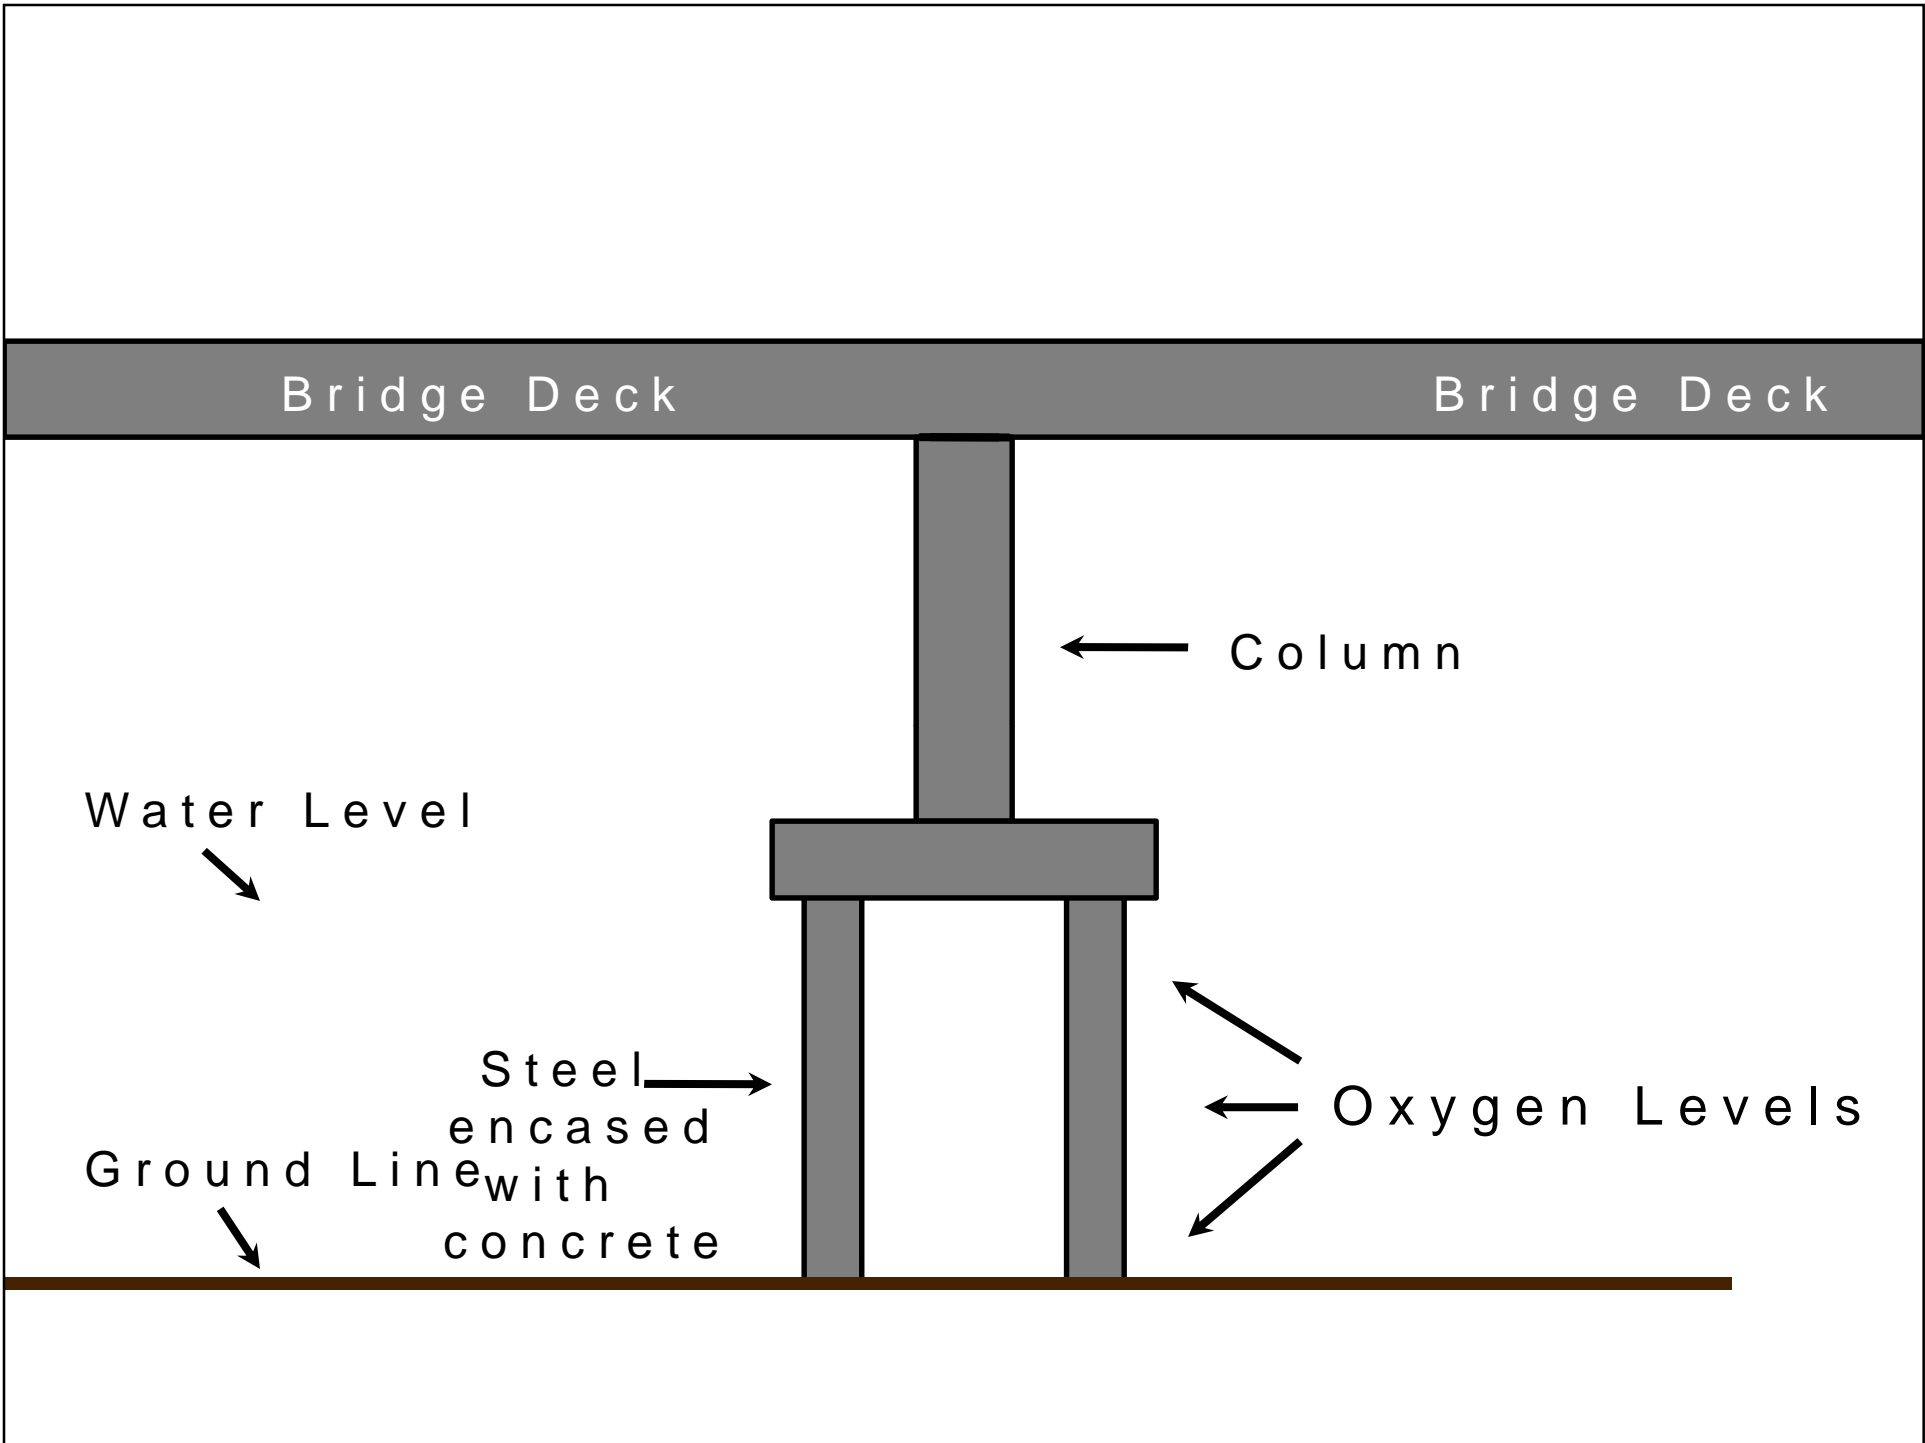
Bridge Deck

← Column

Water Level

Steel  
encased  
with  
concrete

Ground Line

Oxygen Levels

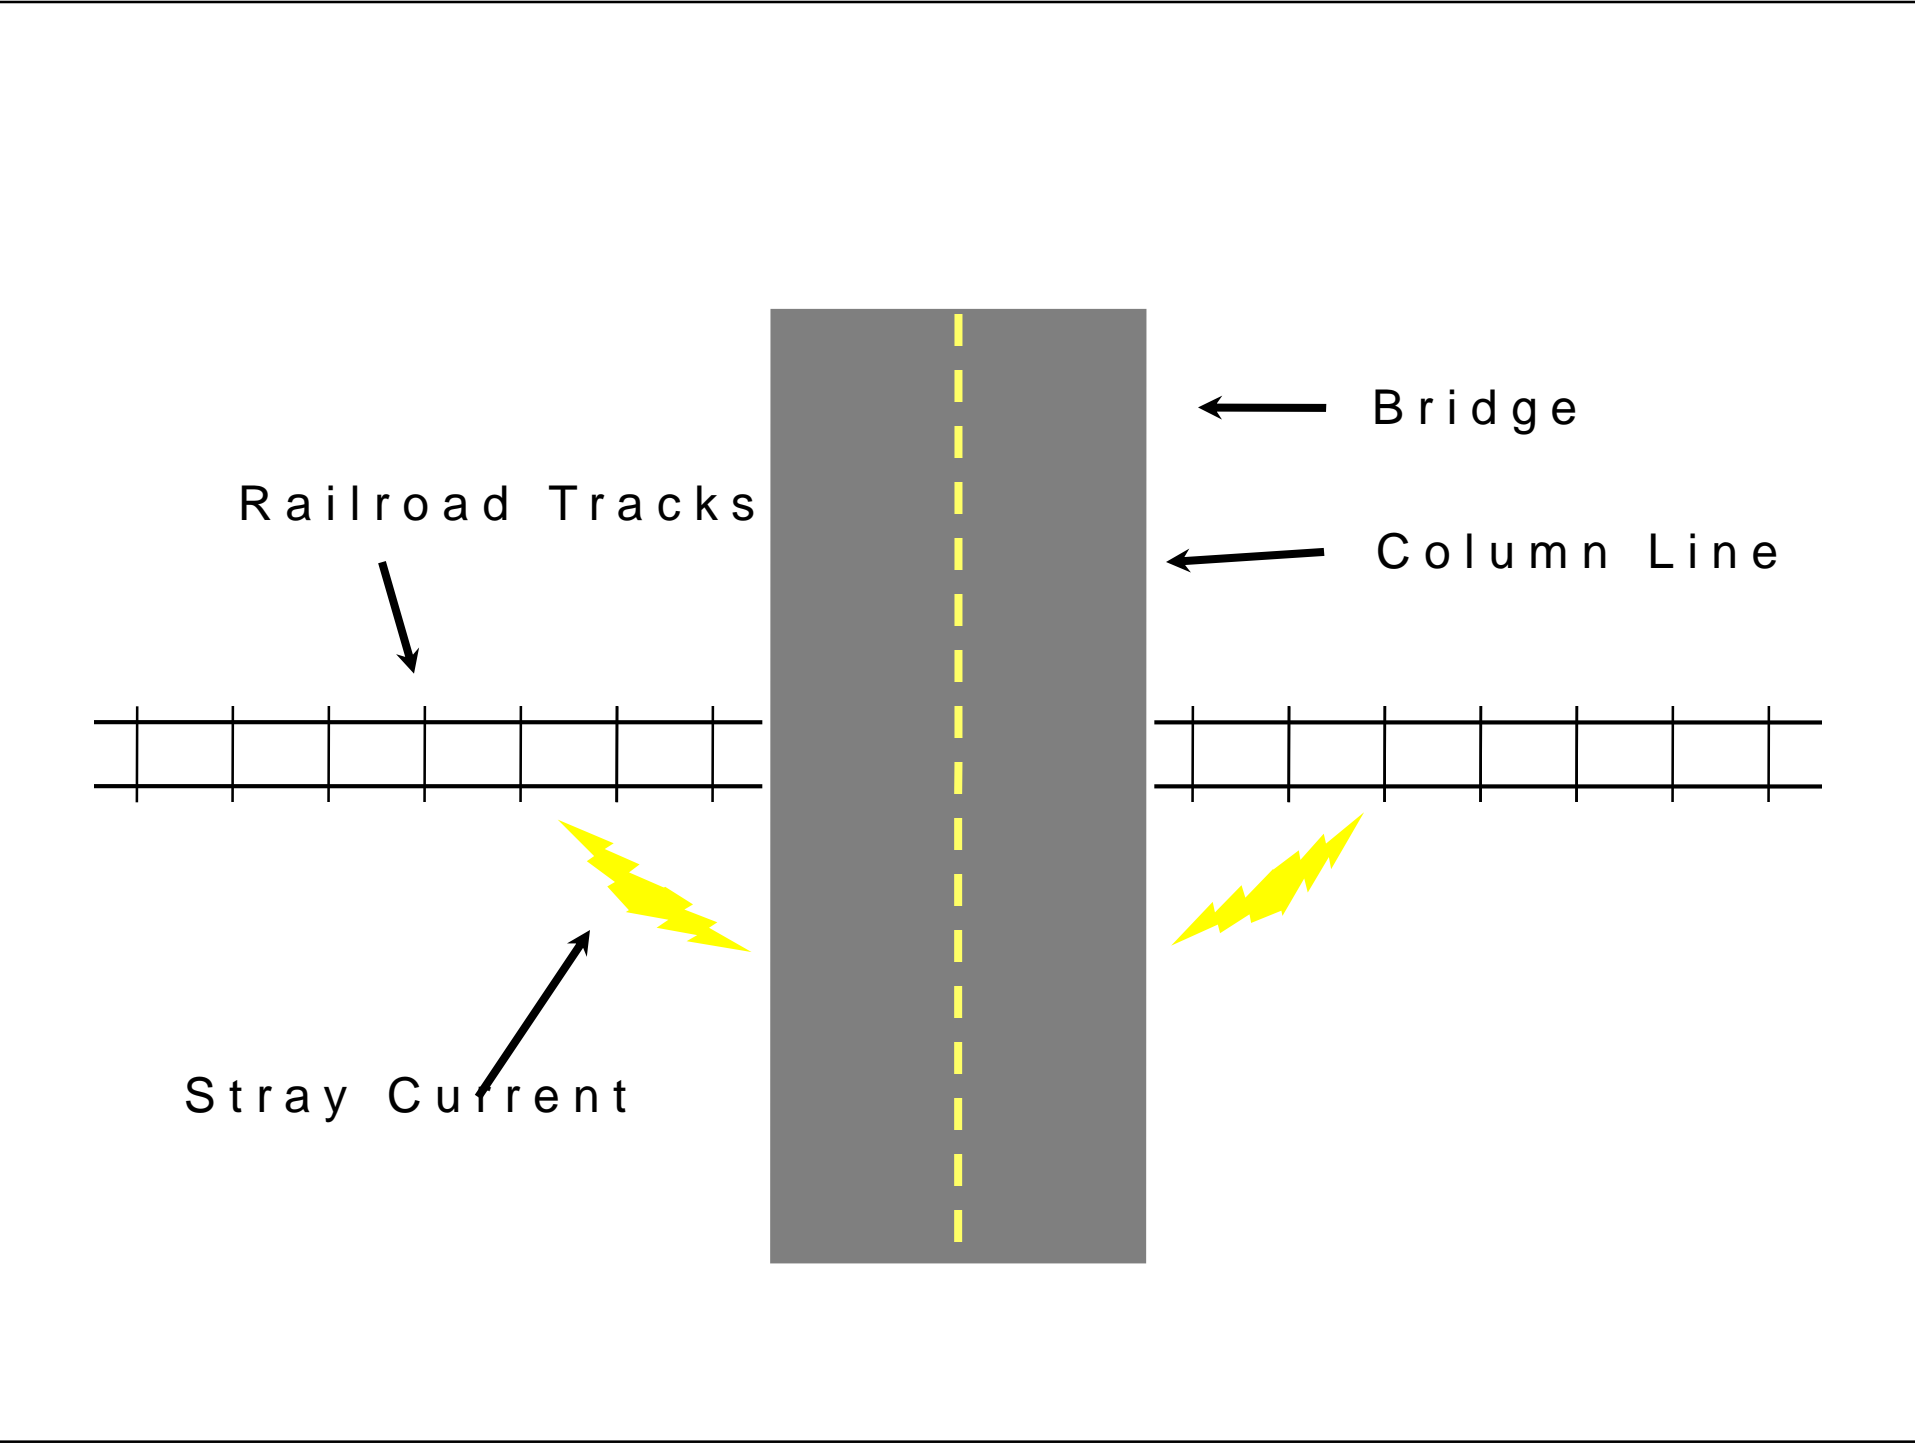
Railroad Tracks

Stray Current

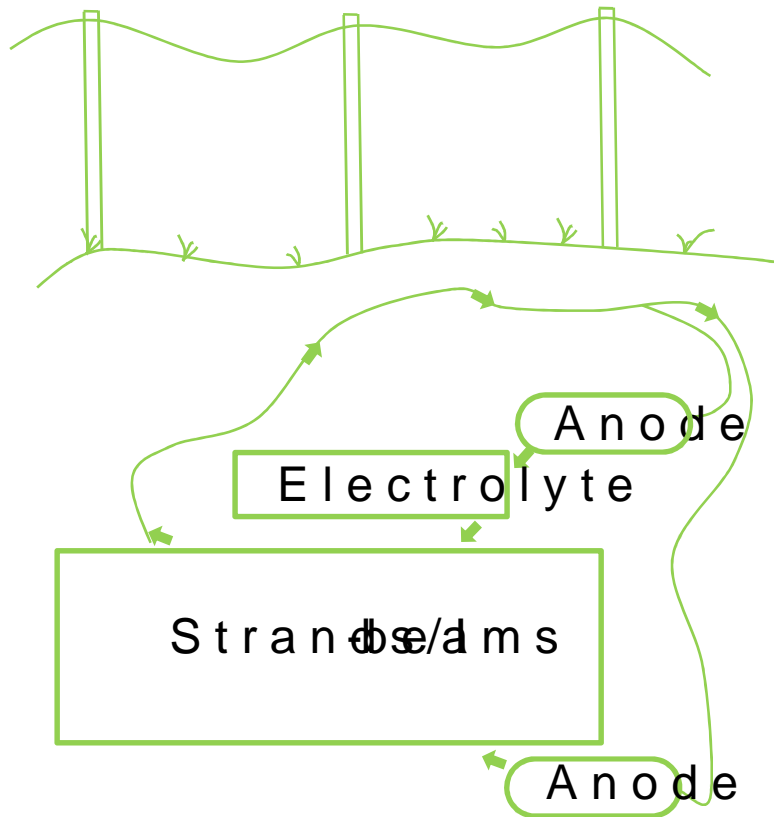
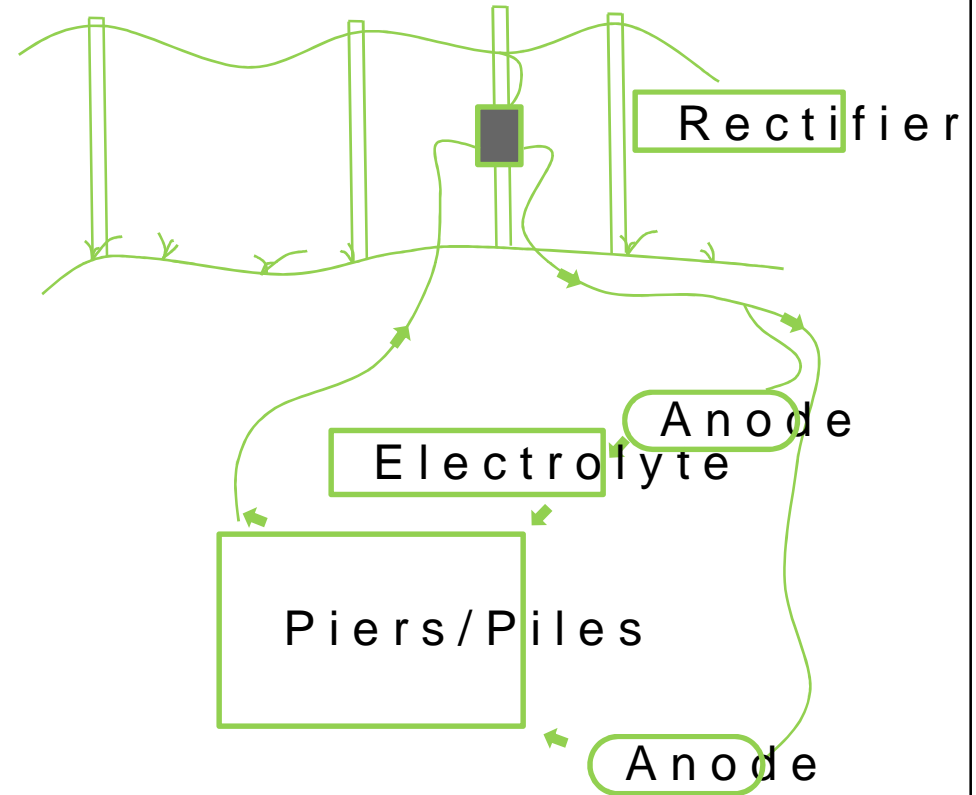
# Typical Solutions

## Galvanic CP Impressed Current

For strands/beams

For piers/piles
