~~Cos~~ Effectively Extending
Lives of Severely Deteri
Concrete Substructure
Purdue Road School
March 8, 2011

Siva Venugopalan
Principal Engineer
Siva Corrosion Services (SCS)
Siva@SivaCorrosion.com
www.SivaCorrosion.com

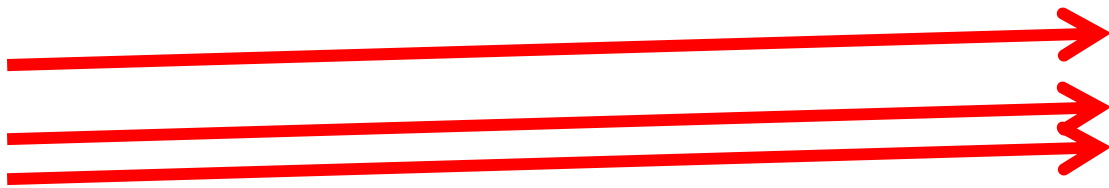
∅ Can find flaws not detectable by GPR and provide more information about those flaws

∅ Well suited for flaw determination on structures with difficult access or multiple layers of materials (e.g. overlays)

Transient Response

← Sound Response

↙ Delaminated Response

• Impact Echo identifies delamination when GPR cannot

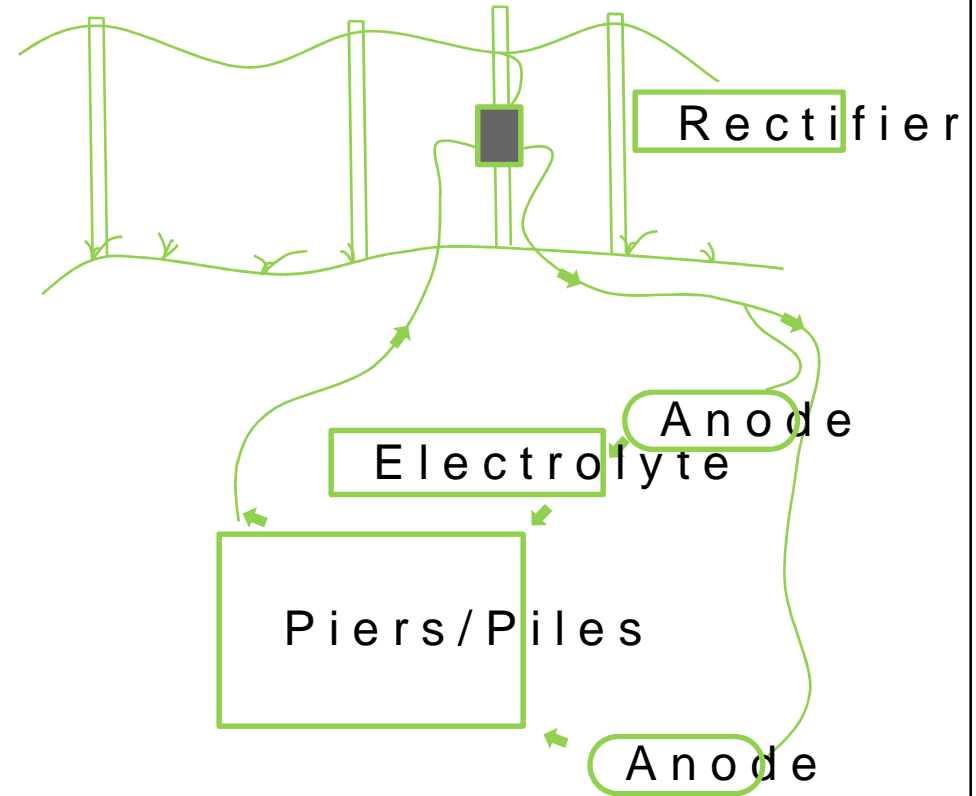
Typical Solutions

Galvanic CP Impressed Current

For strands/beams

For piers/piles
