# A Study on Performance Design Using a Sprinkler System for Fire-Spread Prevention of a Building Exterior

Seung-Un Chae, Heung-You Kim, Uh-Sang Kwon, and Bum-Yean Cho  
 Fire Safety Research Center of Korea Institute of Construction Technology

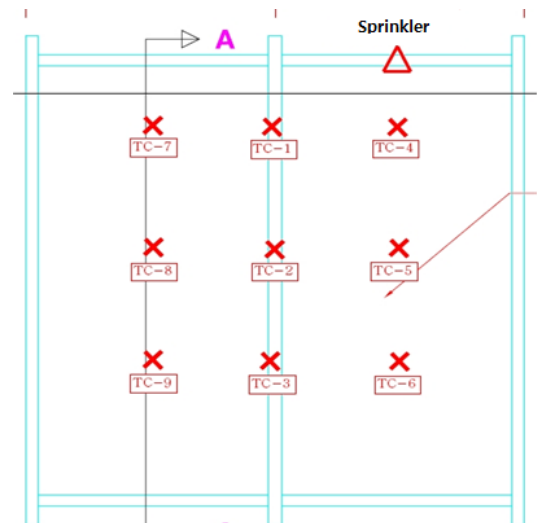
Figure 2. Installation location of temperature surveying line

A total of nine temperature measurement sensors were attached to the surface of the glass exterior material and central frame. They were installed 90 cm, 150 cm, and 210 cm from the floor. The horizontal sidewall sprinkler head used for the fire experiment was set to be operated at 68°C, and a heptane full burner used as the fire source was installed approximately 50 cm from the specimen. The installed glass exterior material specimen, full burner, and the horizontal sidewall sprinkler head are shown in Figure 3.

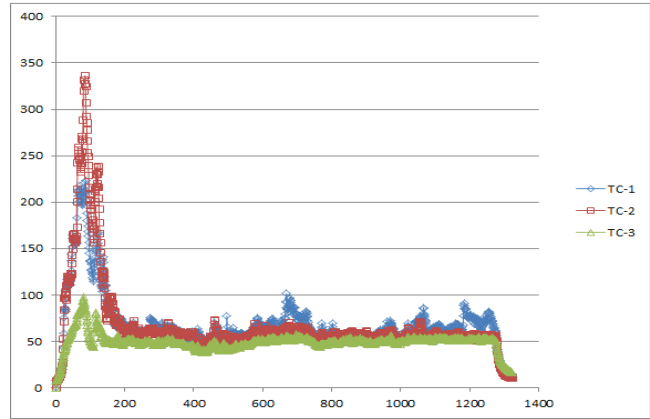
**Figure 5.** Result on the survey of temperature change in the center of the specimen

The temperature measurement sensor (TC1-3) installed in the frame of the specimen with the glass exterior material was installed in the vicinity of the fire source. Then the temperature change was measured. The temperature rapidly decreased 1 minute and 56 seconds after operating the sprinkler due to the effect of the sprinkler head installed in the

right section of the glass exterior material. The temperature change in the frame of the specimen is shown in Figure 5.

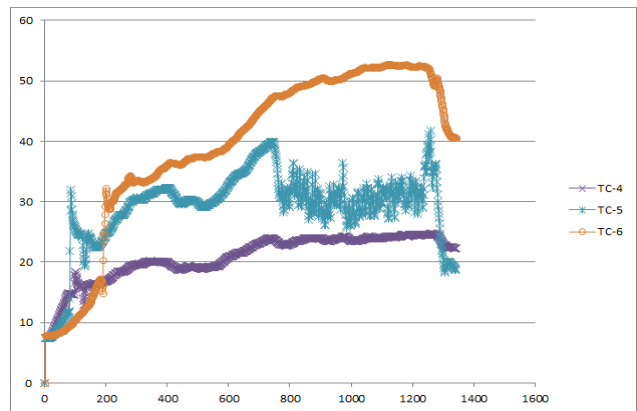
**Figure 6.** Result on the survey of temperature change for the glass block with sprinkler (right side of the specimen)

Figure 6 shows the temperature change of the right glass exterior material where the sprinkler has been installed. The temperature decreased at 1 minute and 56 seconds, the time when the sprinkler was operated due to the effect of the water curtain, but it gradually increased after 3 minutes. However, the rapid increase of the temperature of the glass exterior material was restricted due to the effect of the water curtain by the sprinkler. According to the temperature change for each height, the temperature of the low window was higher than that of the window situated in a high position. This is because the water curtain spilled down the glass wall and led to the cooling effect of the top glass wall.
