Smith, T. O., "The Metallography of Impact Fatigue" (1978). *International Compressor Engineering Conference*. Paper 253.
<https://docs.lib.purdue.edu/icec/253>

THE METALLOGRAPHY OF IMPACT FATIGUE

Ian O. Smith
Senior Lecturer in Physical Metallurgy *
University of Queensland, St. Lucia, 4067,
Australia.

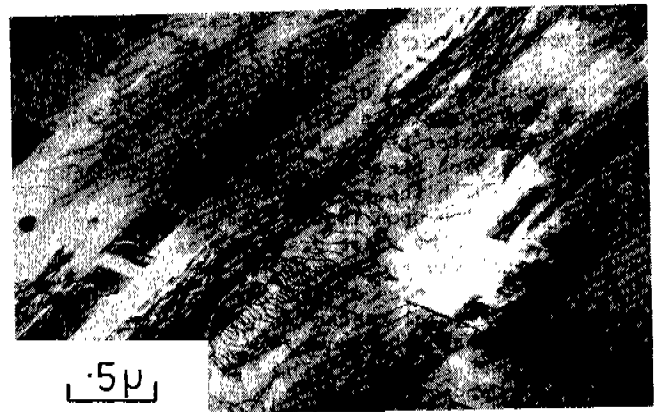
Figure 2(b)

An electron micrograph showing an intense deformation band in the impacted region of a SANDVIK 5R60 sample.

The impact fatigue of 5R60 appears to result in very intense localized deformation. No positive evidence of the association of these intense bands of deformation with any element of the microstructure was obtained.

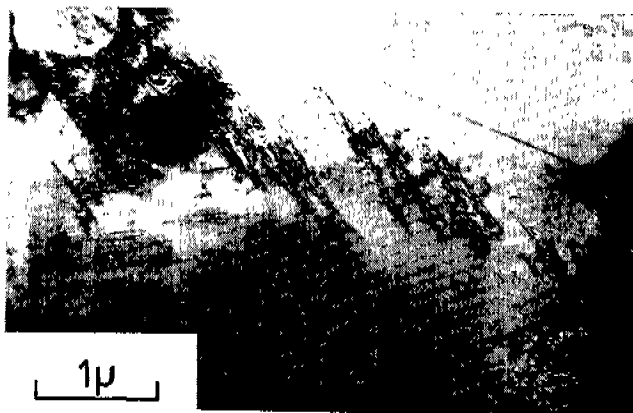
Figure 3(c)
An electron micrograph showing dislocation arrays associated with large second-phase particles in impact-fatigued Nitinol.

Figure 3(a) and (b) are a bright field-dark field pair of micrographs with the dark field image formed from a martensite reflection showing a localized deformation band which appears to have interacted with or originated at a second phase particle. Figure 3(c) shows another example of localized deformation in the form of dislocation arrays which are typical of austenite which has reverted from martensite (2). Again as in the other materials examined, the deformation was extremely localized and the majority of the sample appeared to be unaffected by the impact fatigue.

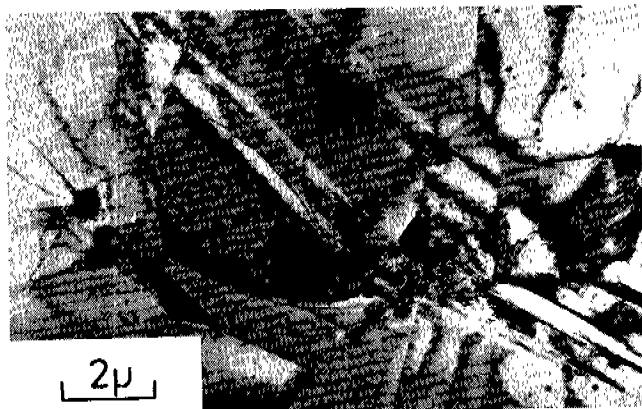
Figure 4(a)
An electron micrograph showing a deformation band crossing several grains in impacted SANDVIK 12R10.

In this material most areas of the foils examined showed no evidence of deformation and the impact fatigue damage was confined to narrow and isolated bands. Figure 4(a) is a low magnification micrograph of a deformation band in impacted 12R10. The crystallographic nature of the band can be seen in

the directional changes when it crosses a grain boundary. Figures 4(b) and (c) show intense deformation bands in which the deformation has transformed some of the austenite to martensite.

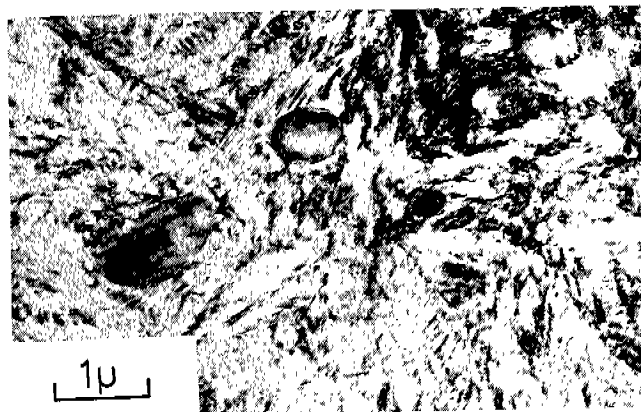
Figure 5(a)
An electron micrograph showing the typical structure of SANDVIK 20C valve steel.

Figures 5(a), (b) and (c) are micrographs of the structure of impact-fatigued 20C valve steel. The microstructure of this material consists of tempered martensite and relatively large carbide particles and is very complex. This complexity makes it difficult to be sure of the effects of impact fatigue. However, Figure 5(b) and (c) show a higher than average dislocation density in the vicinity of carbide particles. As such, the micrographs are not unlike those obtained for
