# Angular Contact Ball Bearings with Peek Cages in Refrigeration Screw Compressors

Lars Sjöholm  
*IR Climate Control*

William Bonis  
*SKF USA*

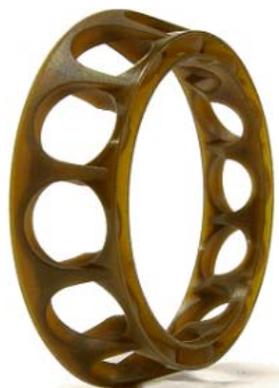
Figure 3: Polyamide cage

The initial selection for bearing cage configuration was pressed window-type sheet brass cage. The discharge temperature as well as bearing temperature was limited to 121.1 °C (250 °F) with occasional temperature spikes up to 135 °C (275 °F). The temperature spikes made it impossible to use glass fiber reinforced polyamide cage material (figure 3). The lubricant was polyolester type ISO VG120. The refrigerants are R404A, R134a and R407C. The applications of this screw compressor are mobile refrigeration (transport refrigeration, trailer) and bus air-conditioning. The maximum speed of the bearing (or the rotor) was 12,000 rpm. The bearing with pressed sheet brass (figure 4) worked well with those application limits.

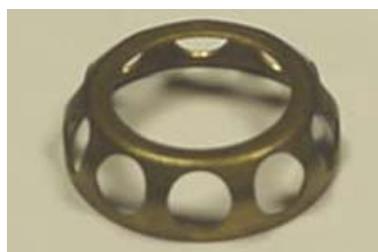
Figure 4: Pressed (stamped) brass cage

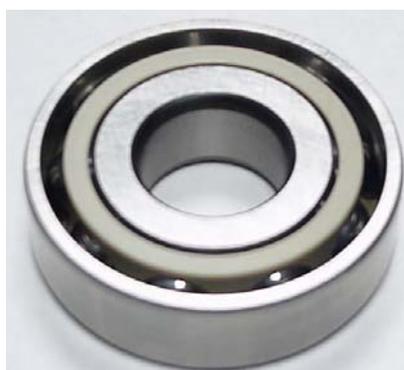
Figure 6: Bearing with machined PEEK cage

The main cage alternatives were pressed sheet steel cage, machined steel cage or machined brass cage. The machined steel cage looked relatively good from cost perspective, but the increased speed (increased centrifugal force on the bearing balls) calls for a smoother contact situation between the bearing balls and the cage as well as a larger surface area of each cage pocket facing each ball. This new operating speed and influence of centrifugal force makes it impossible to use a pressed sheet cage of any material. There was a need for a moldable polymeric material with higher temperature limits than polyamide. A cage made of glass fiber reinforced polyether ether ketone (PEEK) was, at first, considered too expensive. The first approach was to keep the original speed limits and test the pressed window-type sheet brass cage at the increased temperature and the decreased viscosity. Several 1000-1500 hour tests with 148.9 °C (300 °F) temperature and polyol ester ISO VG 30 lubricant showed heavy cage wear (figure 5), which promoted rotation of the inner ring of the bearing relative to the rotor shaft. Heat was generated giving risk for compressor failure. A PEEK cage was considered again. The first prototype bearings, were made with machined PEEK cages, see figure 6. The preliminary test results were promising, giving a positive response to develop a molded PEEK cage.

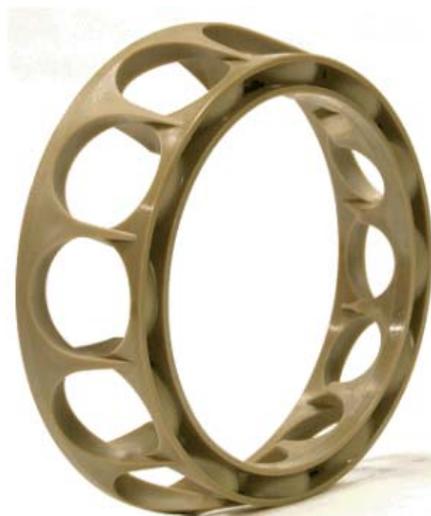
Figure 7: PEEK cage

To minimize the cost of the PEEK cage, the cage had to be molded (figure 7). However, the molded PEEK cage needed more room than the original pressed sheet brass cage. Due to this situation, the number of balls had to be reduced from ten to nine. This would typically mean a reduction of the bearings basic load rating of 10 %. To compensate for this, improved bearing steel was used, further optimization of the heat treatment of the bearing steel as well as improved surface finish on the balls and the raceways. This way, the final bearing had an actual slightly increased basic load rating. Several 1000 hour tests were performed with different combinations of the refrigerants and the extended operating conditions. All results were positive. The final test was to mix some air in the refrigeration system and disconnect the maximum discharge temperature cut out function. The discharge temperature varied between 176.7 °C (350 °F) and 204.4°C (400 °F). The test ran for more than 1000 hours. The lubricant was discolored, indicating break down with acid formation. The inner race showed bluish discoloration, however the cage looked good (figure 8). This test showed that the cage is no longer the weak link, now placing more emphasis on the lubricant film and/or fatigue properties of the inner race.

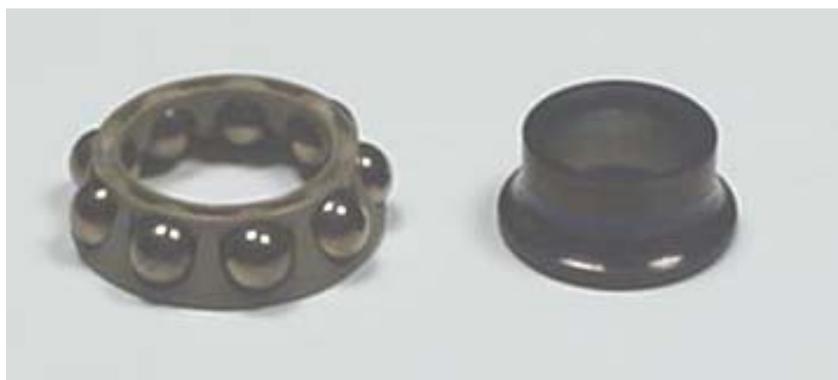
Figure 8: Bearing exposed to extreme heat and air
