Blind Inlets as Conservation Practices to Improve Water Quality

J.M. Gonzalez¹, D.R. Smith², and S.J. Livingston³

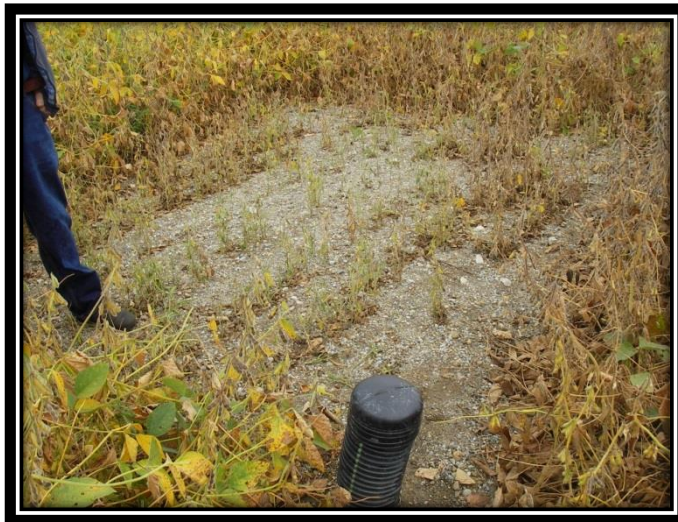
Figure 1. Blind inlet and a tile riser on a field with a soybean crop.

drainage tile, and into the outlet channel or ditch. Blind inlets are an alternative conservation practice that can drain the pothole depressions with added benefits (Figure 1). Daily farming operations can be conducted over the blind inlets, including tillage, planting, and harvesting. Furthermore, since the blind inlets are filled with a combination of fine and coarse materials (Figure 2), this bed serves as a filter for sediments and increases the tortuosity of the draining water; thus, sediment runoff and flow rate are reduced. Since losses of nutrients and pesticides are impacted by sediment losses and flow, it is anticipated that surface losses of nutrients and pesticides are impacted by the blind inlet.
