Mortar Quality Assessment for an Iconic Building Repair in Sydney Australia

ABSTRACT

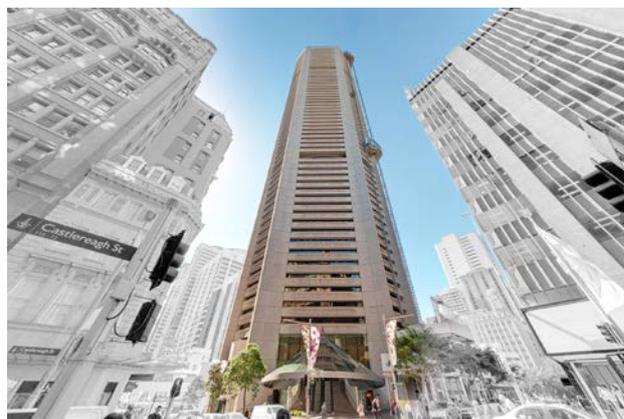
The MLC Centre is a thriving hub in Sydney centre, offering office retail and open space in the Sydney CBD (Fig. 1). The main building is 244m high, having 67 floors and the tower was reported as the tallest reinforced concrete office building in the world on completion in 1977. It was Australia's tallest building from 1977-1985.

Fig. 1. Photo of MLC building

The façade of the tower consists almost entirely of 90 mm thick off-white exposed aggregate finished precast concrete column panels and spandrel panels with dark grey anodized aluminum window frames, grey-tinted tempered glass and deep marble veneered windowsills.

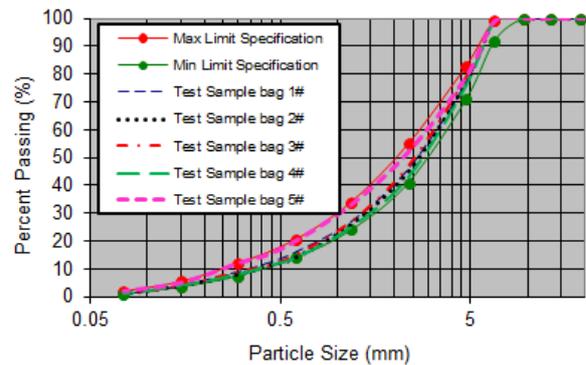
Bags of white quartz blend were randomly selected for the particle size distribution (PSD) assessment as per AS 1141.11.1 and the 75 μm with AS 1141.12. The PSD of the imported MLC Quartz blend is presented in Fig. 2 together with a graphical representation.

The PSD is very consistent and complies with specified envelope; including as low as 1% of 75 μm fraction, a sign of a clean aggregate. The quartz sand has its particle density of 2.63t/m³ and very low water absorption at 0.4%, tested by AS 1141.6.1.

Fig. 2. Particle Size Distribution of Quartz sands

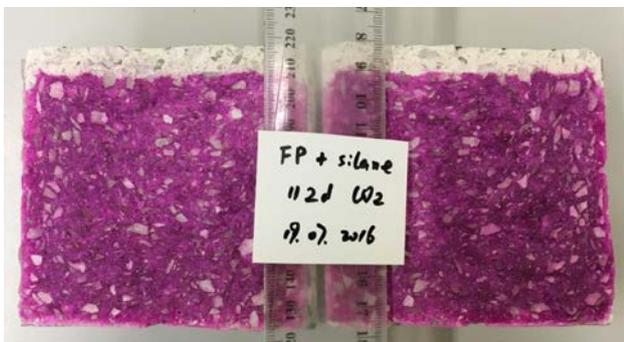
After exposure of 1, 4, 9 and 16 weeks, the depth of carbonation was measured by the traditional phenolphthalein method RILEM CPC-18 as presented in Fig. 3.

Fig. 3. Foreva MLC Form & Pour winter mix + Silane after 112 days CO₂ expose

Considering the previous research work, as above noted, the carbonation depth and exposure time generally follows the Fick’s first law. The coefficient Ka can be calculated.

carbonation in laboratory conditions. For concrete in open air structures sheltered from rain (i.e. XC3 in EN standard) urban exposure, Neves (2013) reported the statistics of $Ka/Kn = 11.7 \pm 4.3$ (mm/week^{0.5}), indicating the lower limit is about 7.4 times. Therefore, the ratio $Ka/Kn = 7$ were used conservatively for the service life estimation due to carbonation induced corrosion. The results are presented in Table 1.

Therefore, assuming a good construction quality (consistent compressive strength, no voids and good concrete compaction, fully coated with silane), the service life is estimated at 76 years for the winter Form & Pour mix, exceeding the required service life of 40 years.
