Experimental Study of Fouling Performance of Air Conditioning System with Microchannel Heat Exchanger

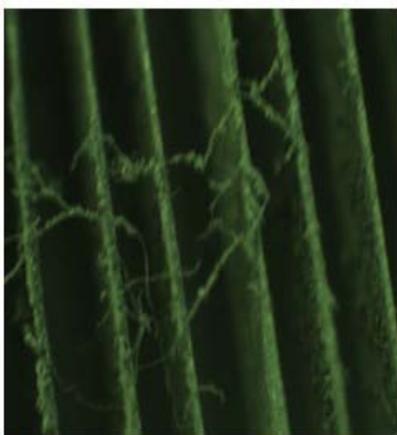
Figure 12: The dust on #1(a) and #2(b) of the group 2 air condition systems after 3 months

As described above, we added group 2 which run according to the control strategy to verify its effectiveness. We tested the performance of group 2 and compared with group 1, which is shown in figure 9 to 11. We can see the performance of group 2 improved a lot compared with group 1. After they run for 3 months, the cooling capacity decreased by 5.5% and 2%, the energy consumption increased by 7.8% and 2.3%, and COP decreased by 12.3% and 4.3% for louver fin and wavy fin MCHX respectively. This is main because the regularly blowback of the fan can prevent the fibers dust depositing on the surface of the MCHX and the particulate dust blocking the flow channel of the air. Though there still have a layer of dust on the surface of the fin, it just affects the heat transfer coefficient and doesn't decrease the air volume of the condenser, so the decrease of heat transfer of the condenser is limited, which results the better performance of group 2. We can also find that the performance of the system with wavy fin MCHX is better than the system with louver fin, this is main because the dust on the surface of the wavy fin can be blown out more easily than the louver fin. This also proved by figure 12, which shows the detail condition of the fin.
