# Design of Accelerated Fatigue Tests for Flame Free Refrigeration Fittings

Michael WILSON<sup>1\*</sup>, Chad BOWERS<sup>2</sup>

<sup>1</sup>Cerro Flow Products LLC  
Sauget IL  
[mwilson@cerroflow.com](mailto:mwilson@cerroflow.com)

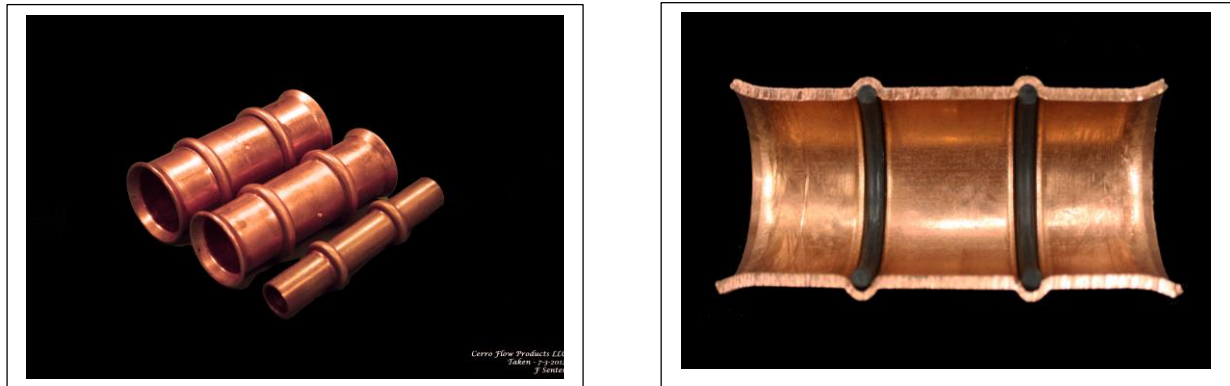
**Figure 1:** View of Flame Free Fitting

The test article for this study is a flame-free fitting designed to join tube carrying refrigerants. The fitting is designed to be chemically compatible and structurally sound to work with refrigerants currently in widespread use in HVAC&R applications i.e. (R134a, R410A, R404A). Pictures of the fitting and the joining method appear in Figure 1 and

Figure 2. As shown in Figure 1 the fitting is made from a round piece of metallic tubing (in this case copper) and has two bulged sections near each end for placement of an o-ring. The o-ring material composition is selected to be both materially compatible with refrigerants and lubricants and elastic enough to make a leak free seal once compressed. To make a leak free connection, a metal tube is slid into each open end of the fitting, with the tube marked to ensure that the tube is inserted deep enough so that the o-ring can seal. Lastly a crimping tooling with a specially designed set of jaws is actuated to deform the fitting and create a leak tight joint. The fittings tested in this study are designed to join tube diameters with wall sizes listed in Table 1.

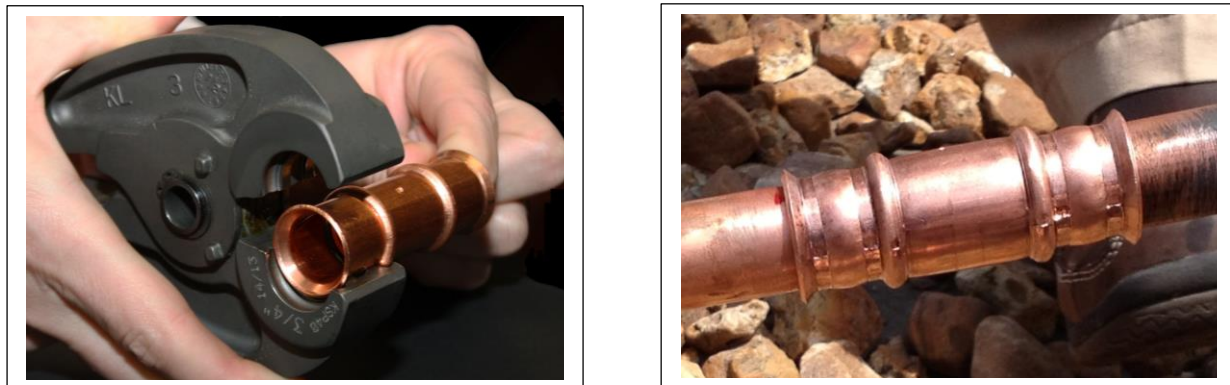
**Figure 2:** View of Fitting During and After Crimping

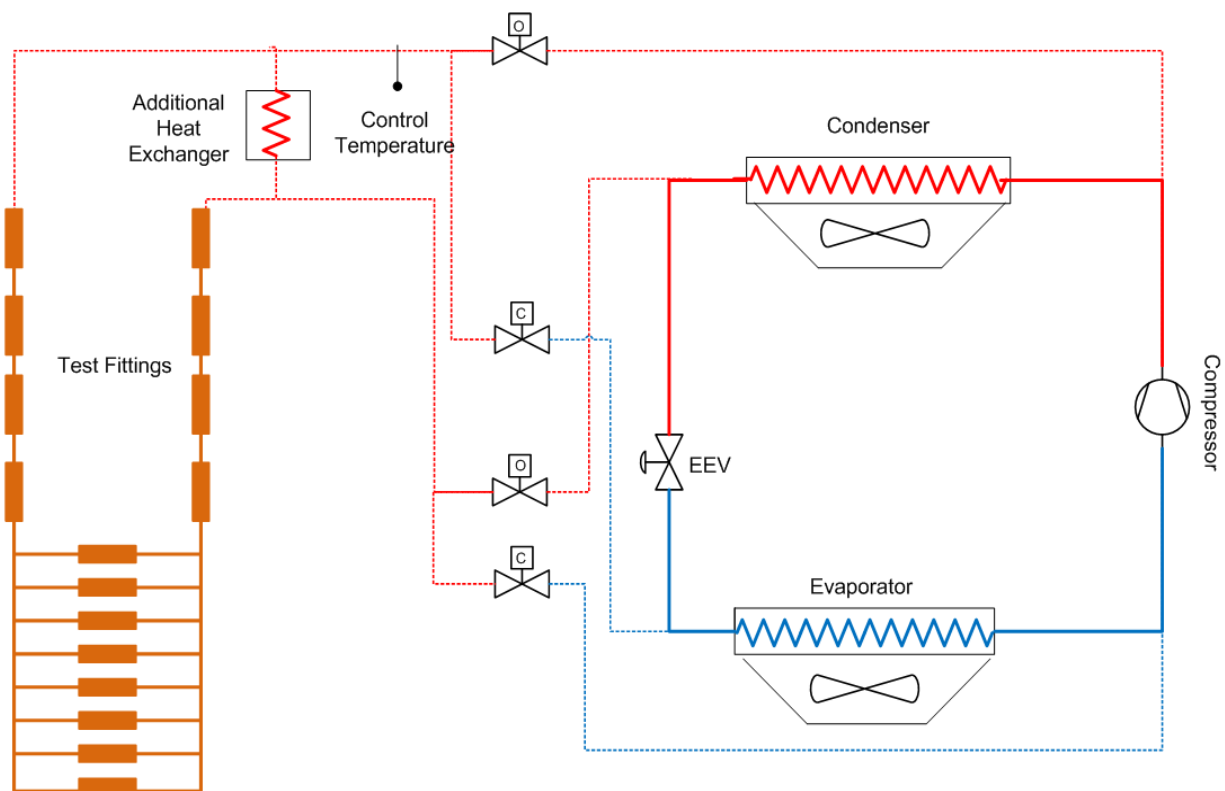
**Figure 3a:** Heating Mode Schematics for Thermal Shock Test

The test apparatus uses an existing support vapor compression system with a set of solenoid valves used to direct either hot high pressure refrigerant or cold low pressure refrigerant to the test section. In heating mode, the hot discharge gas from the compressor is split between the condenser and the test section. Downstream of the test section is a small heat exchanger to fully condense the refrigerant before it is then recombined prior to entering an electronic expansion valve, where the fluid is expanded and fed to the support system evaporator. The system operates in heating mode until a temperature set point,  $90^{\circ}\text{C}$ , of the refrigerant leaving the solenoid valves and going to the test assembly is reached.

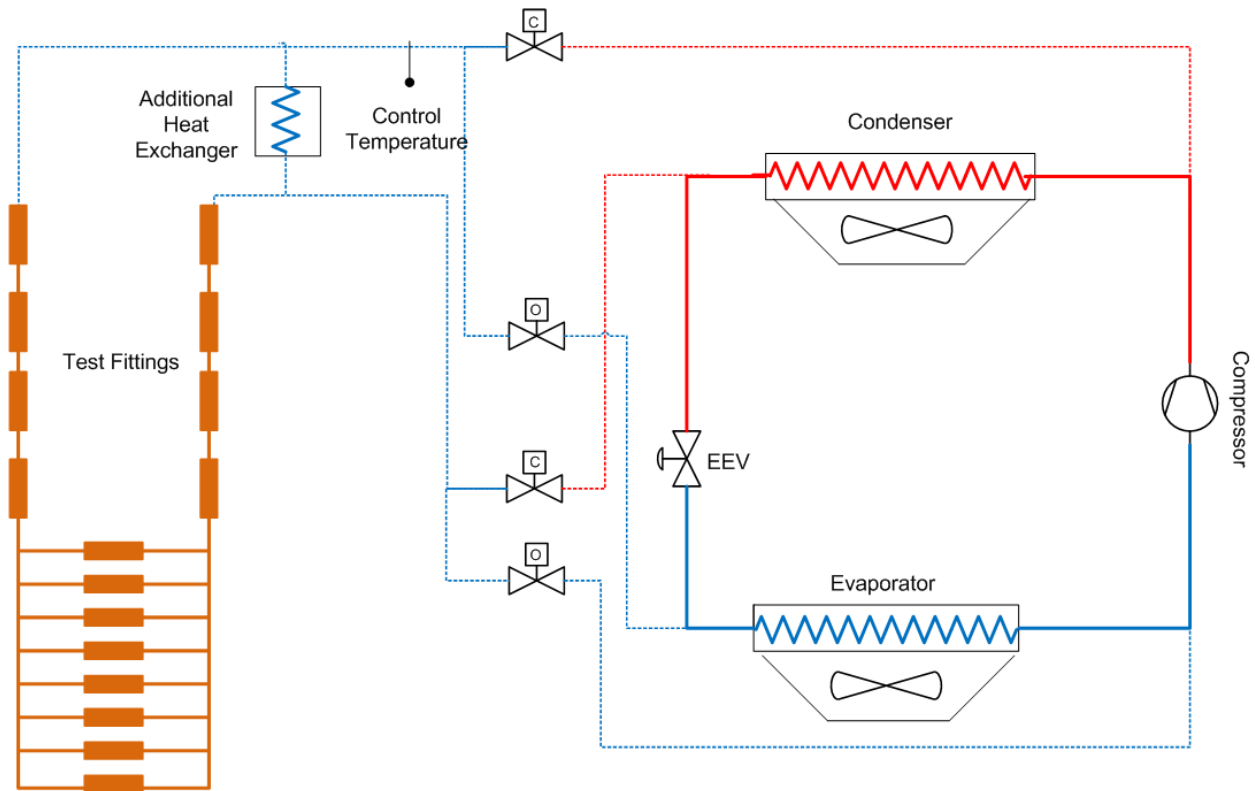
**Figure 3b:** Cooling Mode Schematics for Thermal Shock Test

Upon reaching the high temperature set point, the system switches from heating to cooling mode through operation of the solenoid valves, as depicted in Figure 3b. In cooling mode, all discharge gas is sent to be condensed in the support system's condenser. The subcooled liquid is then sent through the electronic expansion valve, after which the low pressure two-phase fluid is split between the test units and the support system evaporator. This system configuration is maintained until a specified refrigerant temperature set point,  $\sim 12^{\circ}\text{C}$ , at the inlet of the test unit is reached. At this point, the system is switched back into heating mode using the four solenoid valves. A chart showing the temperature and pressure profiles in the test fitting apparatus during several thermal cycles is shown in Figure 4. In this example, the first full heating cycle begins at approximately 10 seconds. The initialization of the heating cycle results in a sharp increase in both pressure and temperature for a few seconds. After this initial sharp rise in pressure and temperature, the rate of increase for both slows, but both still steadily climb until the set point is reached at approximately 45 seconds. Upon reaching the setpoint, the cycle switches to cooling mode which causes both the pressure and temperature to drop dramatically over the next 15 seconds. Over the course of nearly fifty days, all sixteen test fittings were subjected to continuous testing for a total of 80,000 pressure-temperature cycles, without failure. Weekly leakage testing was performed by spraying a soap solution on each joint and looking for forming bubbles to verify that no failures had occurred. At the end of the cycle testing, the test section was pressurized with nitrogen to 689 kPa (100 psi) and the test article was sprayed with soap solution to visually inspect for leaks. No leaks were identified at the end of the testing period.

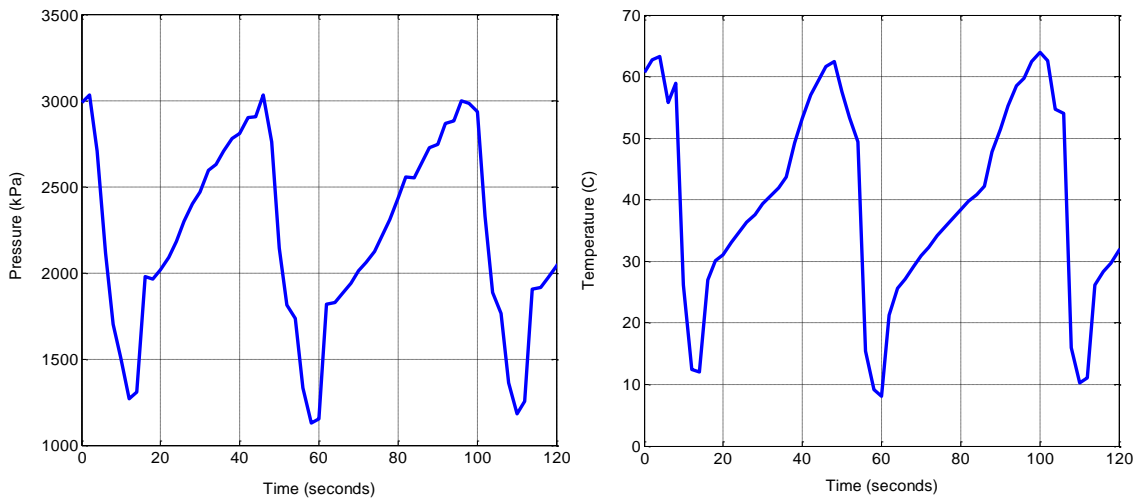
**Figure 4:** Example Pressure and Temperature Profiles during Shock Test

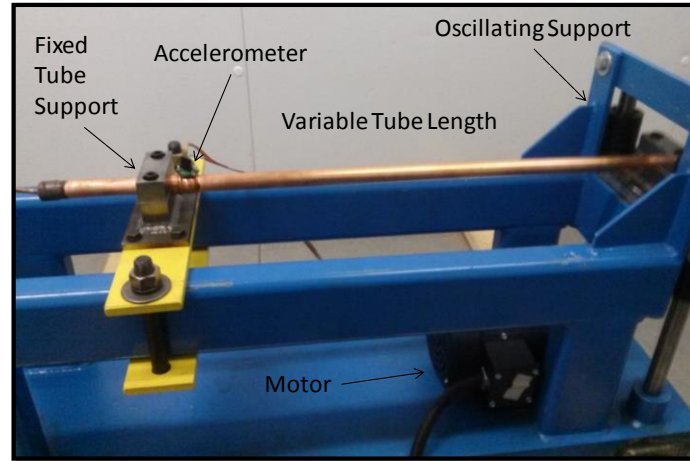
**Figure 5:** Vibration Fatigue Test Facility

Refrigerant leaks at braze joints caused by vibration induced failure are a major cause of concern when designing and fabricating HVAC systems. The 1998 study by AHRI and CDA (Hourahan, 1998) suggested that the quality and depth of the braze joint is also important in reducing vibration related failures. To better study vibration induced fatigue, a test was conceived to simulate field vibration in refrigerant carrying tubes. The test set up, shown in Figure 5 has two tube supports with one support fixed and the other support oscillating vertically at an amplitude of +/- 3.0 mm. The oscillations are the result of a four bar mechanism coupled to a rotating motor with an eccentric shaft. The motor had a variable speed drive capable of producing oscillating vertical motion between 0 and 60 Hz on the fitting; however, all fatigue testing was performed at 28.5Hz (a 1725RPM motor running at 60Hz). The length between the supports is measured from the closest edge of each clamp to the other clamp. The values are a direct as a function of tube outer diameter size and are based off of the existing UL 109 standard for tube fittings. Table 2 presents the length between the fixed tube support and the oscillating tube support for the 6 tube diameters evaluated.

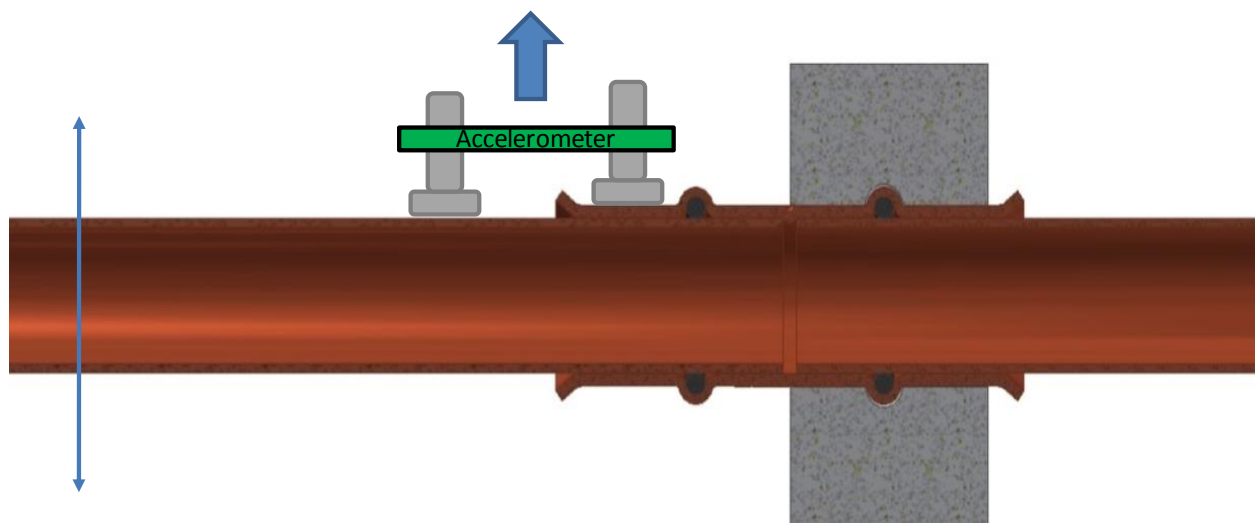
**Figure 6:** Diagram of Fixed Support and Fitting during Vibration Test

An important feature of the test is the how the fitting is secured into the fixed support. The way tubing and components are supported in HVAC systems varies among manufactures and mechanical contractors, thus it was decided to choose what would be a worst case scenario and secure the back half of the fitting into the fixed support. This is detailed in Figure 7. A specially machined clamp is bolted around the back half of the fitting and then firmly affixed to the facility. This causes the "pivot point" to be located in the center of the braze free fitting itself. To evaluate the severity of the vibrational load, a 1-D accelerometer was attached across the fitting and tube, as shown in Figure 6. The acceleration at this joint was monitored using a datalogger sampling at 300Hz. Exemplar data in both the time and frequency domain from testing of a 22.2mm (7/8") sample is shown in Figure 7. The up and down motion from the oscillating support causes a very consistent acceleration of approximately  $\pm 1g$ . The primary frequency occurs at the 28.5Hz provided by the motor, with a very small amount of power occurring in the second harmonic. All of the fittings listed in Table 2 were pressurized to 2750kPa and cycled at least 1 million times as described above. After vibration cycling, all of the fittings were subjected to a leak test at a pressure of 2750kPa.

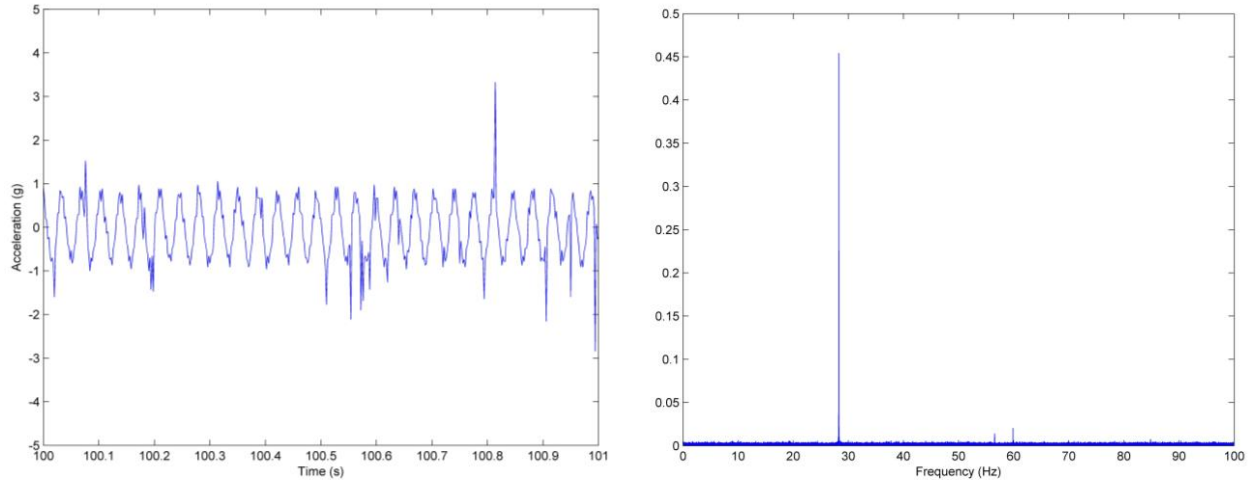
**Figure 7:** Example Time and Frequency Domain Data for 22 mm (7/8'') Fitting

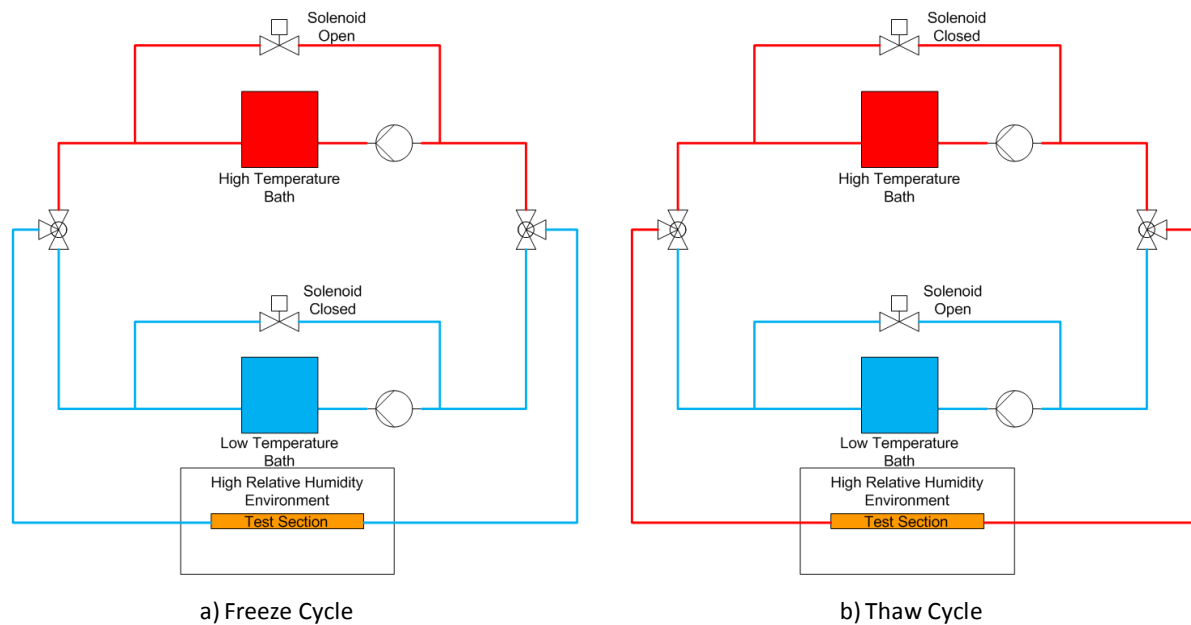
**Figure 9:** Operational Schematic for Freeze Thaw Cyclic Facility in Heating and Cooling Modes

Another reliability and performance concern for reversible heat pump systems is the numerous frosting and defrosting cycles that any component in an outdoor environment must endure. One concern specific to fittings and joints is the infiltration of water into small crevices, going through expansion and contraction during freeze/thaw cycles eventually leading to the failure of the fitting or joint. To simulate this potential failure mode a lab scale freeze/thaw cycling test was devised in which a test section comprised of sixteen (16) fittings were contained in a high relative humidity environment. A diagram of the test setup is shown in Figure 9. An alcohol solution near  $-40^{\circ}\text{C}$  is first pumped through the test section for a fixed amount of time which causes condensation on the fittings eventually leading to ice formation. Once the set amount of time has elapsed, solenoid valves are switched and a warm alcohol solution near  $20^{\circ}\text{C}$  flows through the test section for a fixed amount of time. This higher temperature fluid causes the ice formation to melt completing the freeze thaw/cycle.

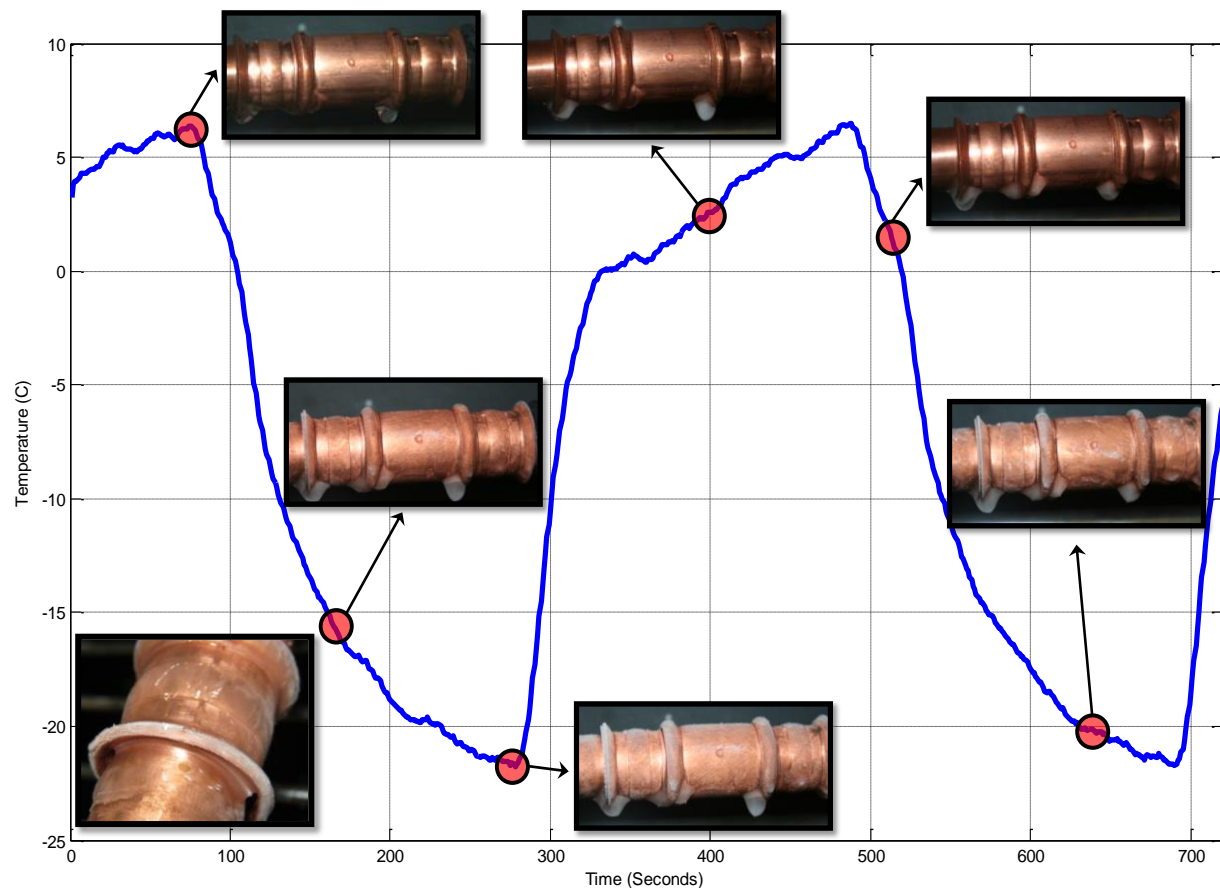
**Figure 10:** Formation and Melting of Ice and Associated Wall Temperatures

An example of images and the wall temperature profile from a single 22.2mm fitting through two freeze/thaw cycles is shown in Figure 10. The temporal plot of the wall temperature profile begins near the end of a thaw cycle. At 80 seconds, the wall temperature peaks at approximately 6°C. The corresponding image shows that there are liquid droplets left on the fitting from the previous thaw cycle. When the solenoid valves are switched, the temperature begins to decrease quickly until, at about 175 seconds, ice/frost is clearly forming on the walls of both the fitting and the tube. The ice formation is also apparent in the gap between the fitting and the tube as shown by the photograph of the top of the tube. At the end of the freezing cycle, approximately 280 seconds, the wall temperature reaches a minimum of -22°C and the tube and fitting are clearly covered in a layer of frost/ice with the frozen droplets hanging in the position that they melted at during the previous thaw cycle. At this point, the solenoid valves are switched and the warm fluid begins to circulate through the test section. About halfway through the thaw cycle, the frost/ice is mostly melted from the surface of the fitting, but ice still exists in the droplets. As the freezing cycle is re-initialized ice/frost begin to form again.
