Building Embankments with Shales

L. E. WOOD

C. W. LOVELL, JR.

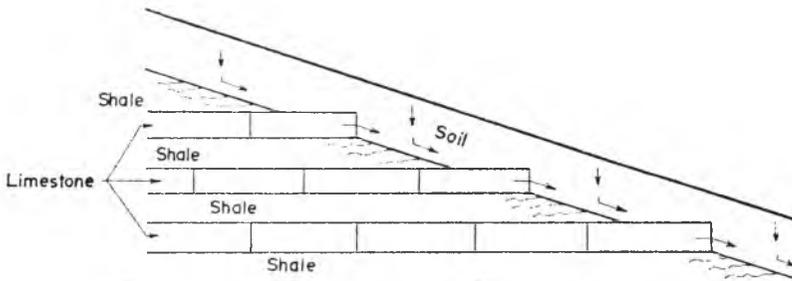
Fig. 2. Movement of Water at Soil-Bedrock Interface.

These soils are heterogeneous. Water movement through them tends to follow irregular pathways of least resistance. One part of the soil may be fairly dry, while another part close by is thoroughly saturated. The most important zone of weakness is immediately beneath the soil at the bedrock-soil interface. The reason for this is that the shale is less permeable than the soil, so that water seeping downward through the soil, as well as water seeping toward the outcrops in beds of limestone, tends to collect and move downslope at the bedrock-soil interface as shown in Figure 2.

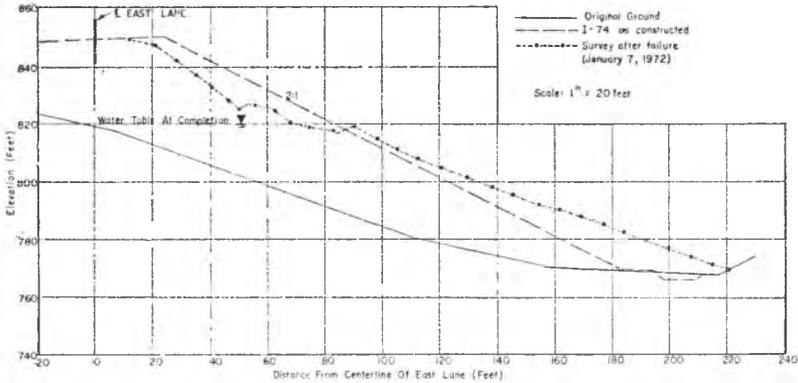
Fig. 3. Cross Section of I-74 Embankment Before and After Slope Failure.

The side slopes were 2 to 1. Figure 3 shows a cross section of the embankment after construction and after failure. According to the classification system proposed by the HRB Landslide Committee (6), the failure is a (rotational) slump slide. Figures 4(a) and (b) show the photographs of failure zones at two locations. Figure 4(a) shows

Before the failure occurred, the site experienced large settlements, which severely cracked the pavements and locally altered the drainage pattern. Nearby fills along I-74 have also experienced similar settlements, suggesting that they too ultimately will be landslide sites.

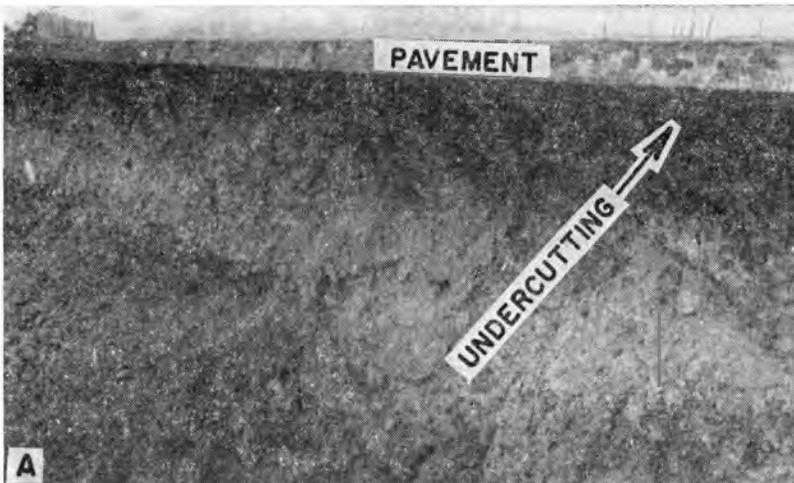
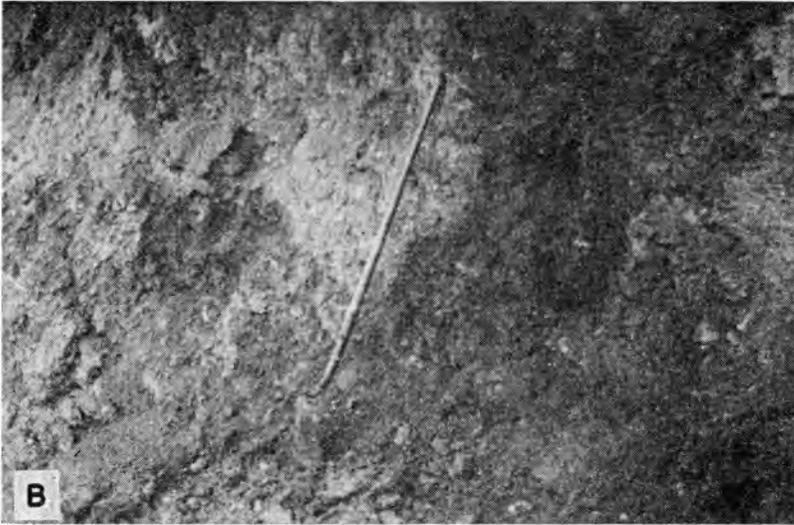
Fig. 4. Photographs of Failure Zone at Two Locations.

the main scarp of the slide; the surface is concave upward. Figure 4(b) shows a close-up of the scarp failure surface. Limestone pieces, shale chunks and soil mixtures could be seen here.

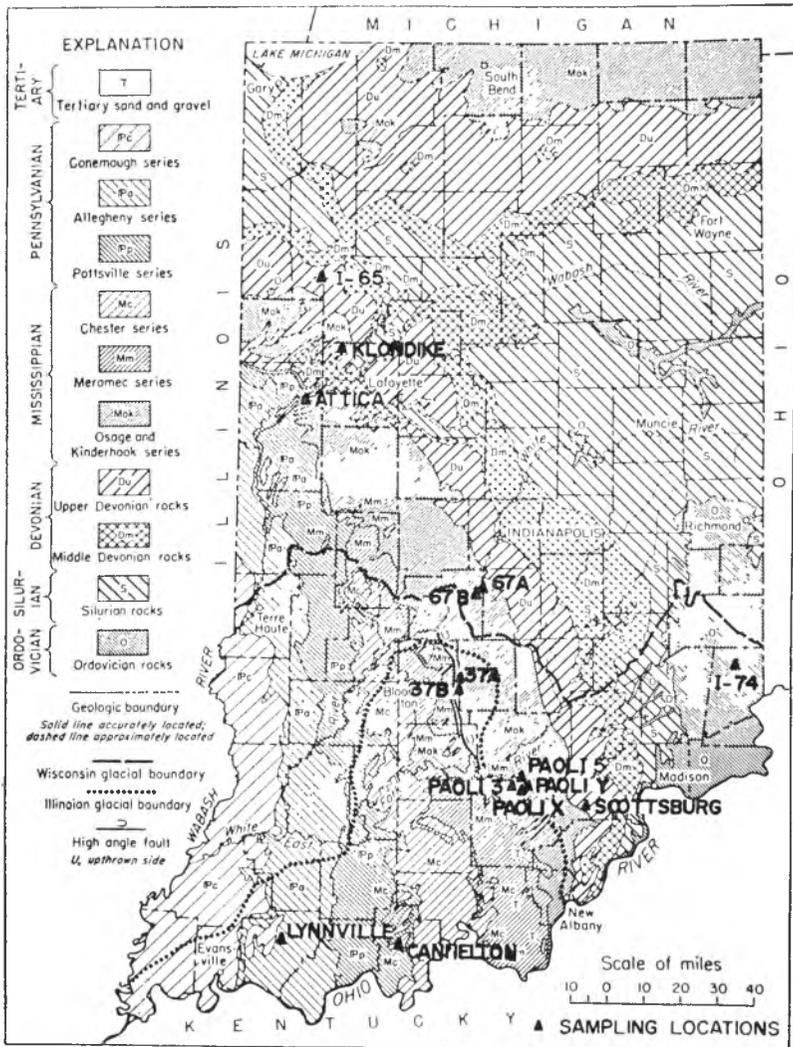
Fig. 5. Bedrock Geology of Indiana and Shale Sampling Locations.

The oldest geologic system of rocks in Indiana that contains shale is the Ordovician. These rocks are exposed in the southeastern part of the state (Figure 5). The previously mentioned Dillsboro Formation lies within the Ordovician. This formation consists of alternating beds

The sampling locations are shown on an Indiana state highway map in Figure 6. Sampling locations were also shown in Figure 5, which is the bedrock geology map of Indiana. Ten of the 15 samples, namely, Klondike, Attica, 67A, 67B, 37A, 37B, Paoli 3, Paoli 5, Paoli X, and Paoli Y are Borden shales of the Osage Series, which is early Mississippian in age (about 330 million years). One, the Cannelton shale, is of the Chester Series, which is of late Mississippian age (about 310 million years). Two, I-65 and Scottsburg shales, are of the New Albany Formation of upper Devonian age (about 350 million years). The Lynnville shale is of the Allegheny Series of middle Pennsylvanian age (about 290 million years). The I-74 shale is of the Dillsboro Formation of late Ordovician age (about 430 million years).

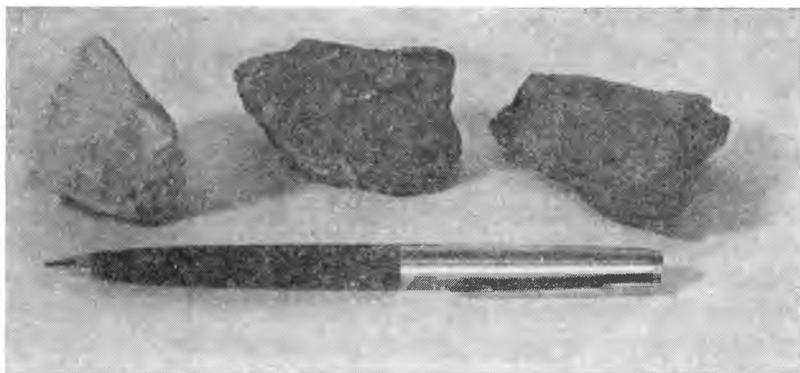
Fig. 7. Massive Breaking Type.

Massive rocks have no preferred directions of cleaving and breaking. Most of the fragments are blocky. Flaggy rocks will split into fragments of varying thickness, but the width and length are many times greater than the thickness, and the two essentially flat sides are approximately parallel. Flaky shales split along irregular surfaces parallel to the bedding, and into uneven flakes, thin chips, and wedge-like fragments whose length seldom exceeds three inches. The three breaking types are shown in Figures 7, 8 and 9.

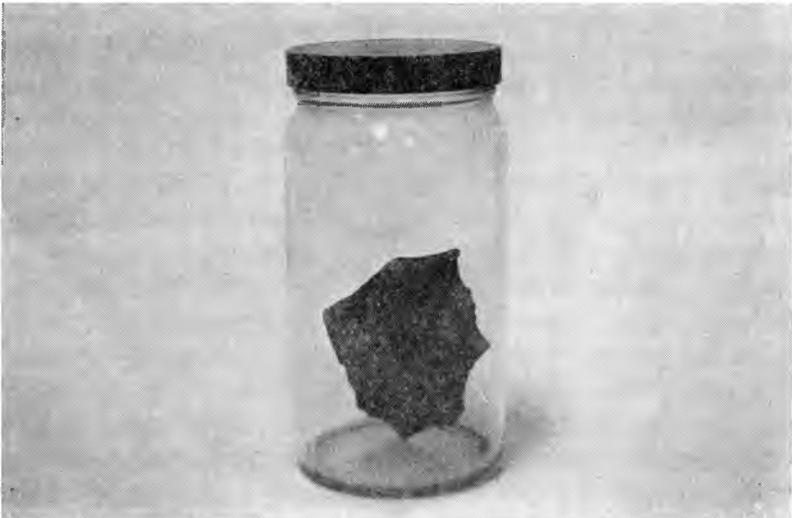
Fig. 10. Cannelton Shale Before Immersion in Water.

Figures 10, 11, and 12 show the extremes of material response in this test. The results of one cycle of wetting are reported Table 1. It

Sample	Slaking Time	Remarks
Cannelton	8-10 minutes.	Completely breaks down.
I-74	Partial slaking in 24 hours.	About one fourth of material is reduced to thin flakes or very small pieces.
Paoli Y	Negligible slaking in 24 hours.	After 24 hours the piece is still intact. However the wa- ter becomes somewhat dirty.
Paoli X; I-65; Paoli 3; Paoli 5; Lynnville; Attica; 67A; 67B; 37A; 37B; Scottsburg; and Klondike	No slaking in 24 hours.	No change in piece or sur- rounding water after 24 hours.

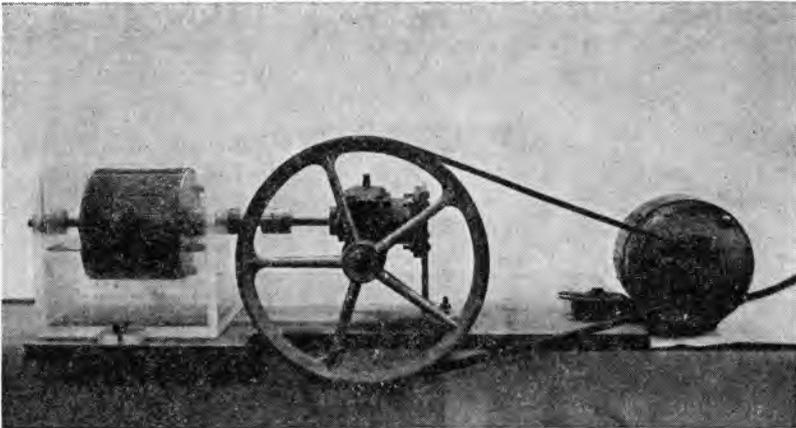
Fig. 13. Slake Durability Apparatus.

The apparatus was developed by Franklin and others at Imperial College London in 1970 (10). The test procedure was modified to suit Indiana shales. The apparatus, shown in Figures 13 and 14, consisted of a drum of 2 mm mesh, 10 cm in length and 14 cm in diameter. A motor drive unit attached to the drum was capable of revolving it at a speed of 20 revolutions per minute. The drum was rotated in a water trough which was mounted to the base board.

A sample of ten representative shale pieces, each weighing 50 to 60 gm, was oven dried and placed in the test drum. The drum was now half immersed in the water bath and rotated. Material detached from

the pieces passed through the mesh, i.e., became a sample weight loss. The durability number was calculated as the percentage ratio of final to initial dry sample weights.
